DUNHAM BRIDGE COMPANY

APPLICATION TO REVISE TOLL CHARGES

Under the Transport Charges etc. (Miscellaneous Provisions) Act 1954
Section 6 Dunham Bridge Act 1830 and Dunham Bridge (Amendment) Act 1994

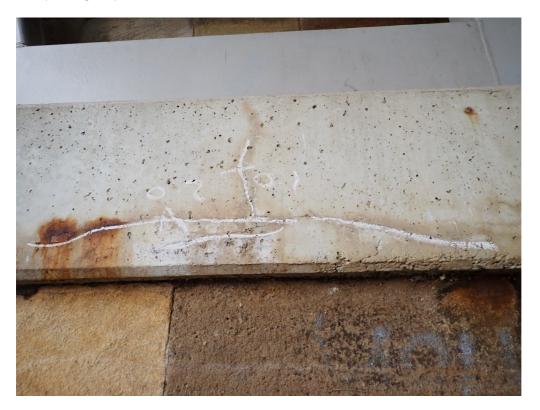
Plate 37. Reinforcement corrosion cracking to West Abutment concrete cap

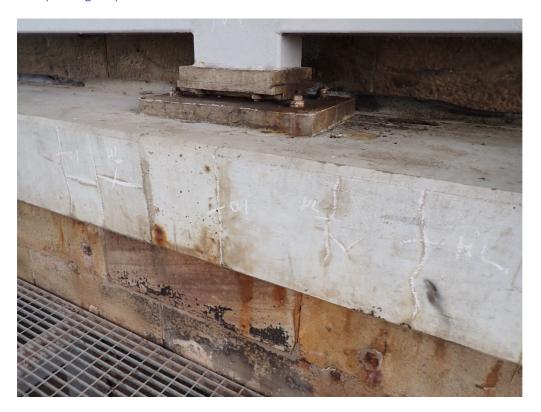
Plate 39. Reinforcement corrosion cracking to East Abutment concrete cap.

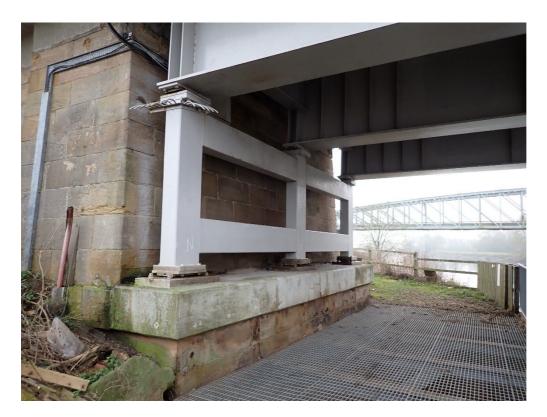
Plate 40. Repair to front face of East Abutment concrete cap

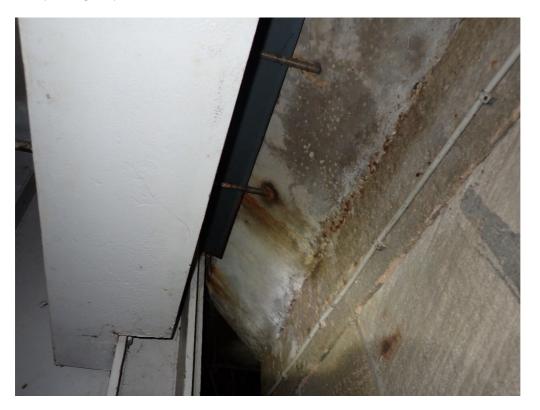
Plate 41. Rust staining emanating from the drainage deflector on the West Abutment, south end

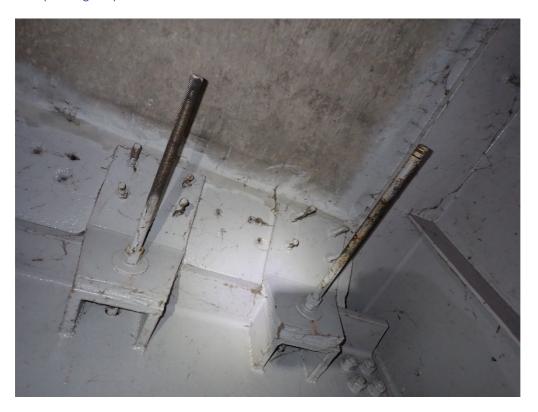
Plate 43. Exposed anchorage bars at the West Abutment, partially painted

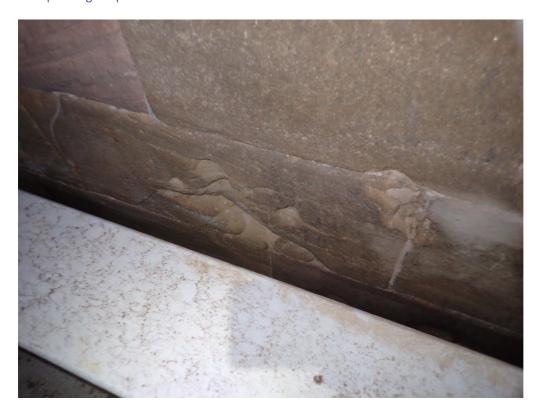
Plate 45. Shallow spall to West Abutment stone

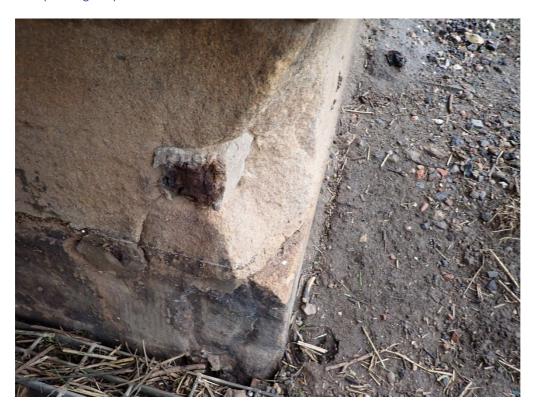
Plate 47. Spall to stone in the East Abutment adjacent to historic fixing, 300 x 10 x 40mm.

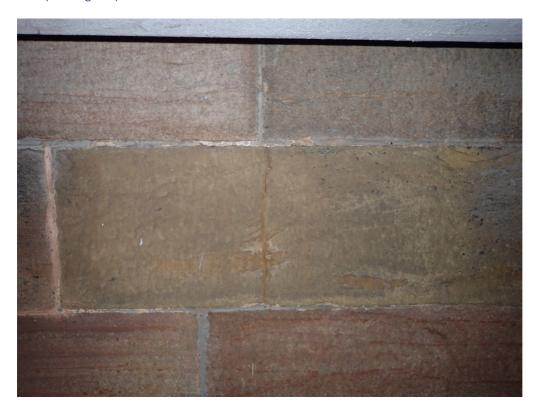
Plate 49. Fine cracking through stones in the East Abutment back wall

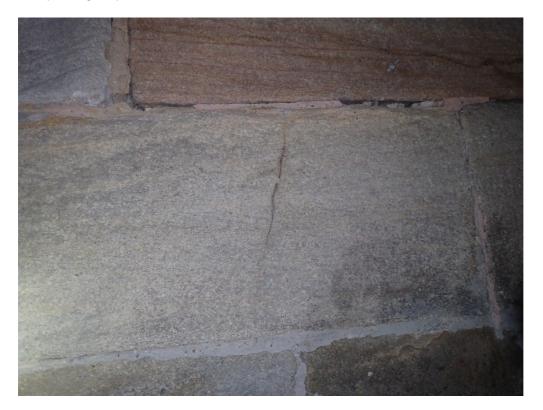
Plate 51. Fine cracking through stones in the West Abutment back wall

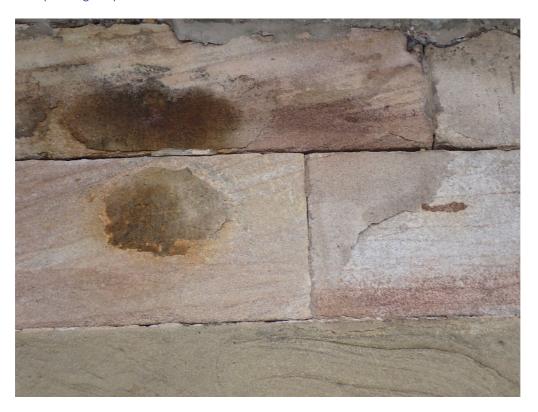
Plate 53. Mortar loss between the East Abutment brickwork

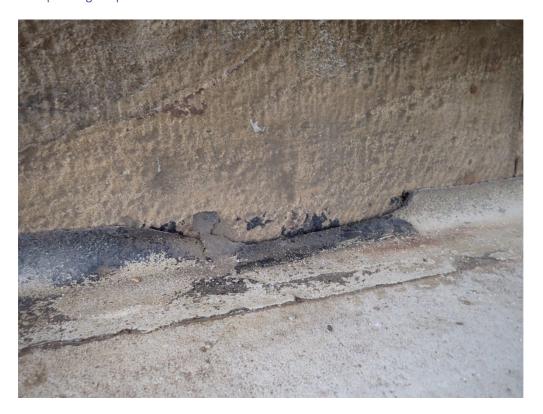
Plate 55. Damage to felt on the East Abutment

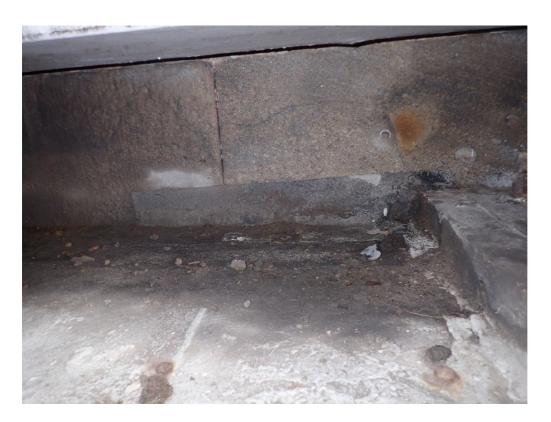
Plate 56. Damage to felt on the West Abutment

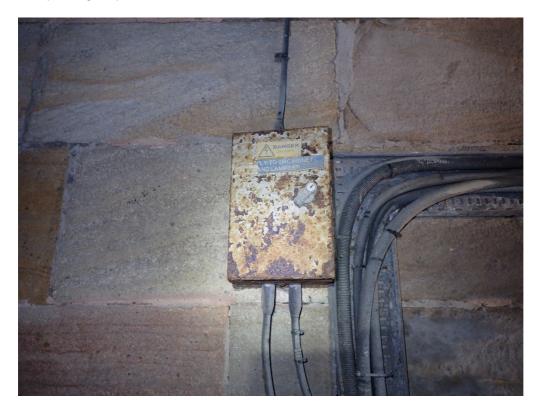
Plate 57. Open and corroded cathodic protection cabinet on the West Abutment back all

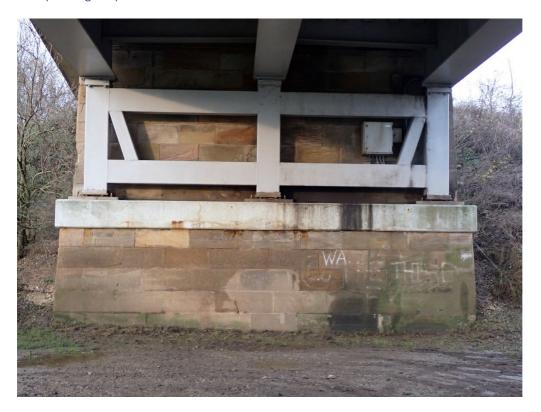
Plate 59. Painted Graffiti on the West Abutment

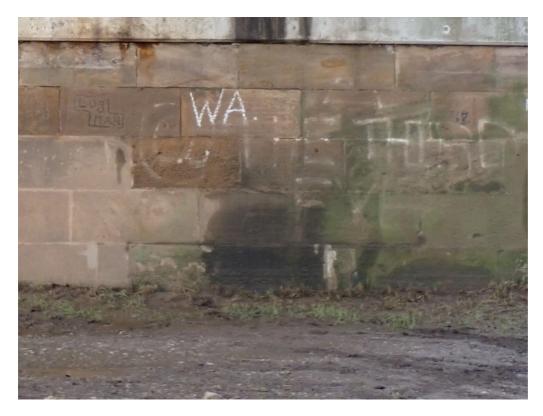
Plate 60. Historic fire damage to the West Abutment

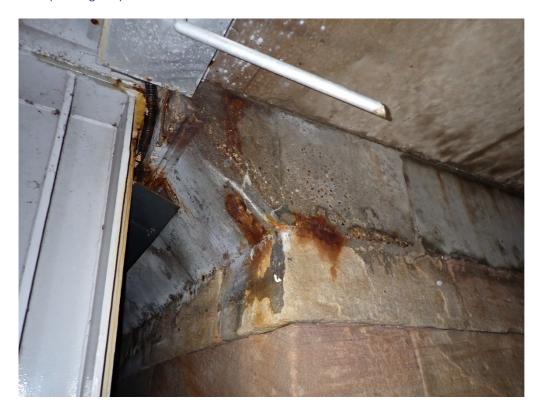
Plate 61. Rust Staining to Slab above South-East Wing Wall

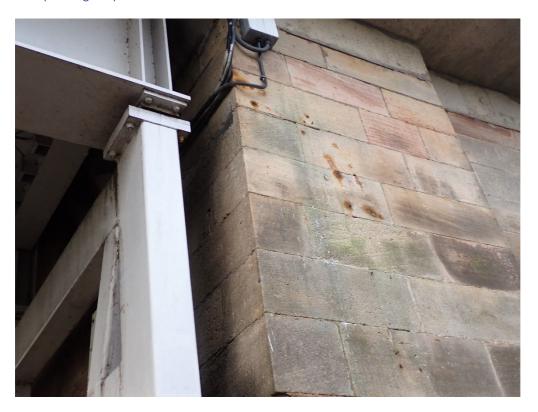
Plate 63. Corroded Historic Fixings, North-West Wing Wall

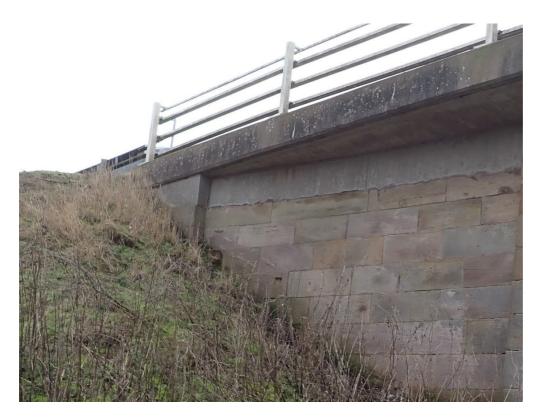
Plate 64. Evidence of Old Cable Tray, North-East Wing Wall

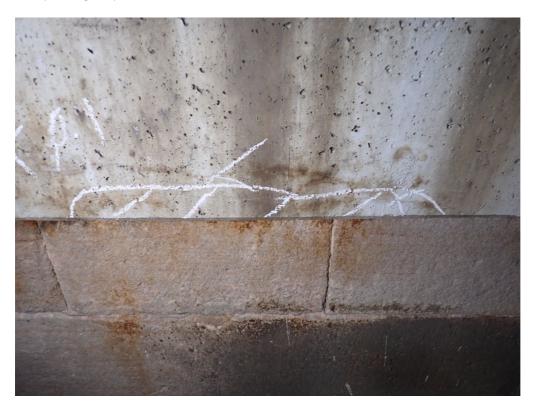
Plate 65. Reinforcement corrosion cracking with adjacent delamination 770 x 80mm, Centre Pier

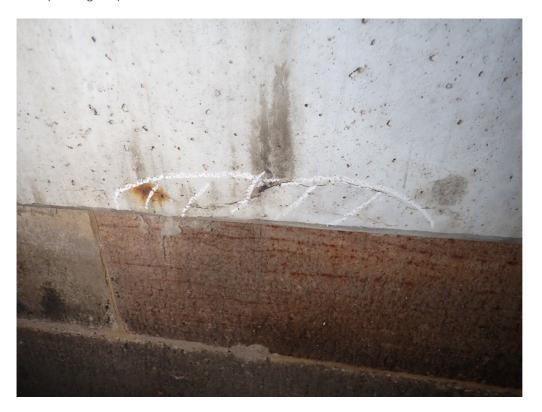
Plate 67. Delamination to the East face of the Centre Pier, 490 x 80mm with corrosion cracking

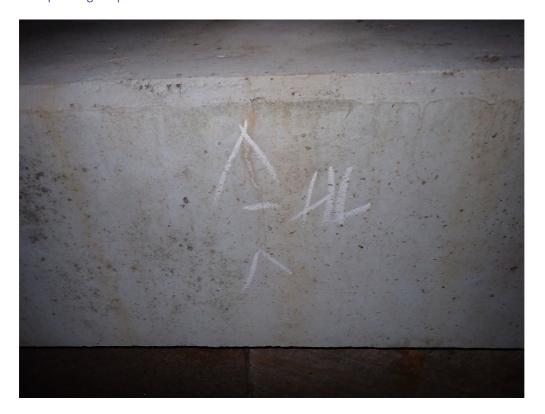
Plate 69. Cracking to the East Pier concrete cap

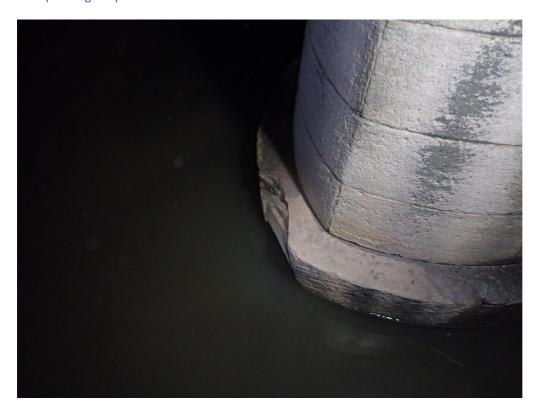
Plate 71. Spall to Downstream End of the Centre Pier

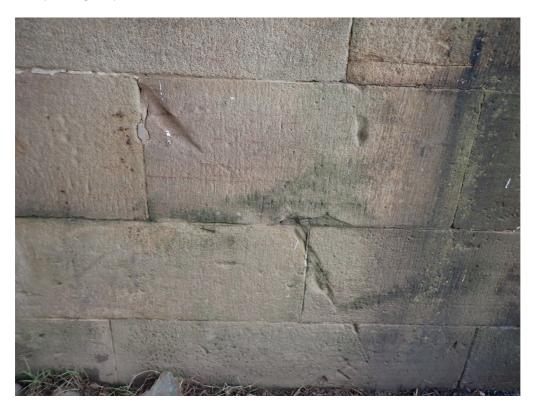
Plate 73. Impact Scraping to the West Pier

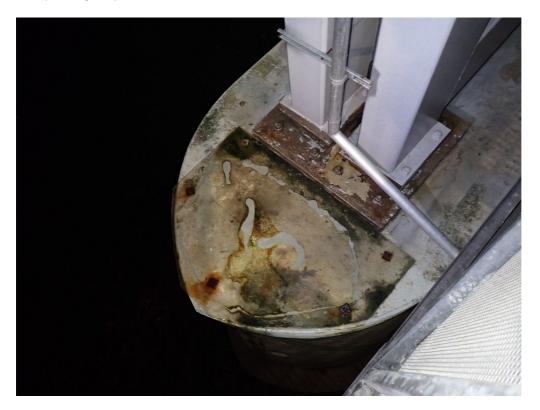
Plate 75. Water staining to upstream end of the Centre Pier

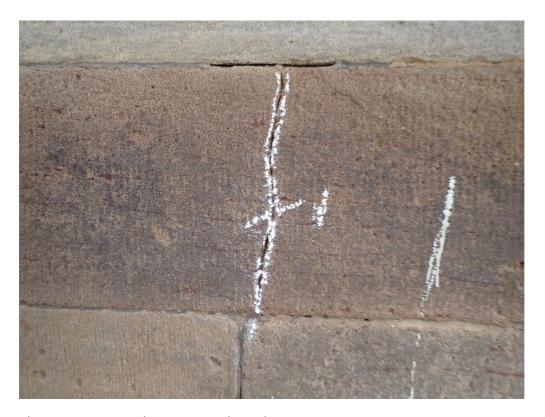
Plate 78. Cracking 1mm wide to the West Pier

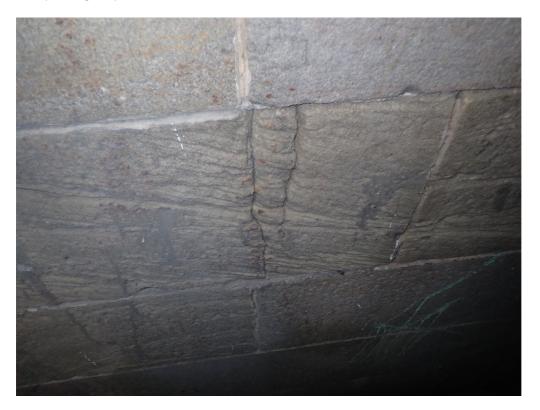
Plate 79. Crack Through Stone in the West Pier

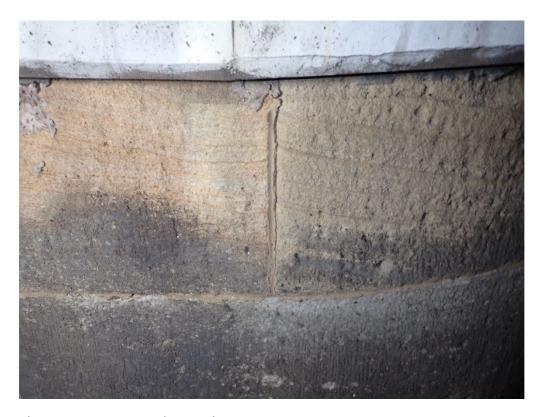
Plate 80. Mortar loss to the East Pier

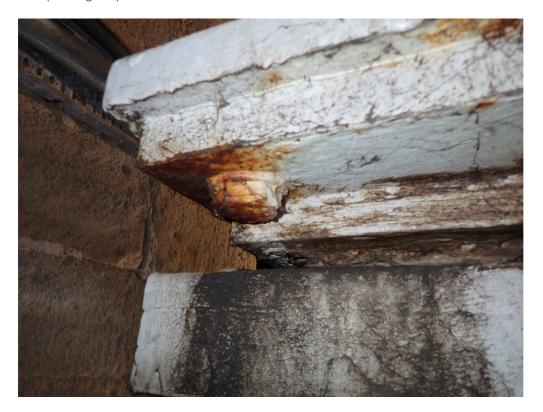
Plate 83. Rust staining to upper connection of upper Bearing, West Abutment

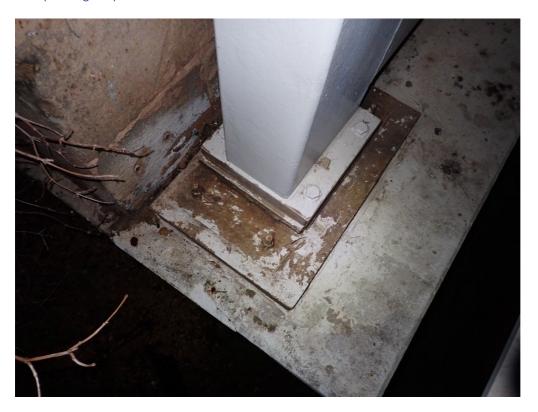
Plate 85. Protective paint loss on the West Abutment lower bearing

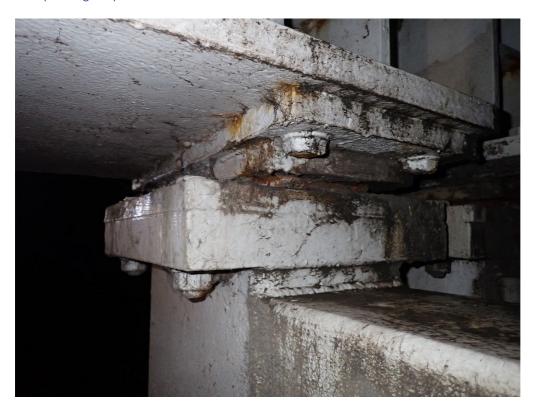
Plate 87. Rust staining to the upper bearing on the West Pier

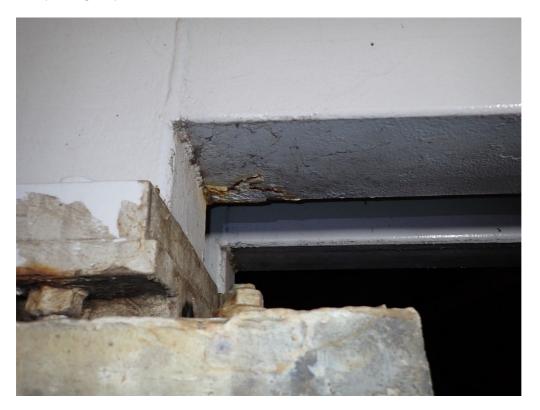
Plate 89. Paint blistering on the East Pier cross beam

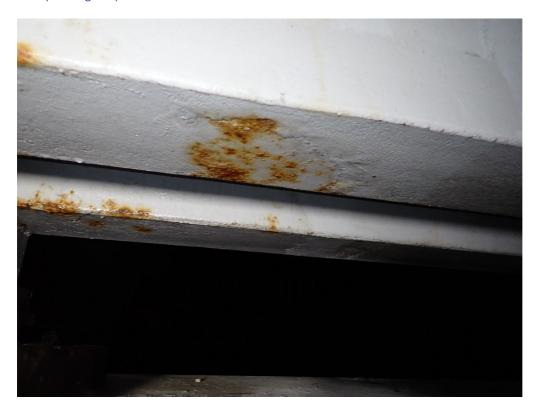
Plate 91. Minor corrosion to the centre Pier cross beam

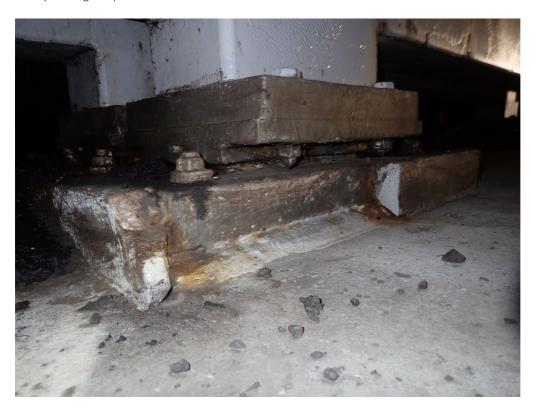
Plate 93. Spalling to the lower bearing plinth on the Centre Pier

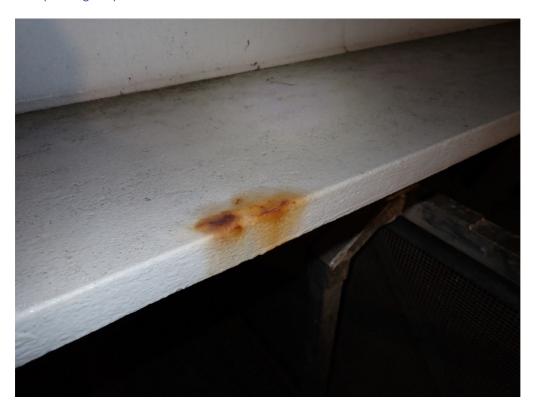
Plate 95. Flaking paint and minor underlying corrosion to North Beam, West Span

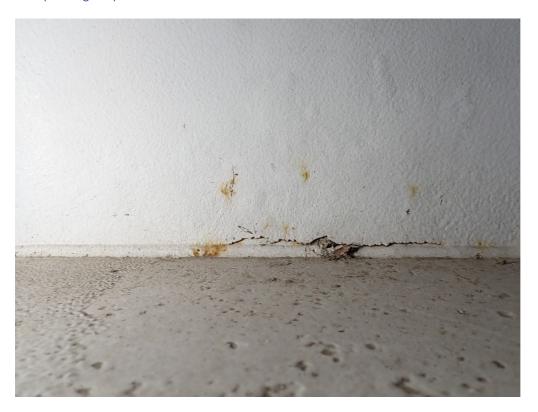
Plate 97. Cracked paint to the North beam on the inner West Span

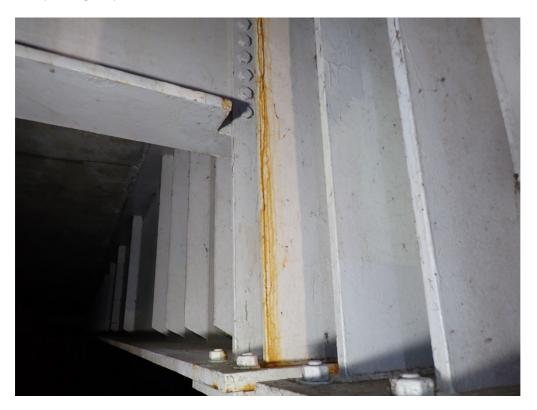
Plate 99. Corrosion Staining to steelwork above the West Pier

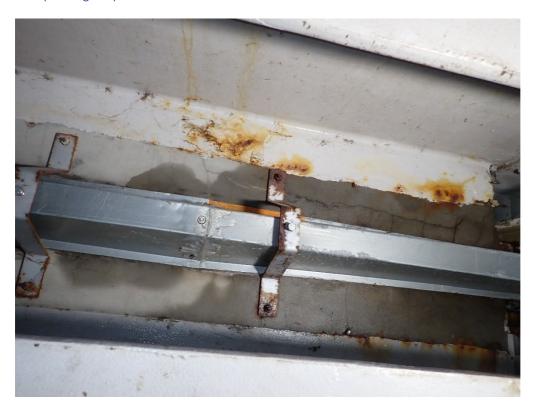
Plate 101. Corrosion to transverse beam at the Centre Pier

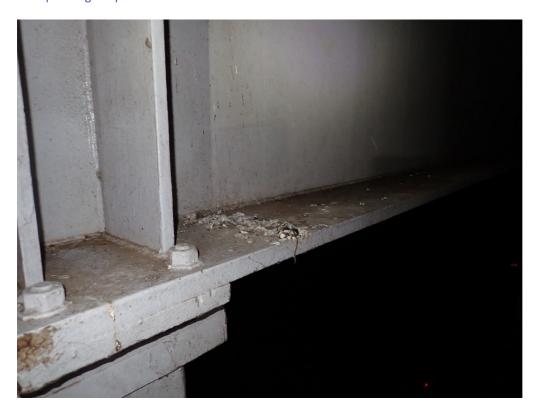
Plate 103. Bird dropping to the South edge beam adjacent the East Pier

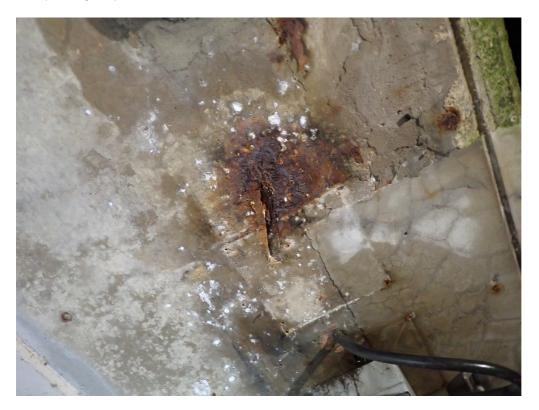
Plate 107. Minor spall and cracked repair to the North edge beam on the West inner span

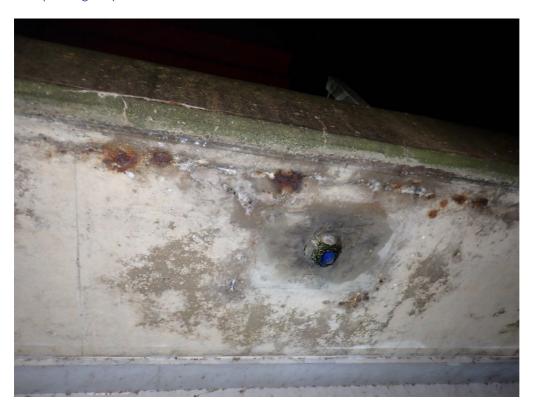
Plate 111. Rust staining to the North edge beam, inner East span

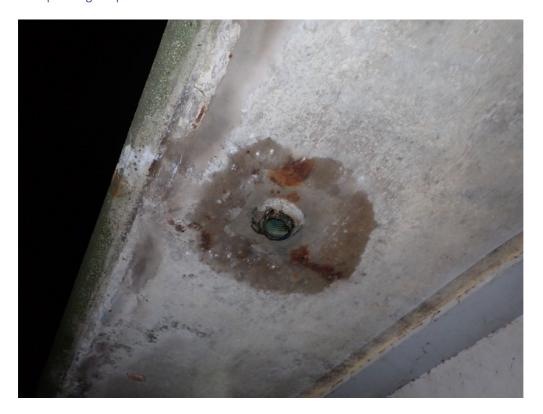
Plate 113. Rust staining adjacent to deck drainage outlet

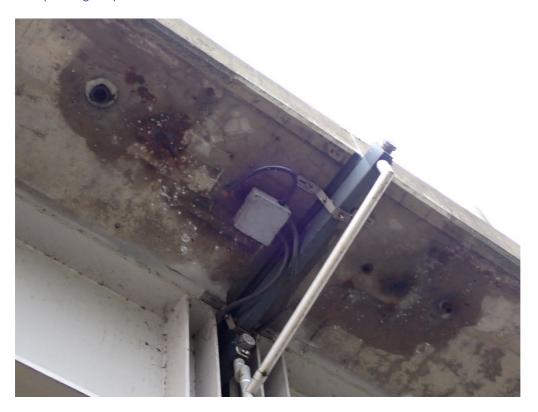
Plate 115. Water seepage to the deck soffit on the North end at the West Joint

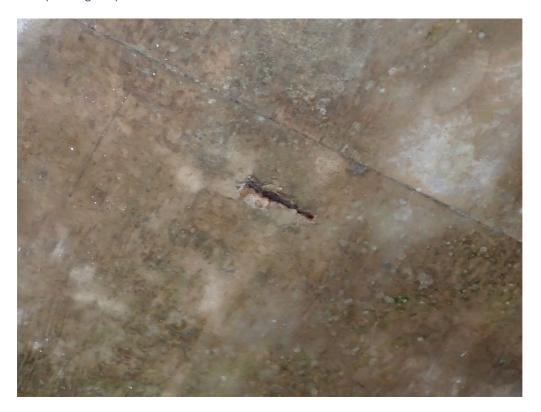
Plate 117. Exposed reinforcement in East Span

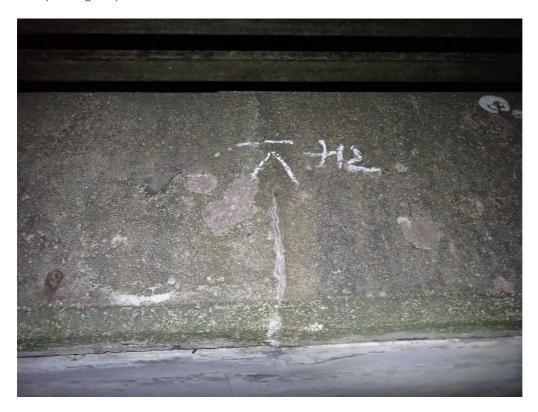
Plate 119. Crack with leachate to the West Span edge beam

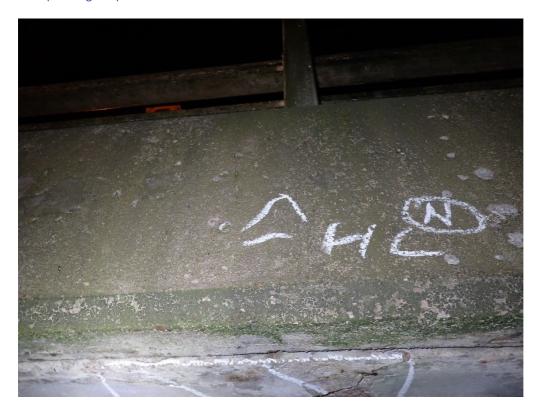
Plate 121. Hairline cracking North edge beam, West Span

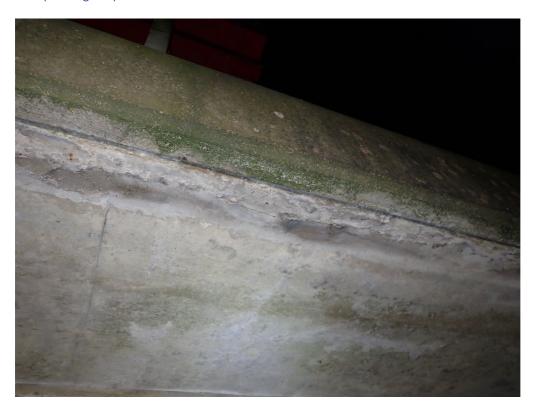
Plate 123. Long narrow repair, inner West Span, South Cantilever Soffit

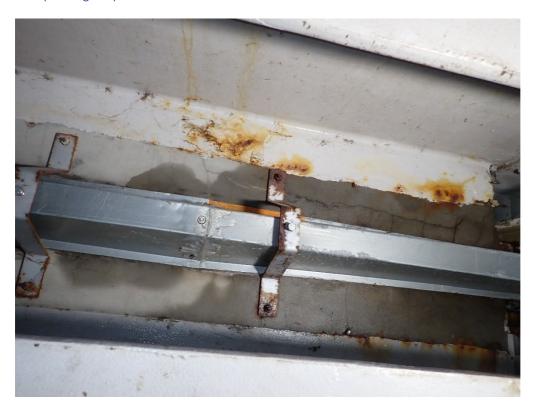
Plate 129. Corrosion to fixings on the Centre Pier joint drainage

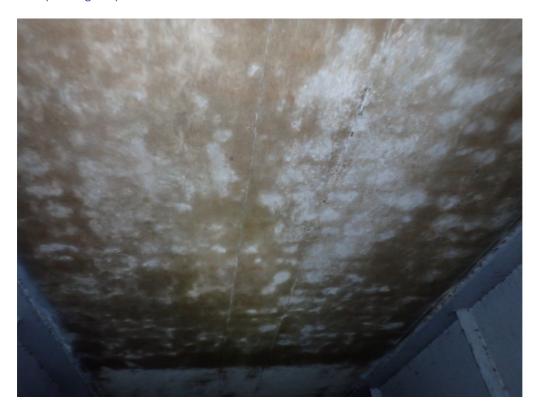
Plate 131. Water staining to the East Span adjacent the East Pier

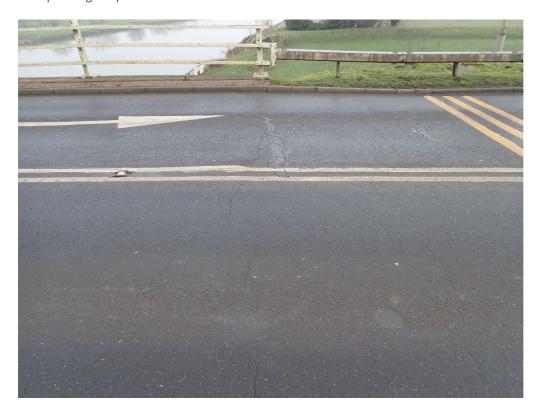
Plate 133. Settlement and transverse cracking on the West Approach

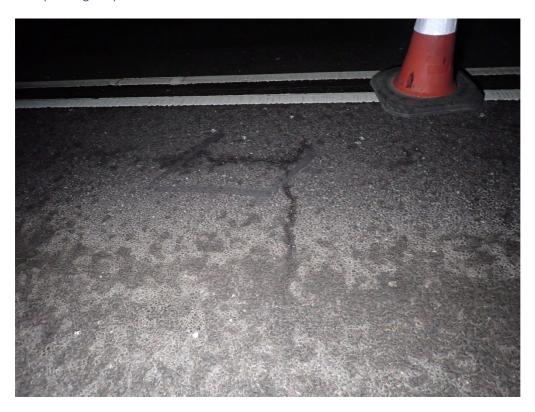
Plate 135. Open and sealed cracks in surfacing on the East Span

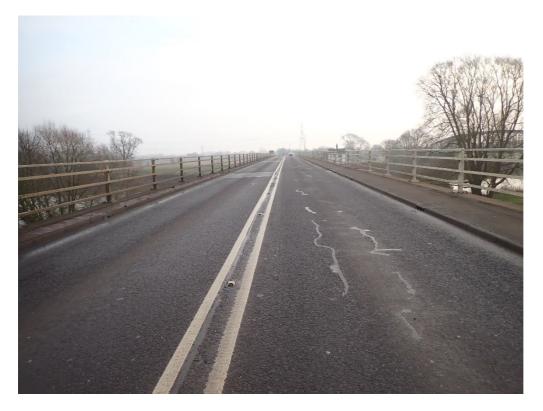
Plate 137. Typical carriageway condition, Inner West Span

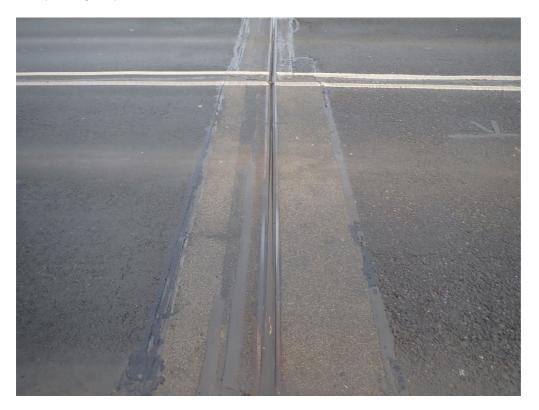
Plate 145. Failed repair to cracking adjacent to the West Abutment Joint

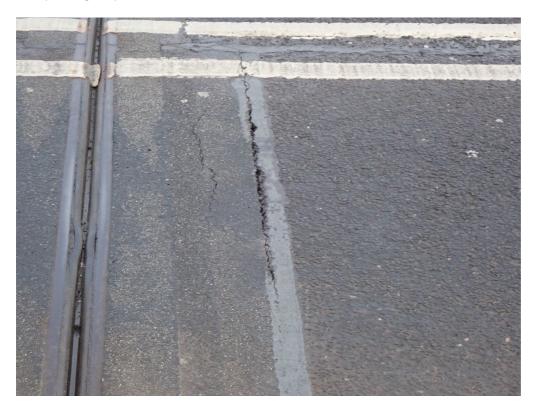
Plate 147. Cracking in the nosing material of the East Pier joint

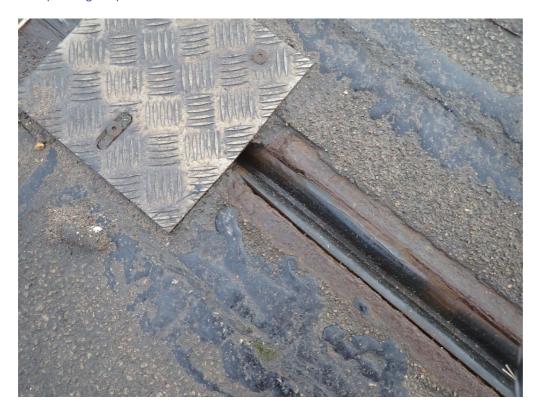
Plate 149. Corrosion and minor lamination to the West Abutment joint rails

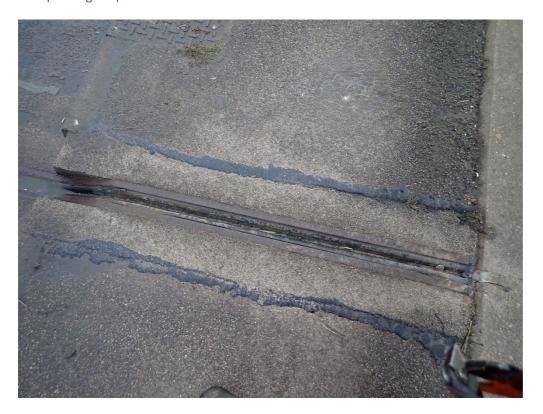
Plate 151. Corrosion to Nosing Rails of the Centre Pier Joint

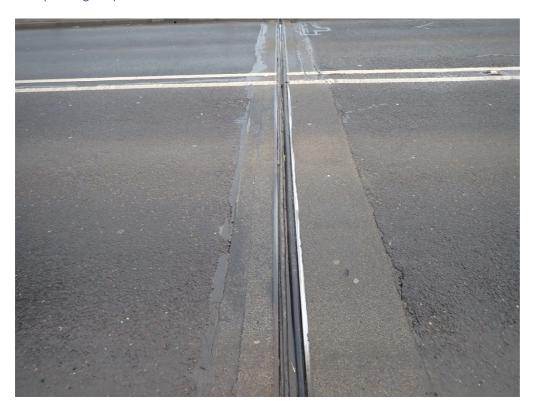
Plate 153. Large Deformed Area of Joint Seal, Centre Pier Joint

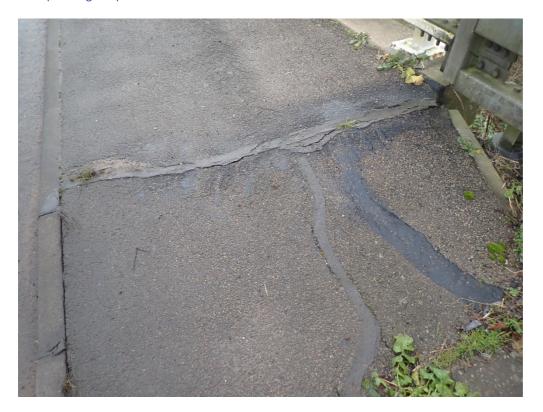
Plate 157. Surface and cracking repairs at the West end of the South Footpath on the approach

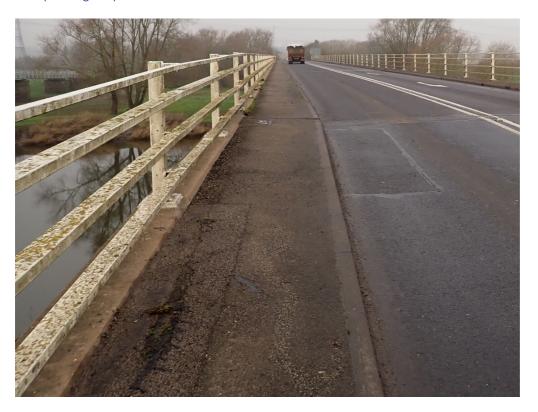
Plate 159. Cracking on the East Approach of the South footpath

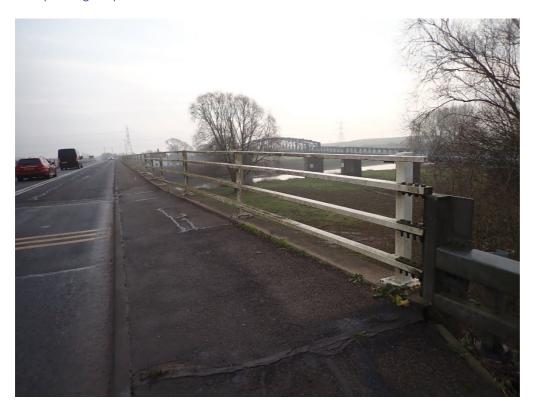
Plate 161. Repair to Crack in the South Footpath

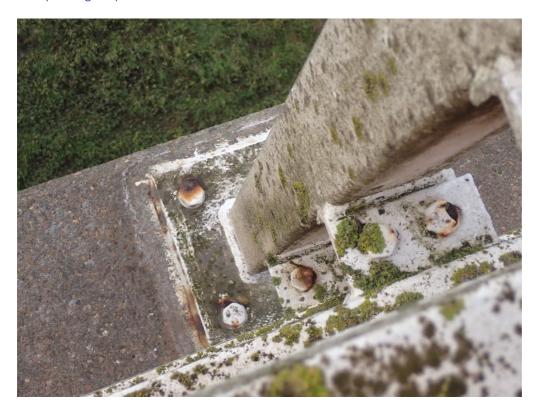
Plate 163. Typical Rust Staining to Parapet post base plates

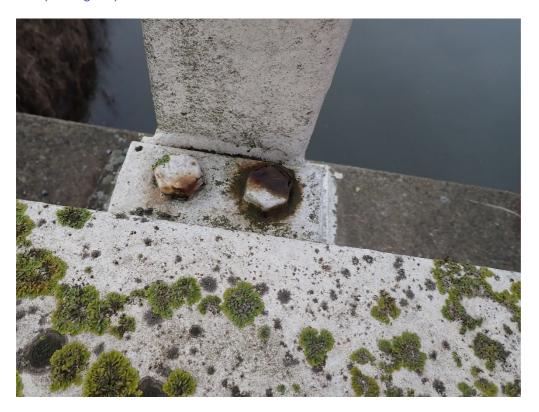
Plate 165. Typical Corrosion to Fixings Where Paint Has Failed

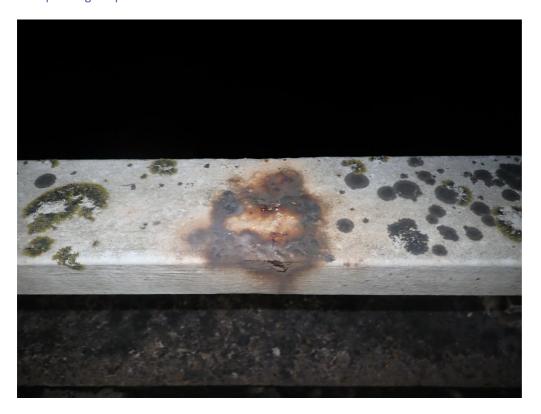
Plate 167. Area of paint loss to the North Parapet where corrosion has occurred

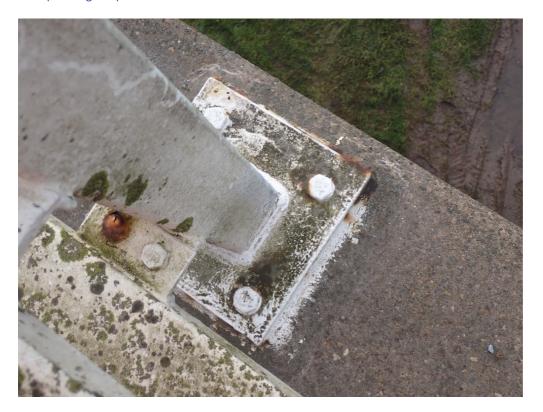
Plate 169. Typical cracking to Parapet base plate mortar

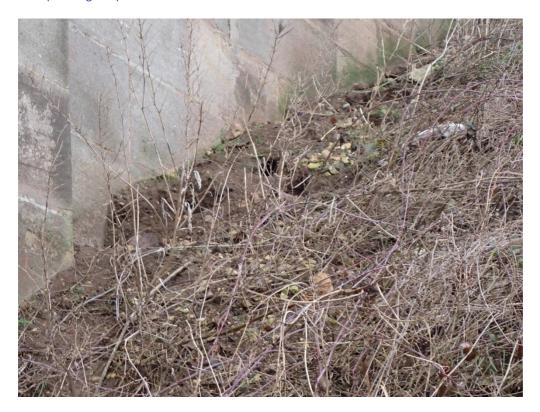
Plate 171. Animal burrows on the bank adjacent to the South-West Wing Wall

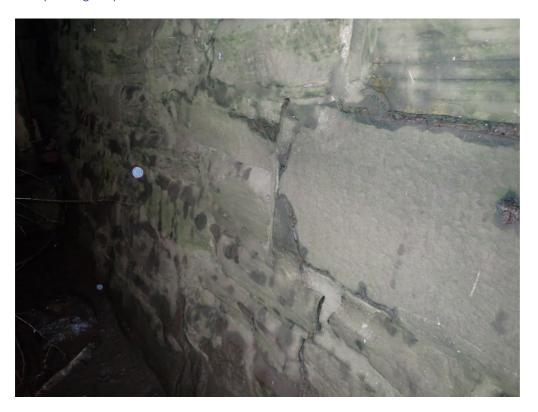
Plate 173. Vertical crack in the North Face of the South Retaining Wall

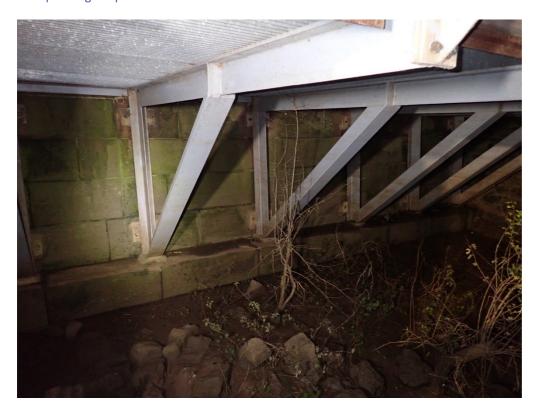
Plate 177. Typical Condition of Walkway Frame

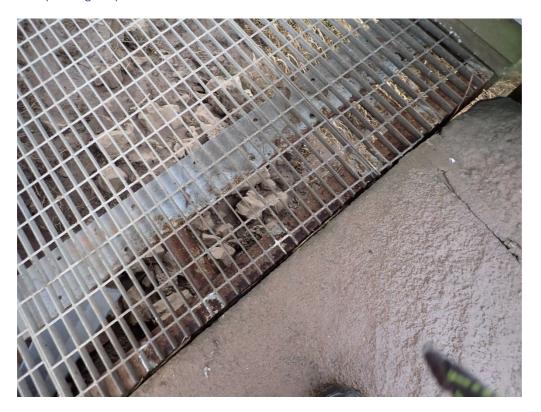
Plate 179. Corrosion to the topside of the Walkway supports
