DUNHAM BRIDGE COMPANY

APPLICATION TO REVISE TOLL CHARGES

THE DUNHAM BRIDGE COMPANY

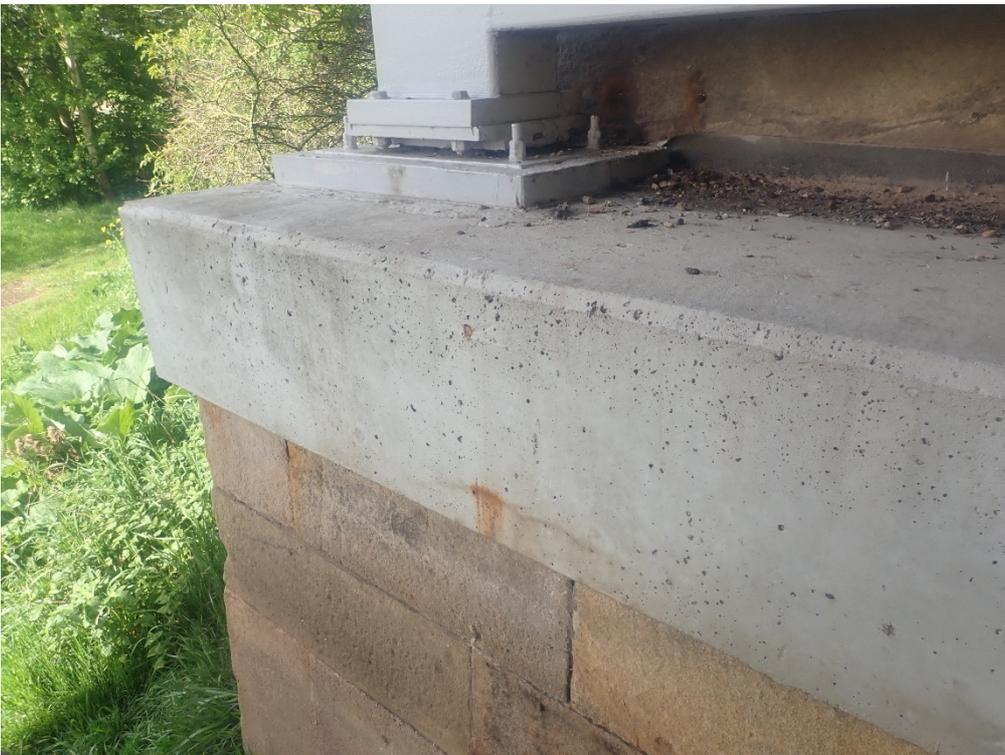
Fine cracking was visible on the vertical face of the reinforced concrete caps on both abutments. Two notable horizontal cracks in the West abutment cap and one in the East abutment cap had associated rust staining implying corrosion to the reinforcement. The cracks on the West abutment cap were 1050mm and 350mm long respectively with the

Plate 38. Reinforcement Corrosion Cracking to West Abutment Concrete Cap

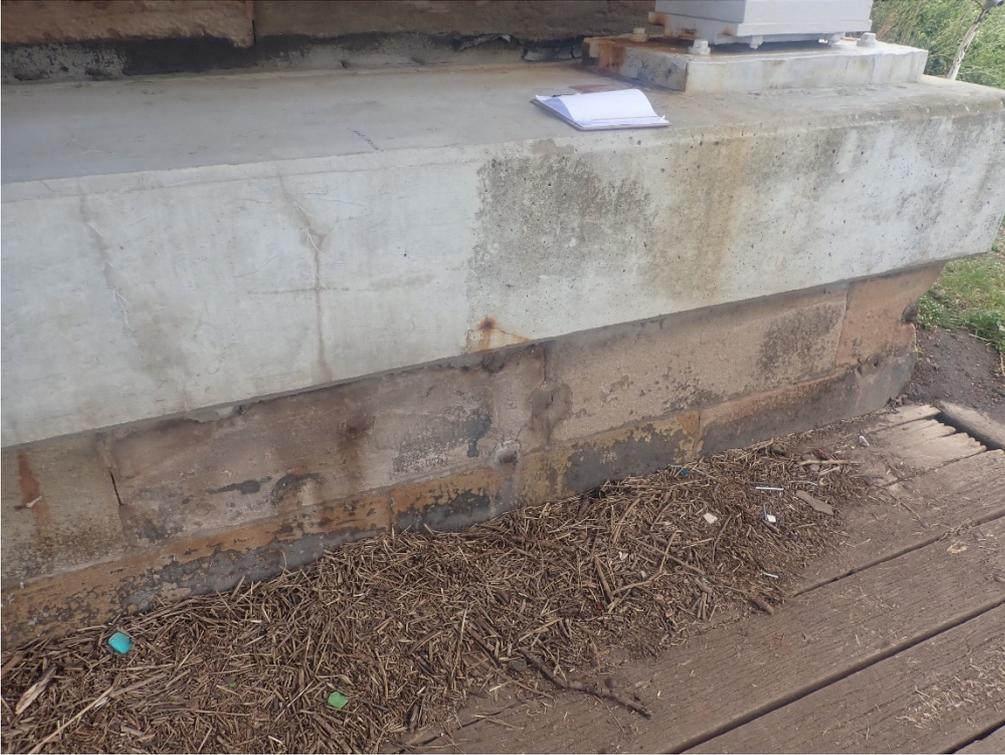
Plate 39. Reinforcement Corrosion Cracking to East Abutment Concrete Cap

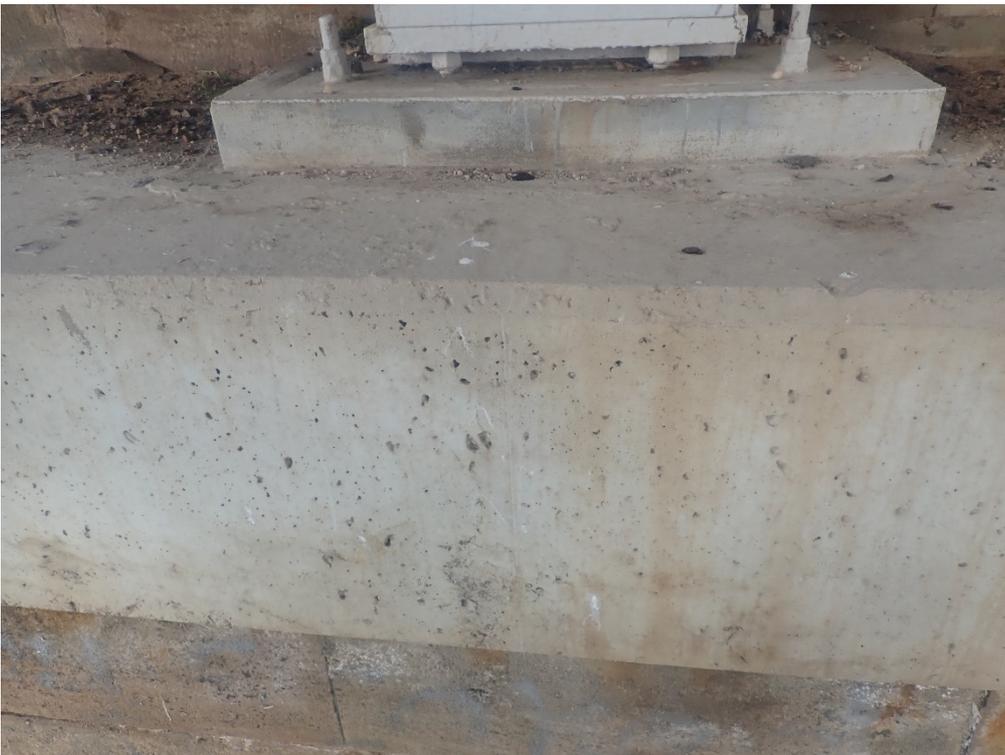
East abutment crack being much shorter. Rust staining was noted on the stone beneath the cracking in the West abutment cap. There was no hollow sounding concrete around the cracks when struck with an inspection hammer at the time of the inspection. Other vertical cracks were also noted but were much finer and likely to be shrinkage cracking. Plates 37 – 40.

Plate 40. Typical Fine Vertical Cracking to Caps, West Abutment

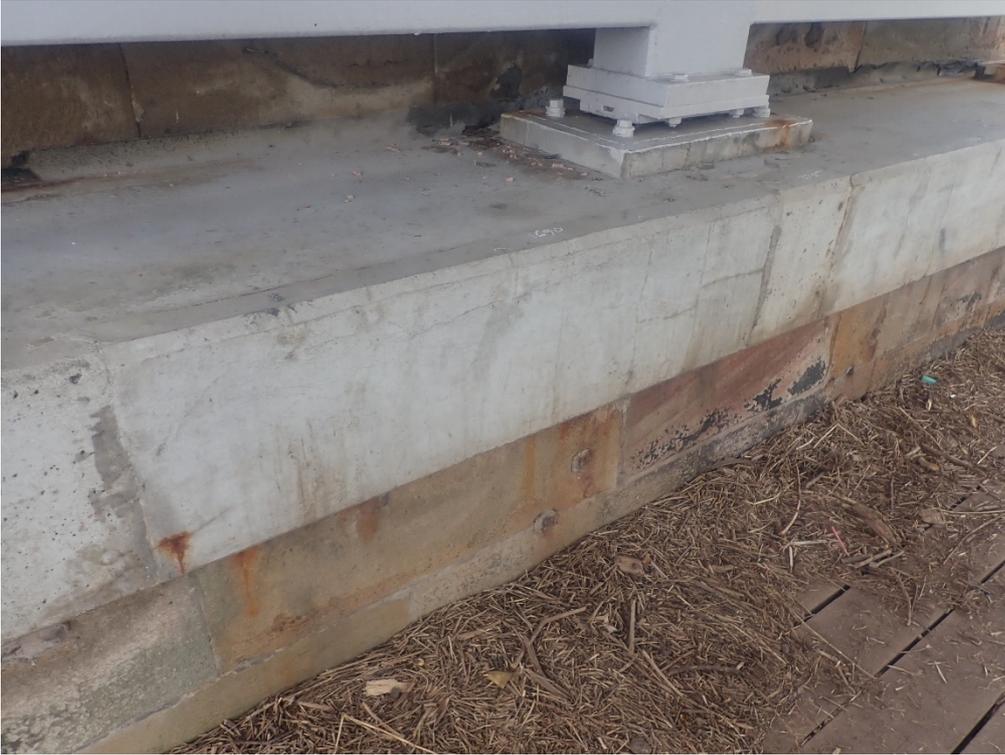
On the front face of the East abutment reinforced concrete cap there were two full height areas of repair measuring 1690mm and 1900mm, respectively. The repairs were sound when struck with an inspection hammer, but cracking was common, most likely shrinkage cracking. There was cracking with associated rust staining at the base of the North repair. Plates 41 – 43.

Plate 41. Repair to Front Face of East Abutment Concrete Cap

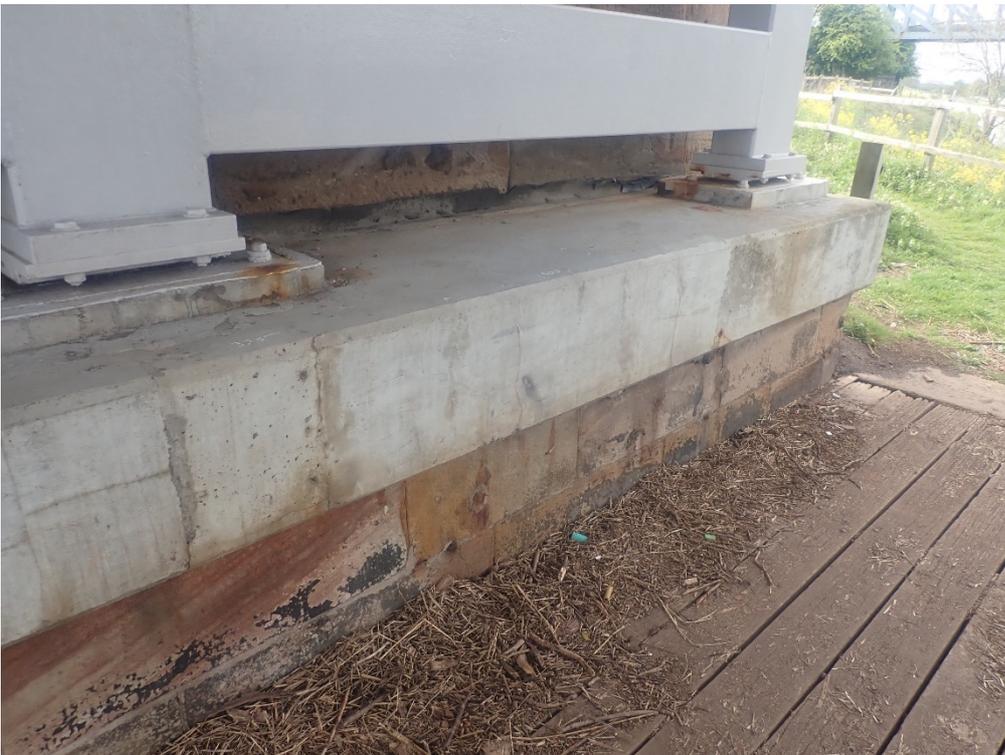
Plate 42. Repair to Front Face of East Abutment Concrete Cap

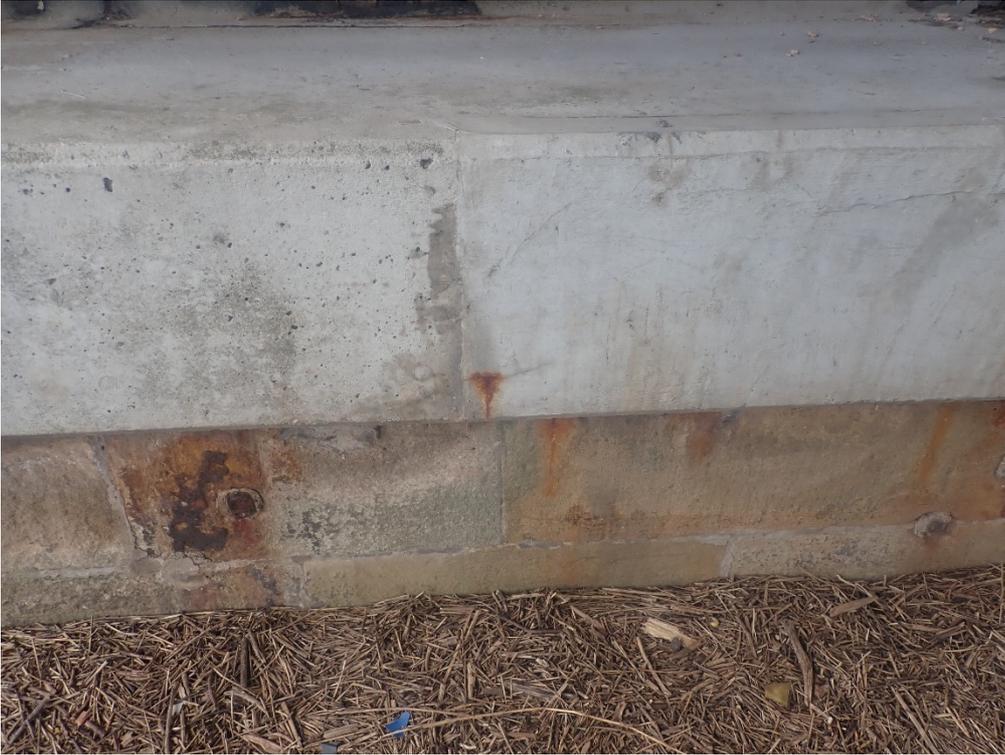
Anchorage bars embedded at the top of the back wall on the West abutment appeared to have been previously coated in a bitumen wrap. There was a residue on the anchor bolts which had been partially painted locally, with minor corrosion visible. Plates 44 – 46.

Plate 43. Rust Staining to North Repair, East Abutment

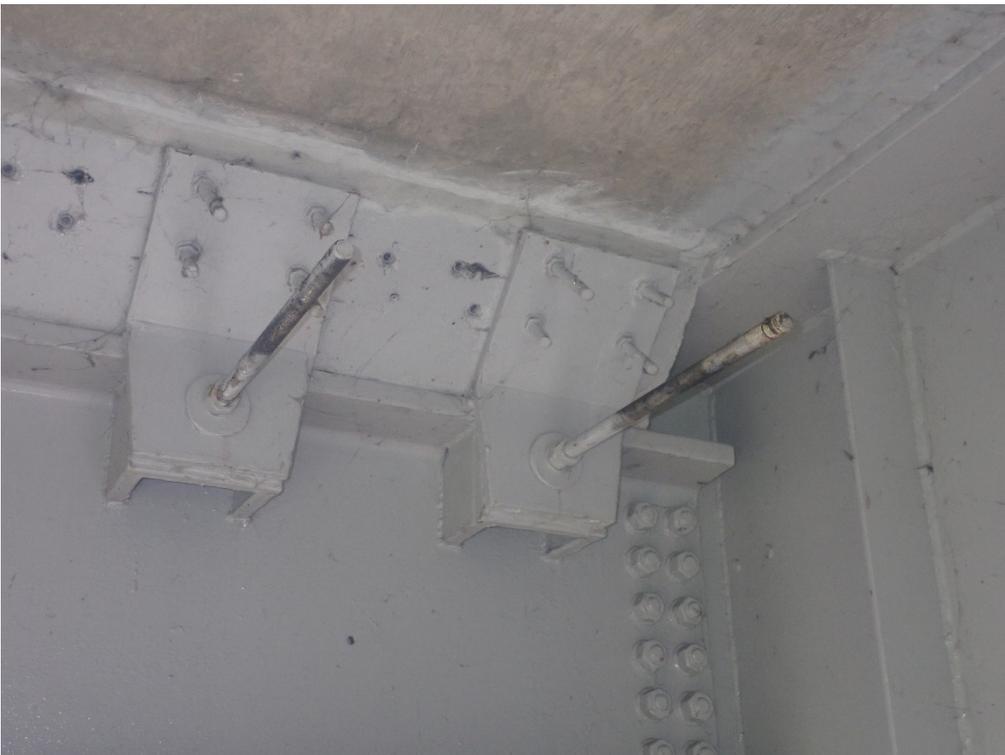
Plate 44. Exposed Anchorage Bars at the West Abutment, Partially Painted with Old Residue

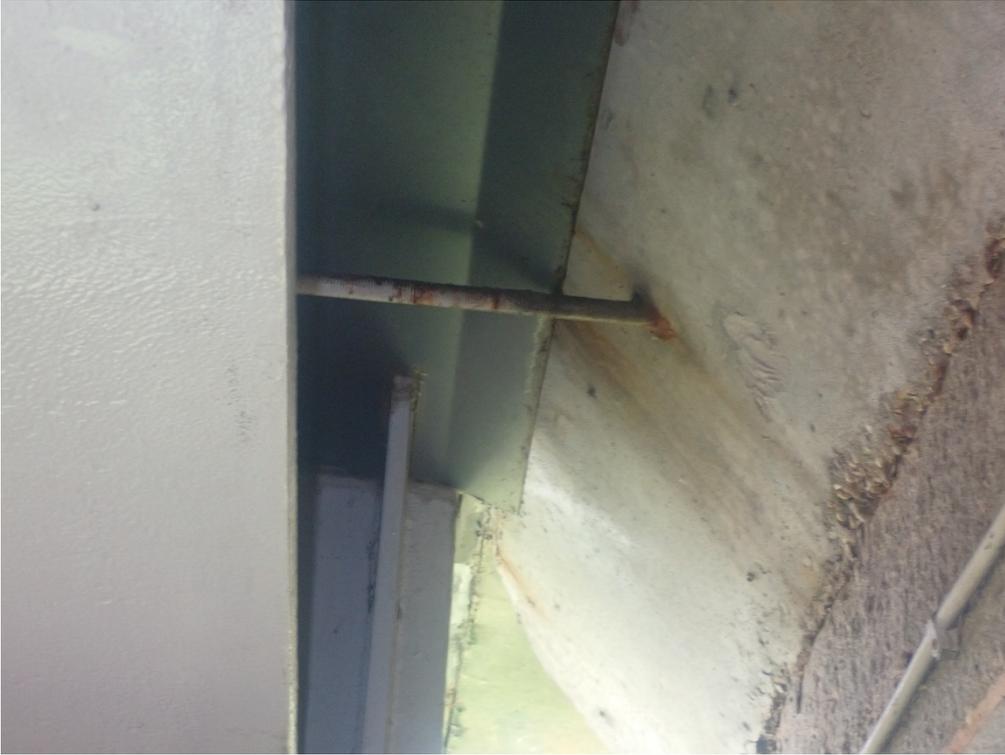
Plate 45. Corrosion to Anchorage Bar

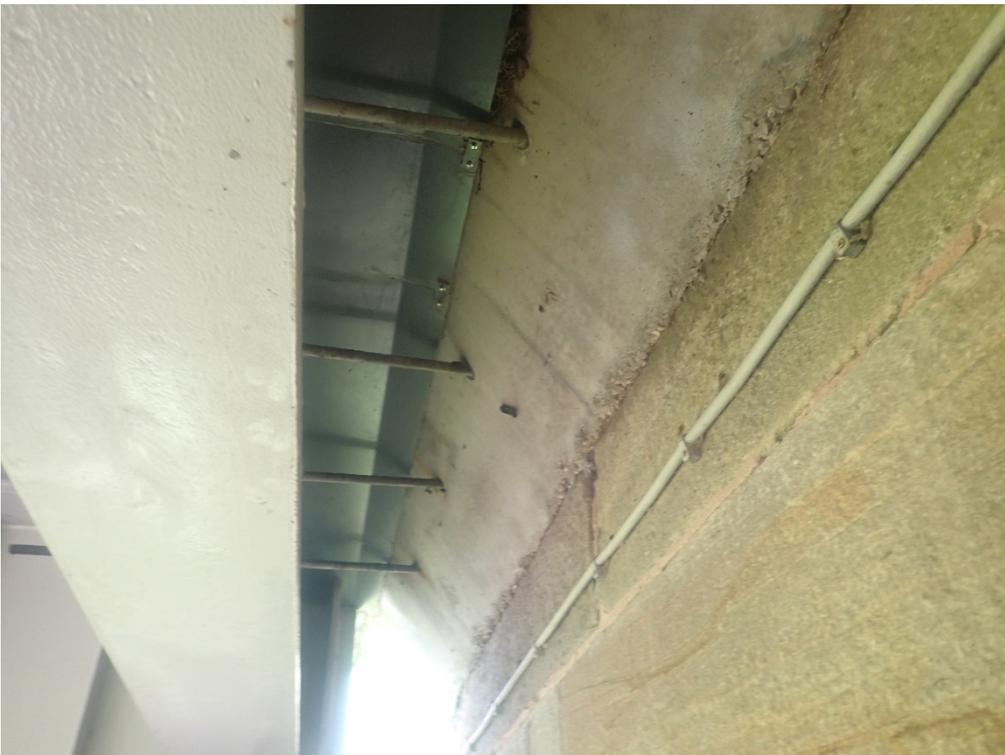
Plate 46. Typical Condition of Anchorage Bars

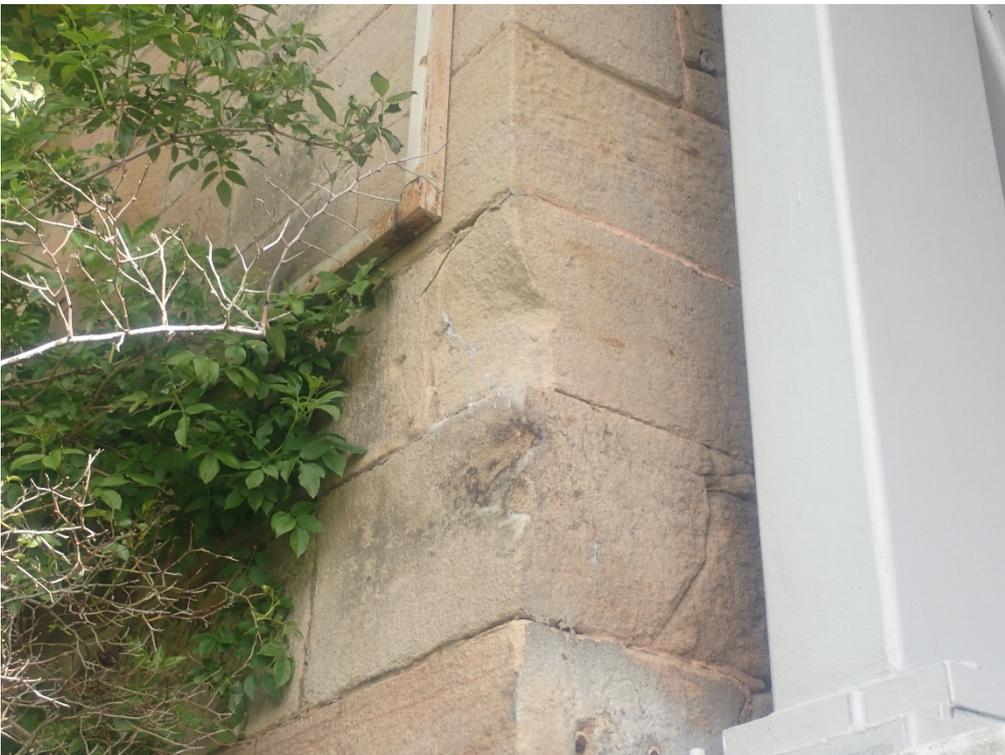
A small number of stone masonry units on both abutments had minor spalling. There were historic corroding fixings in the East abutment. One abutment spall may have been due to the expansion of the historic fixings. Plates 48 – 50.

Plate 48. Shallow Spall to West Abutment Stone

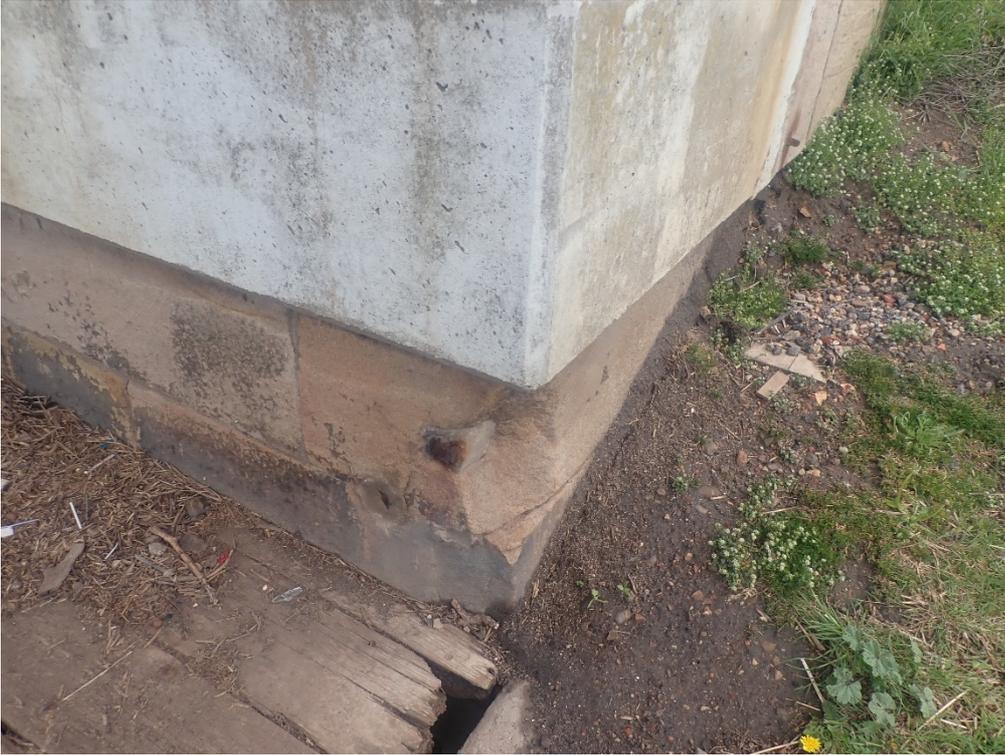
Plate 49. Spall to Stone in the East Abutment Adjacent to Historic Fixing

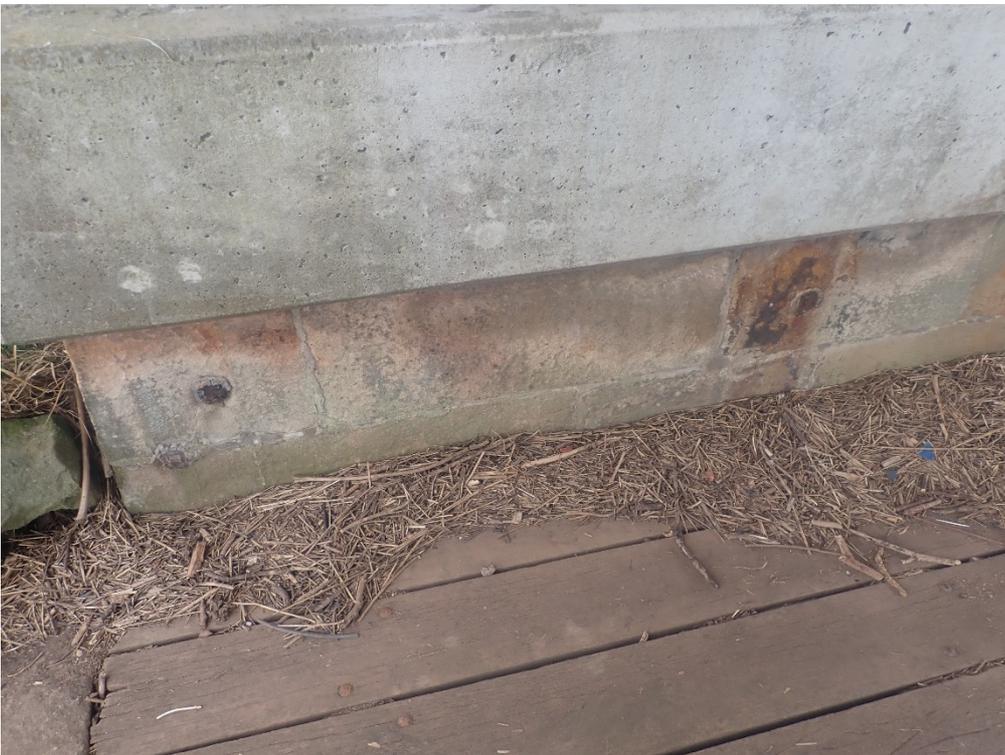
Plate 50. Corroded Historic Fixings in the East Abutment

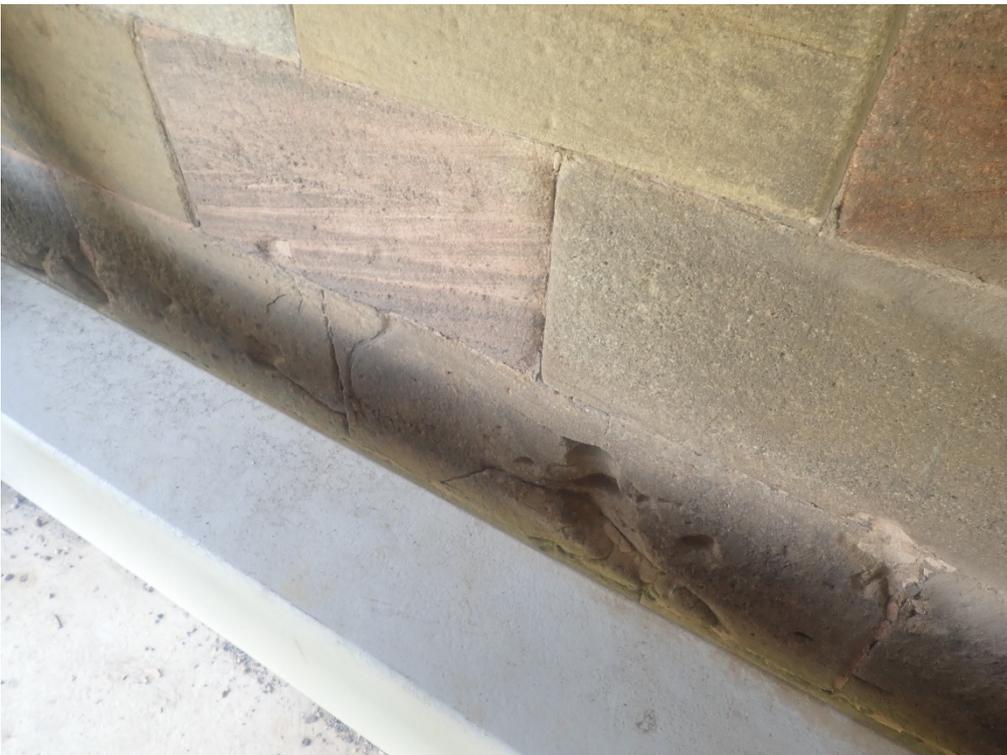
Several cracks were also found in the stone masonry units of each abutment. The cracks appeared to non-continuous and limited to individual stones. Plates 51 – 53.

Plate 51. Cracking Through Stones in the East Abutment Back Wall

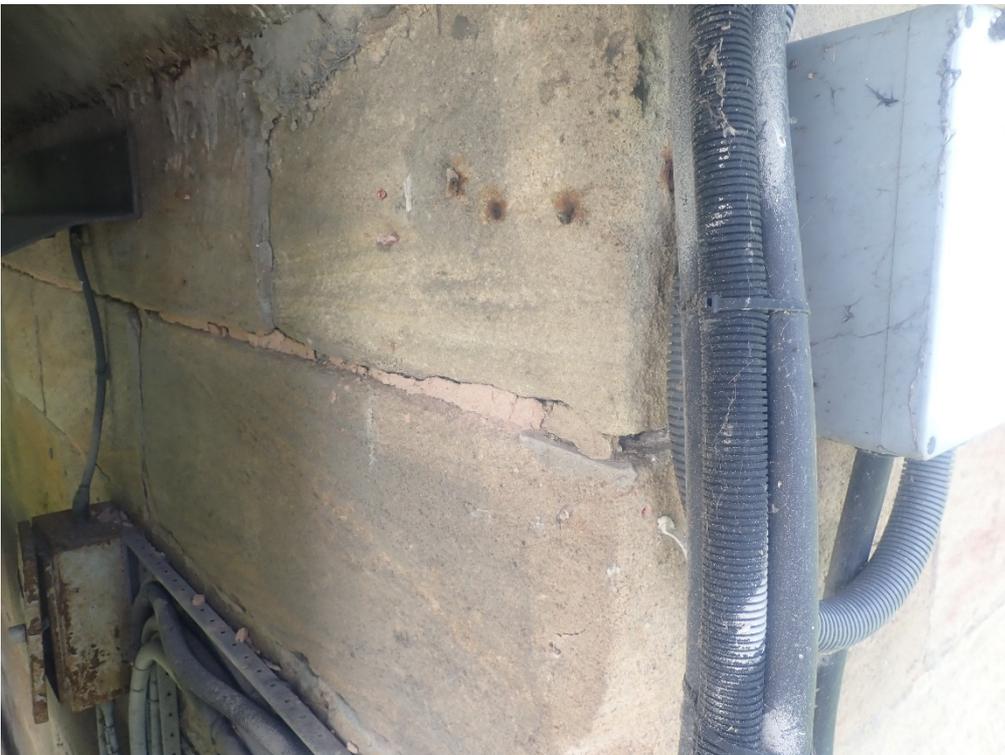
Plate 53. Cracking Through Stones in the West Abutment Back Wall

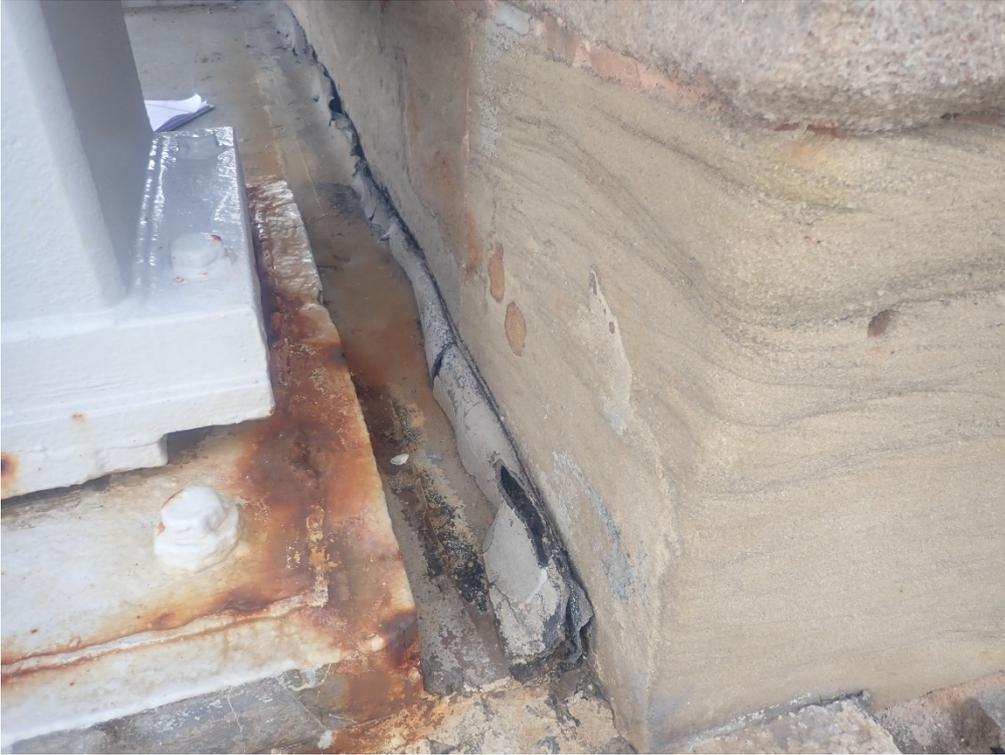
Plate 54. Typical Condition of Mortar on the West Abutment Back Wall

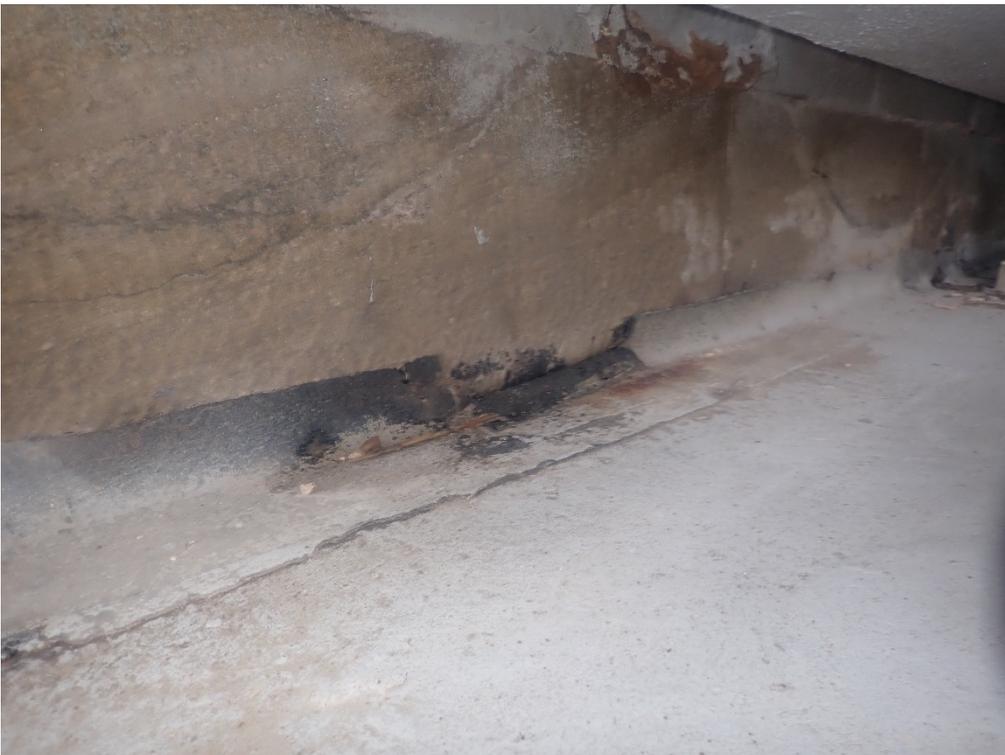
Felt material had been adhered to the joint between the back wall of the abutments and the reinforced concrete caps, presumably to prevent water ingress behind the cap. The felt at the East abutment was particularly worn. Plates 55 – 57.

Plate 55. Damage to Felt on the East Abutment

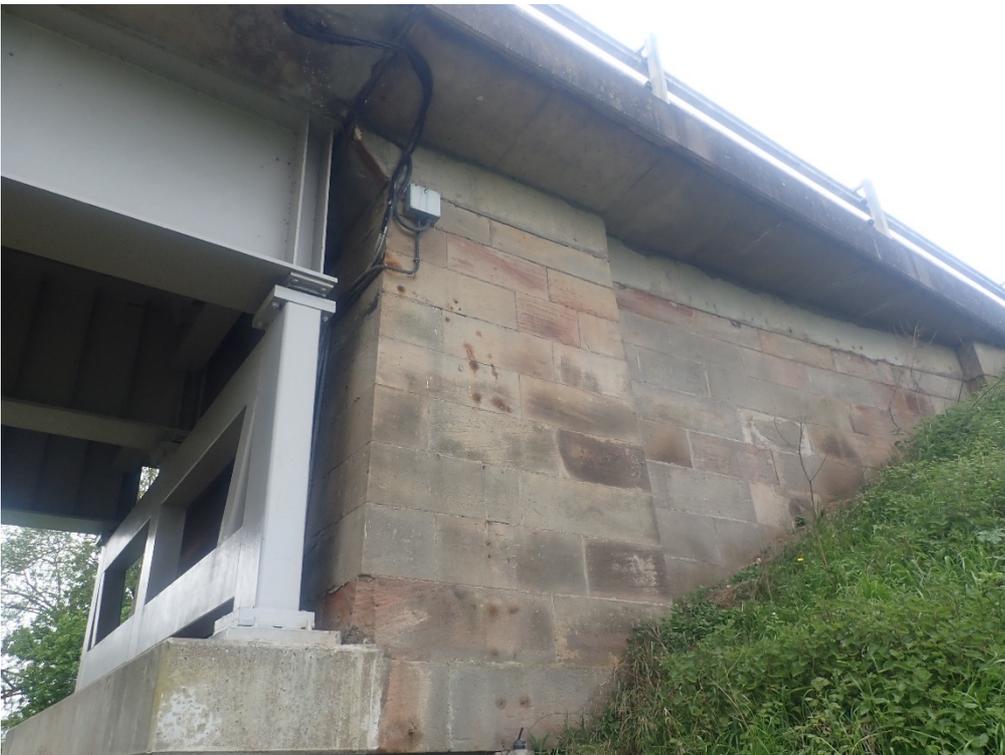
Plate 63. Mortar Loss Towards the Top of the South-West Wing Wall

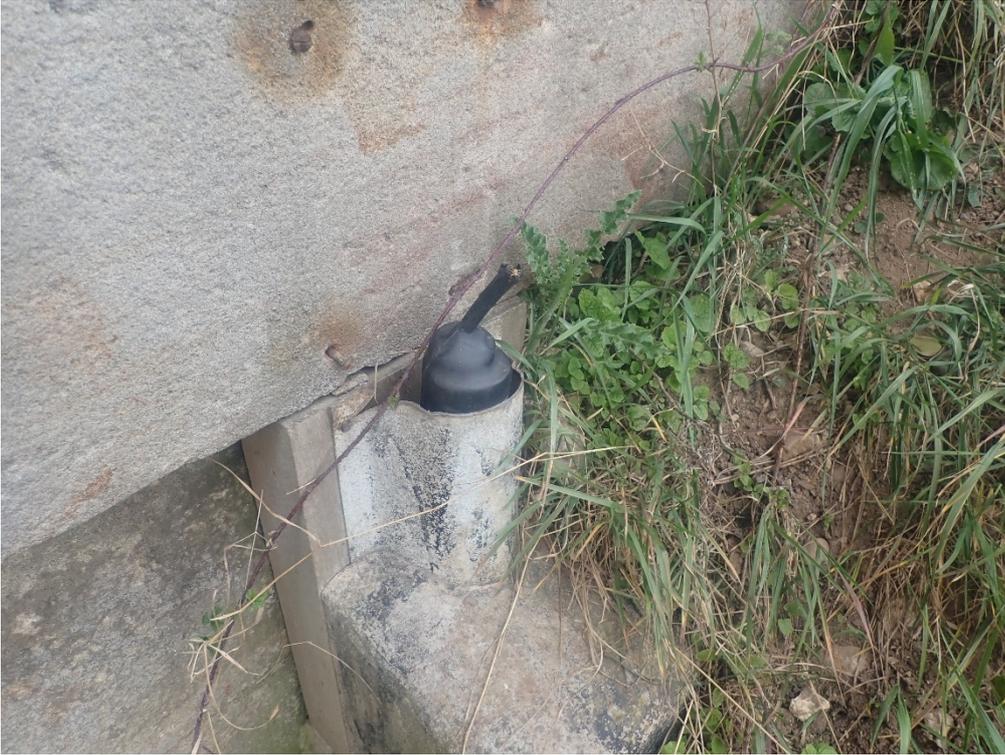
Plate 64. Corroded Historic Fixings, North-West Wing Wall

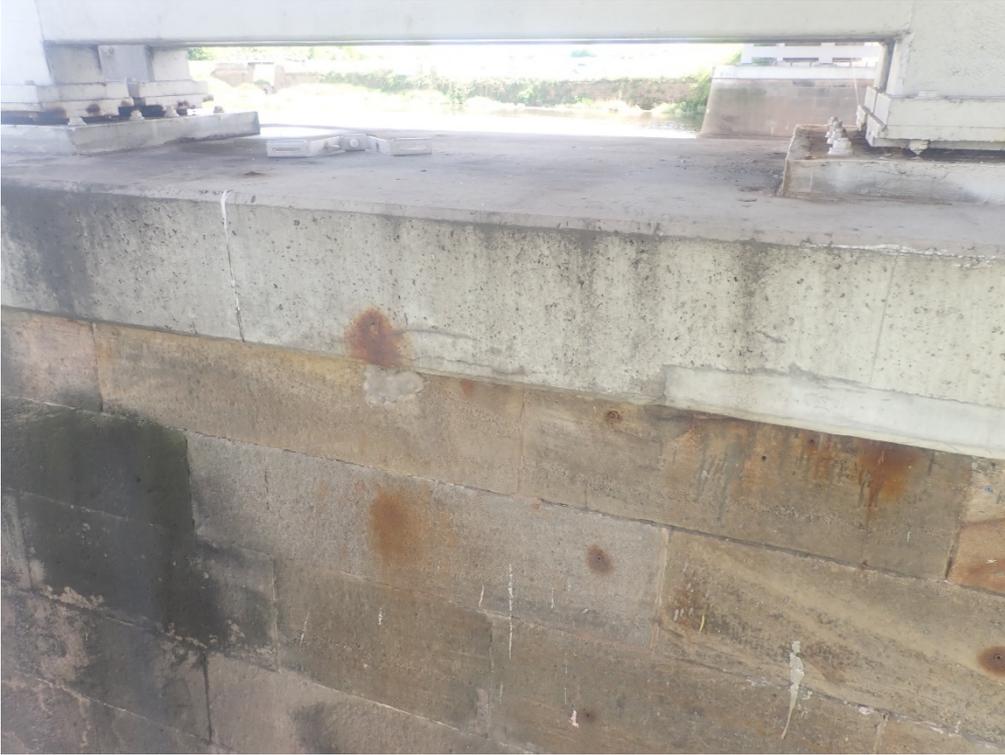
Plate 66. Evidence of Old Cable Tray, North-East Wing Wall

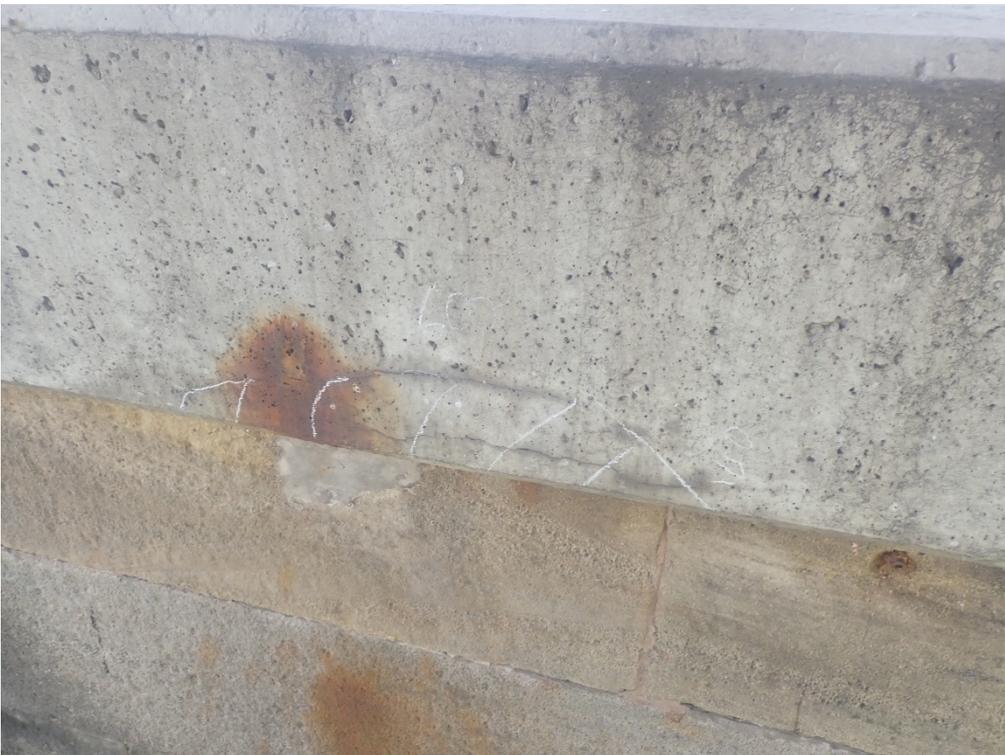
Plate 67. Reinforcement Corrosion Cracking with Adjacent Delamination, Centre Pier

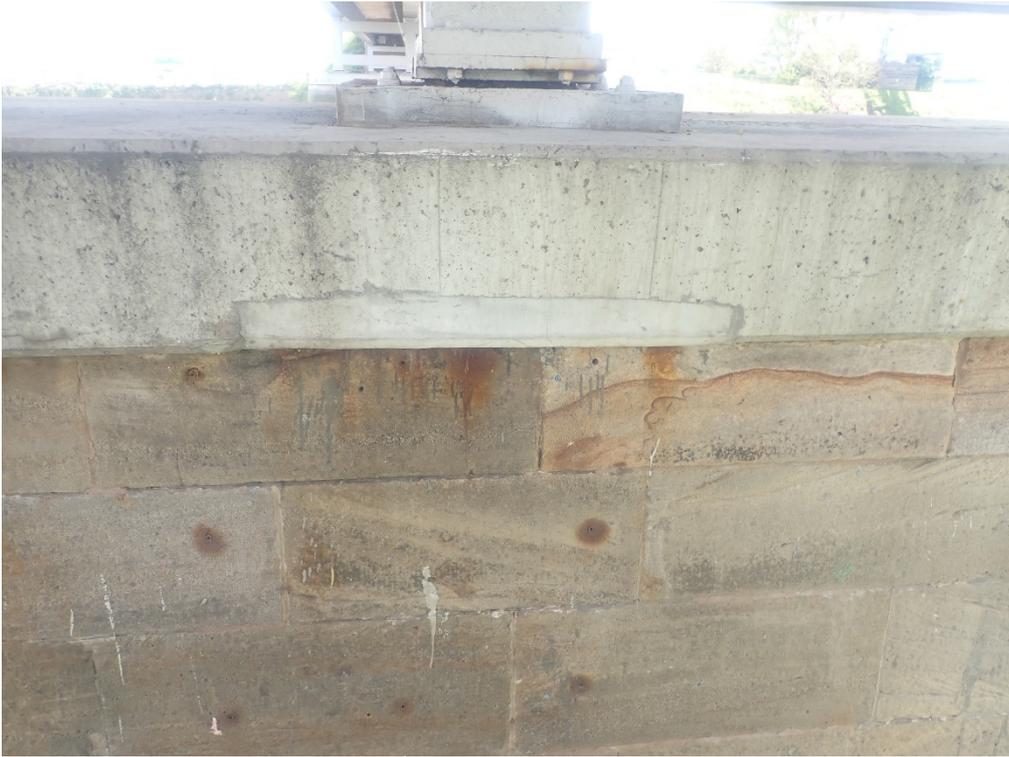
Plate 68. Delaminated Area, Centre Pier

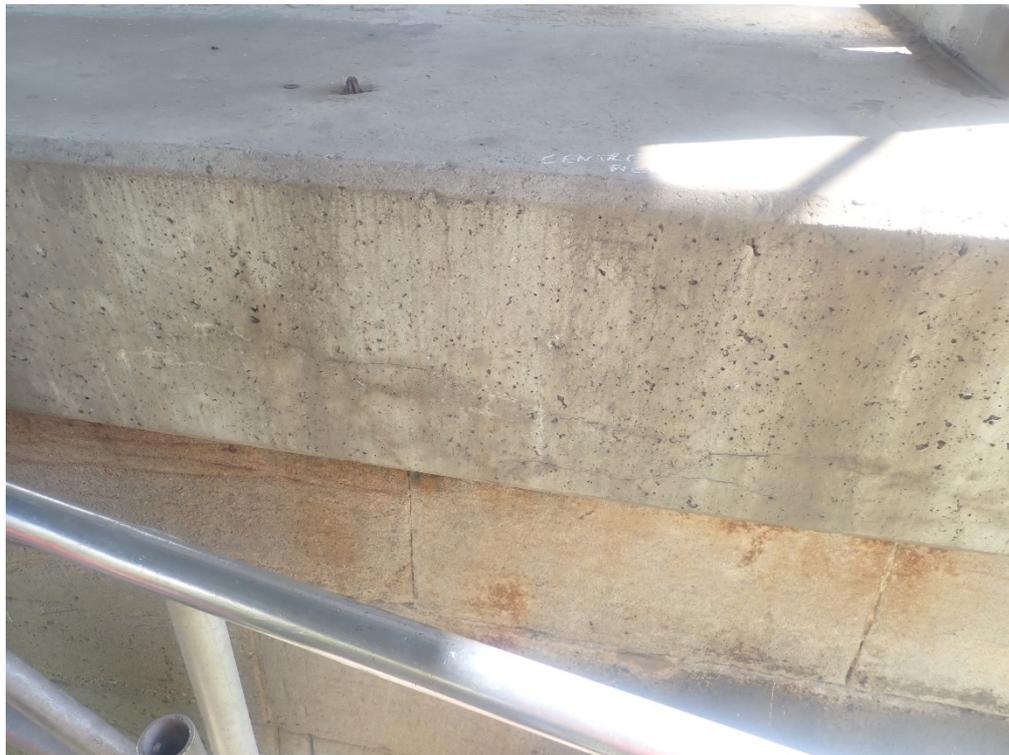
Plate 69. Repair on Centre Pier with Historic Rust Staining Beneath

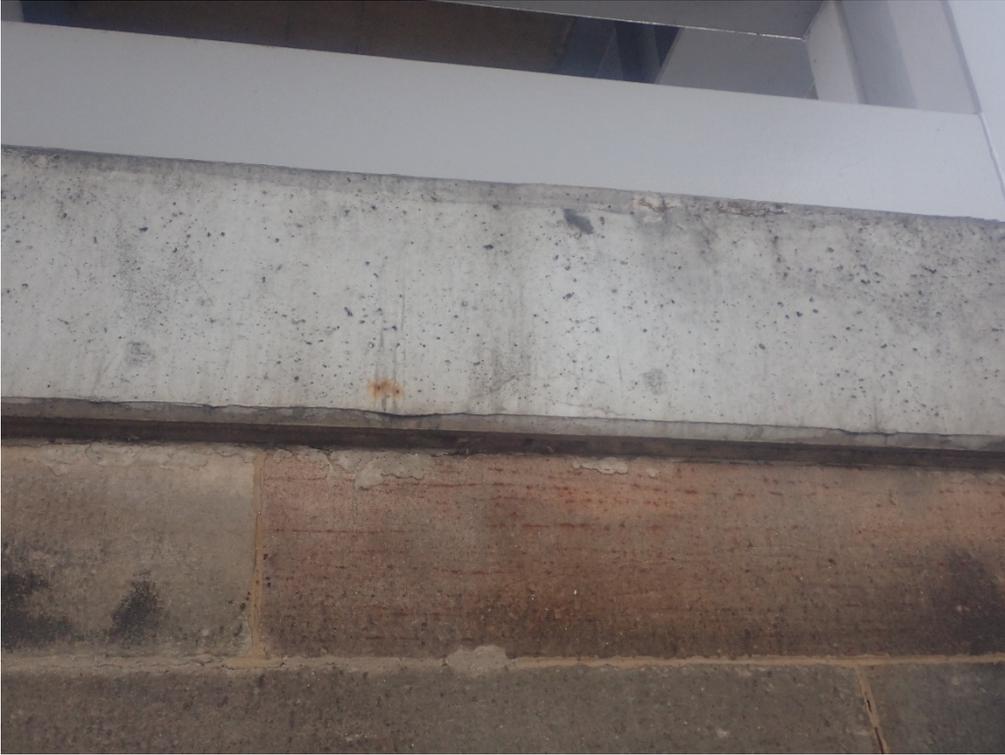
Plate 70. Further Reinforcement Corrosion Cracking to Centre Pier

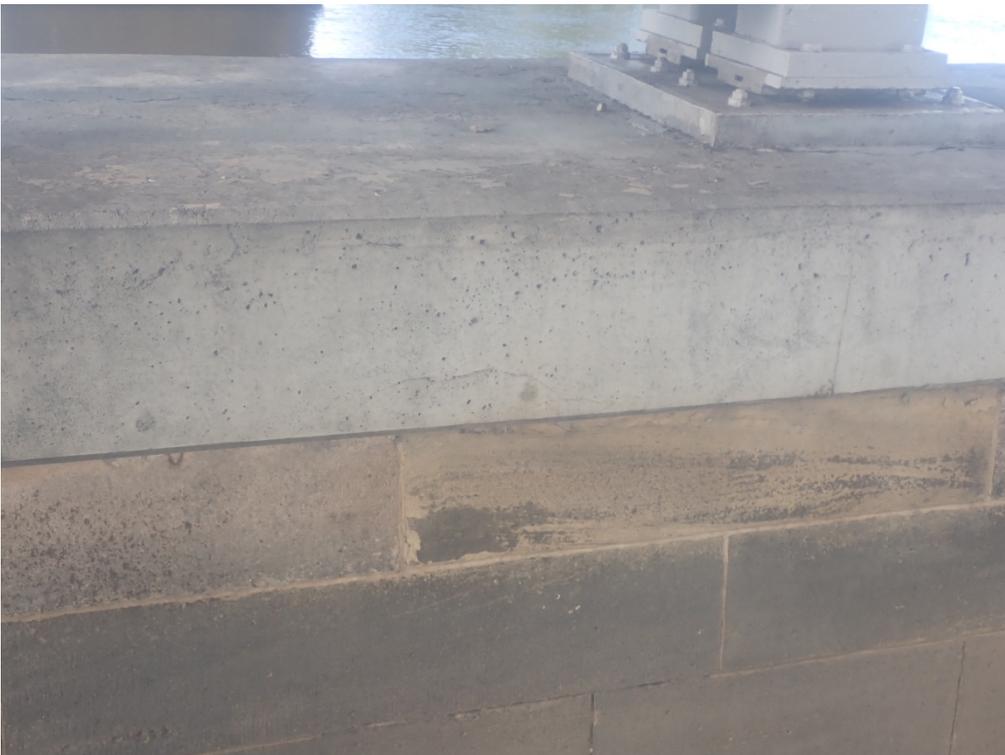
Plate 71. Further Cracking with Associated Rust Staining

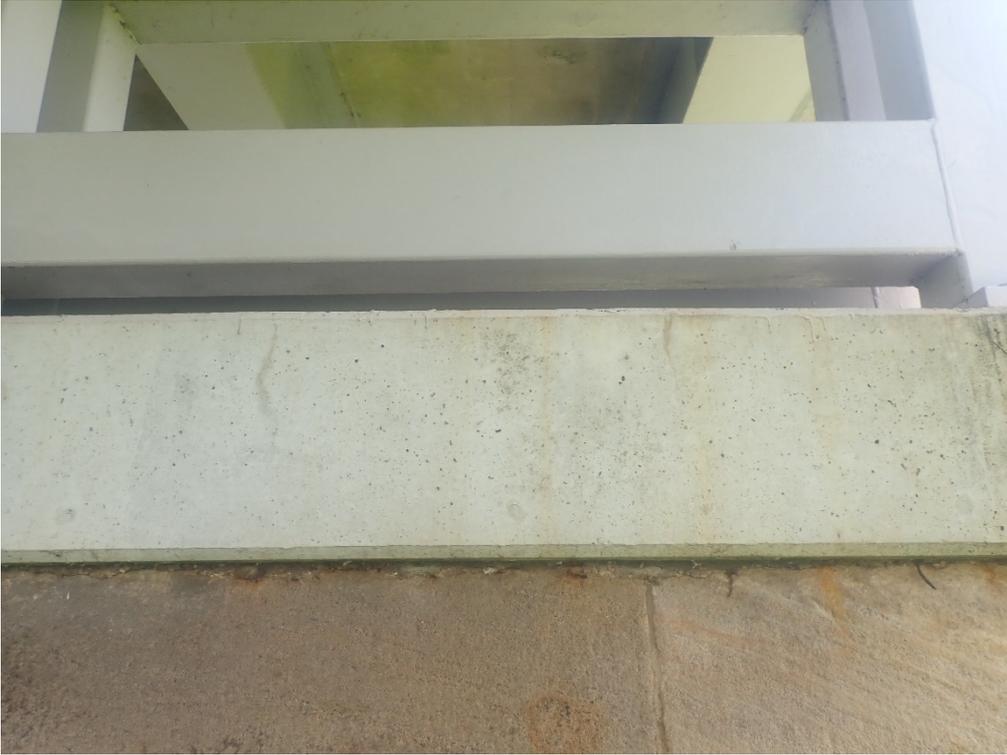
Plate 72. Typical Cracking to Pier Caps, East Pier

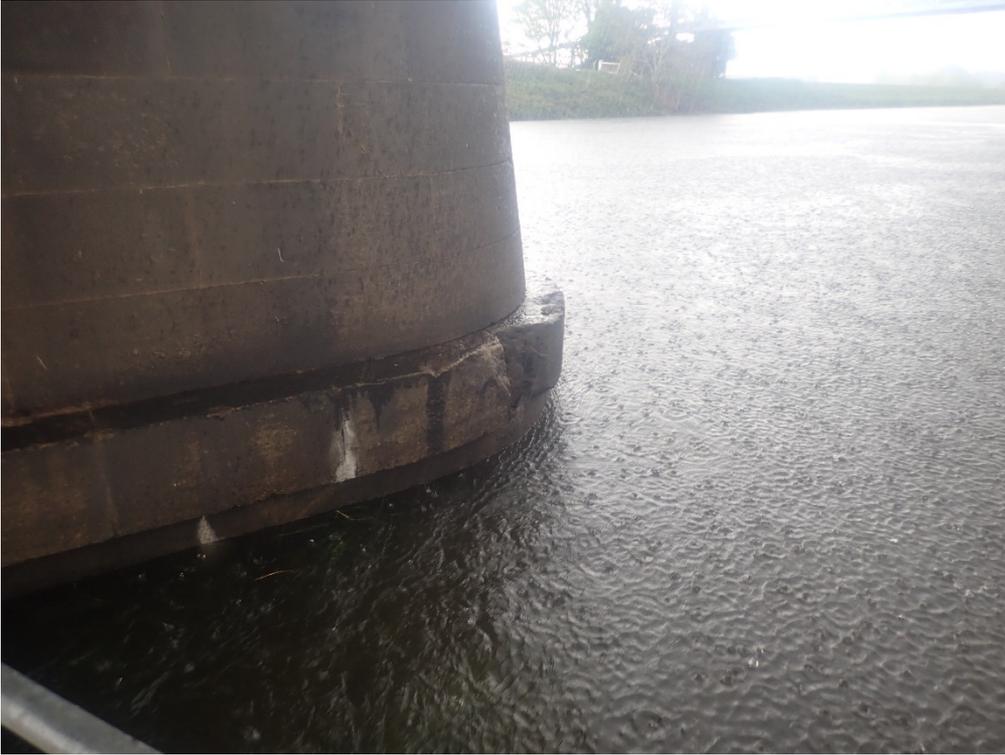
Plate 74. Spall to Downstream End of the Centre Pier

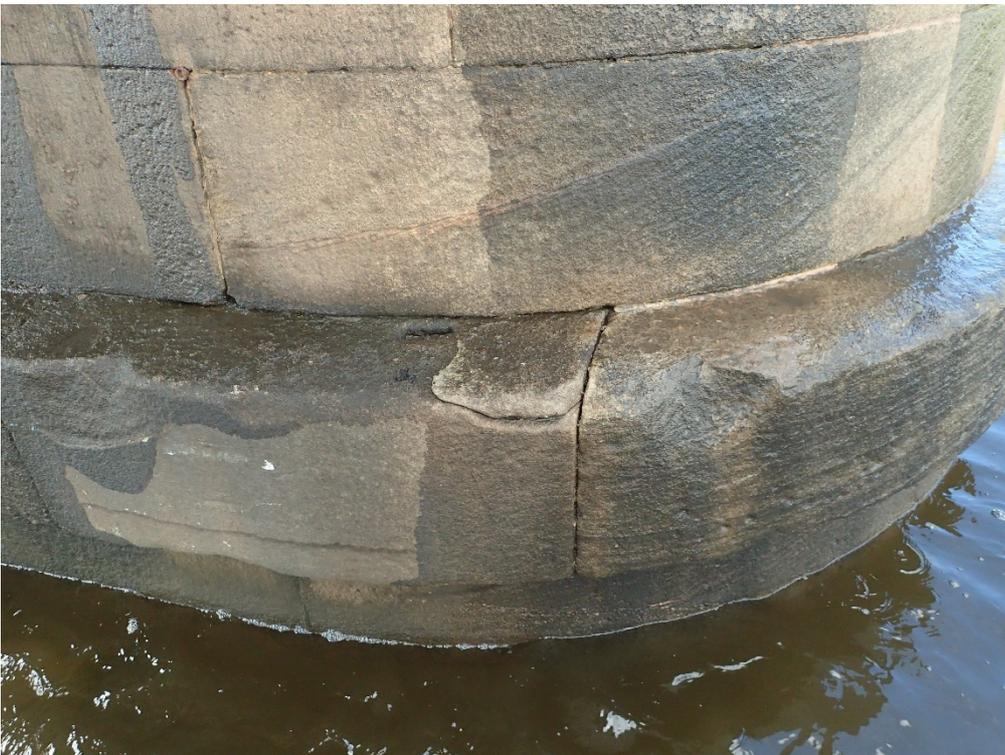
Plate 75. Impact Damage to Upstream End of the East Pier

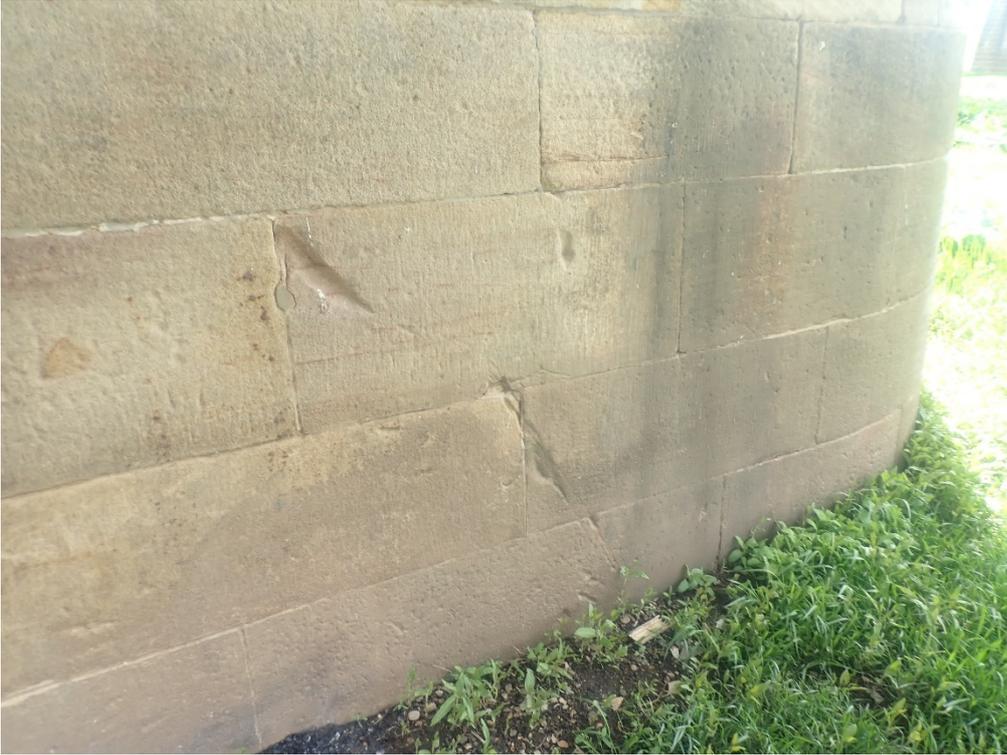
Plate 76. Crack Through Stone at the Downstream End of the Centre Pier

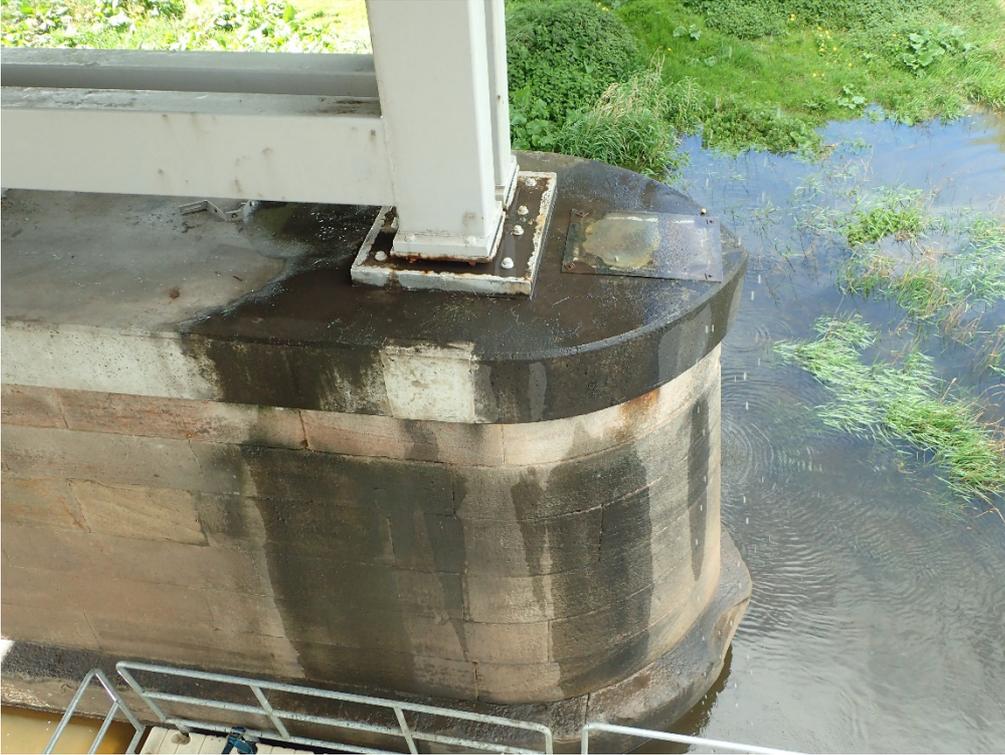
Plate 78. Impact Scraping to East Pier
