DUNHAM BRIDGE COMPANY

APPLICATION TO REVISE TOLL CHARGES

THE DUNHAM BRIDGE COMPANY

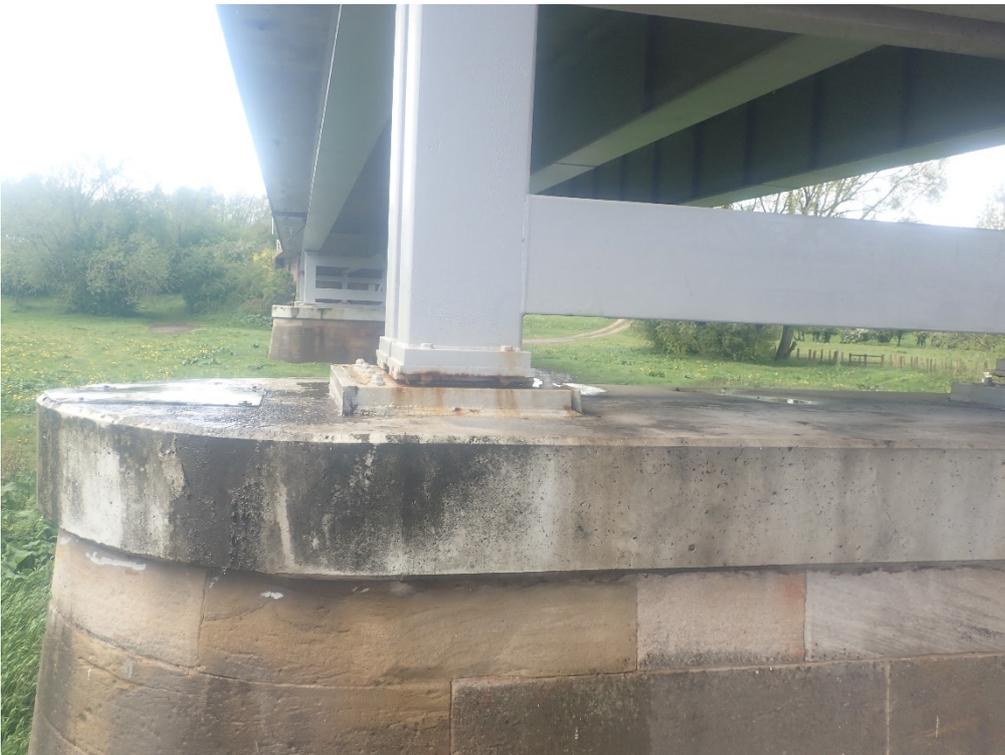
Plate 79. Heavily Water Stained Downstream End of the Centre Pier

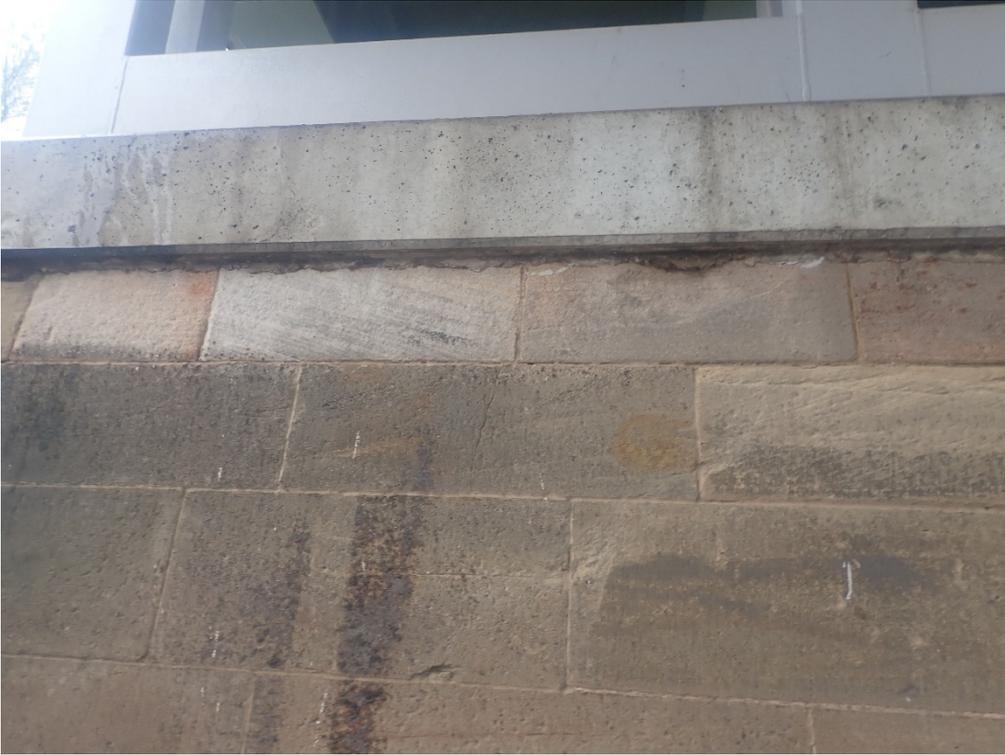
Plate 82. Calcite Deposits to the Upstream End of the East Pier

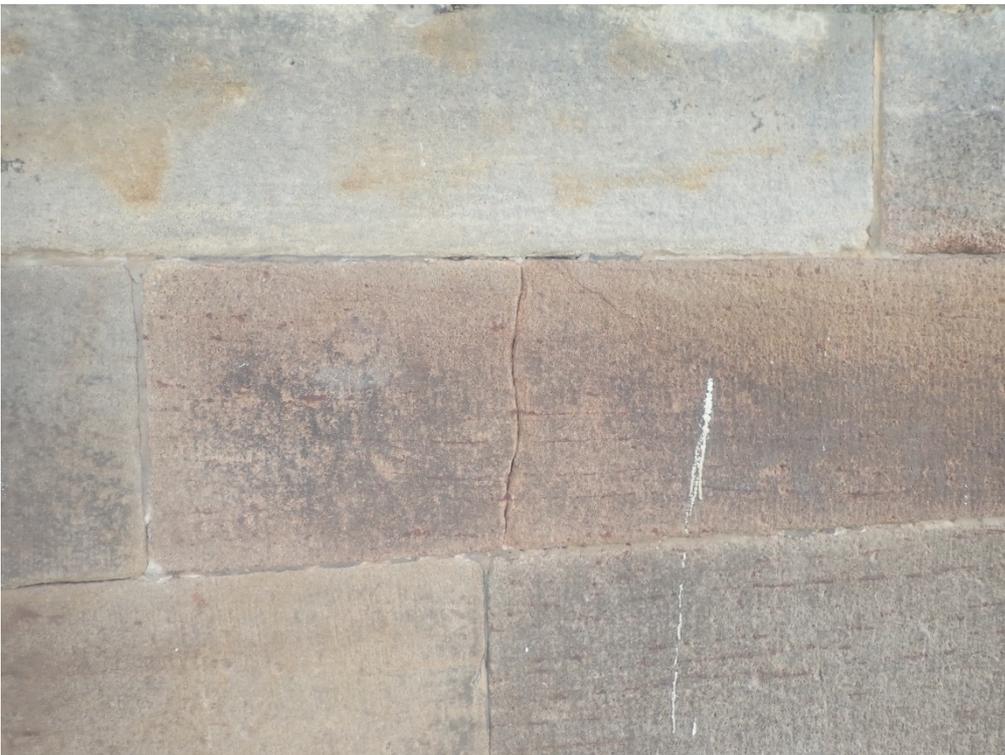
Plate 83. Crack Through Stone in Centre Pier

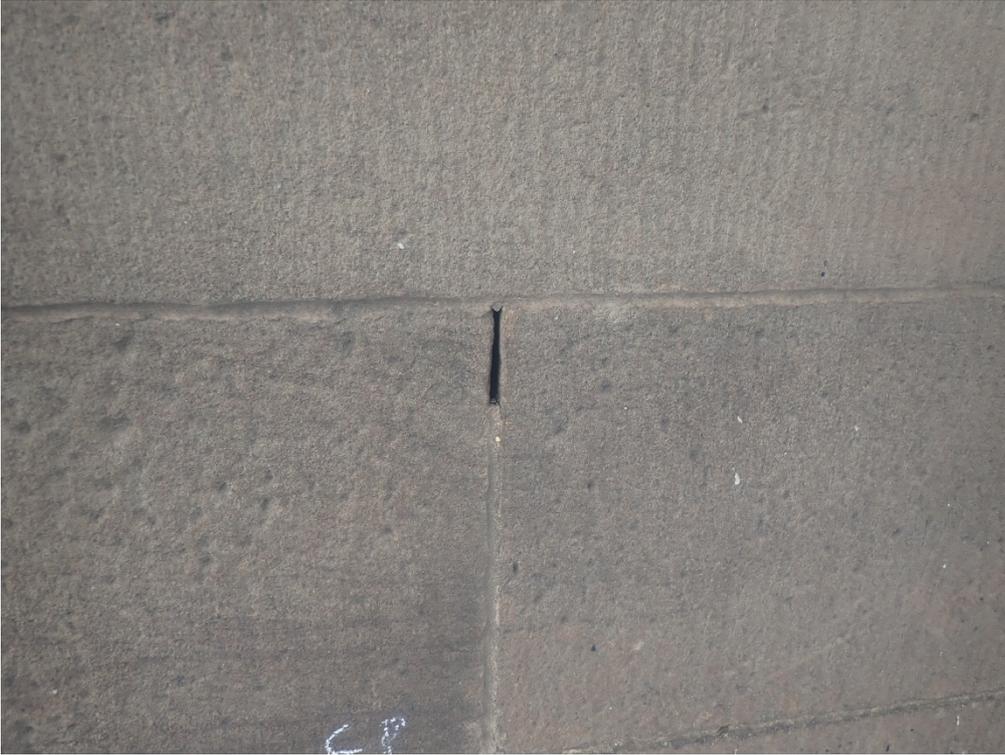
Plate 84. Crack Through Stone in the West Pier

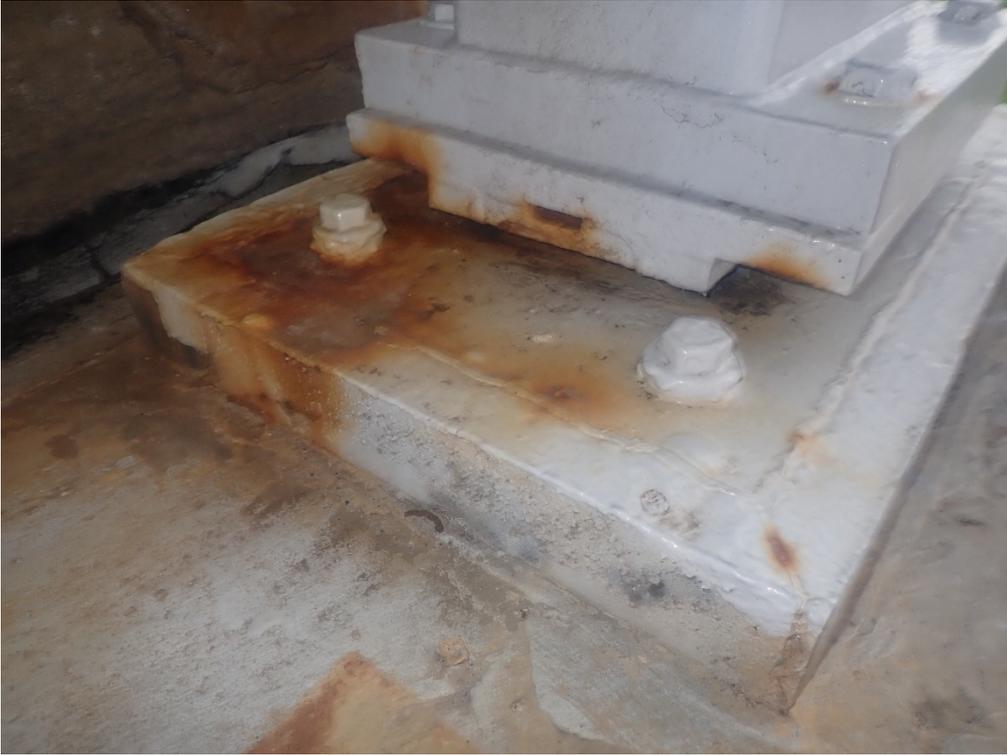
Plate 88. Evidence of Fire Against the West Side of the West Pier

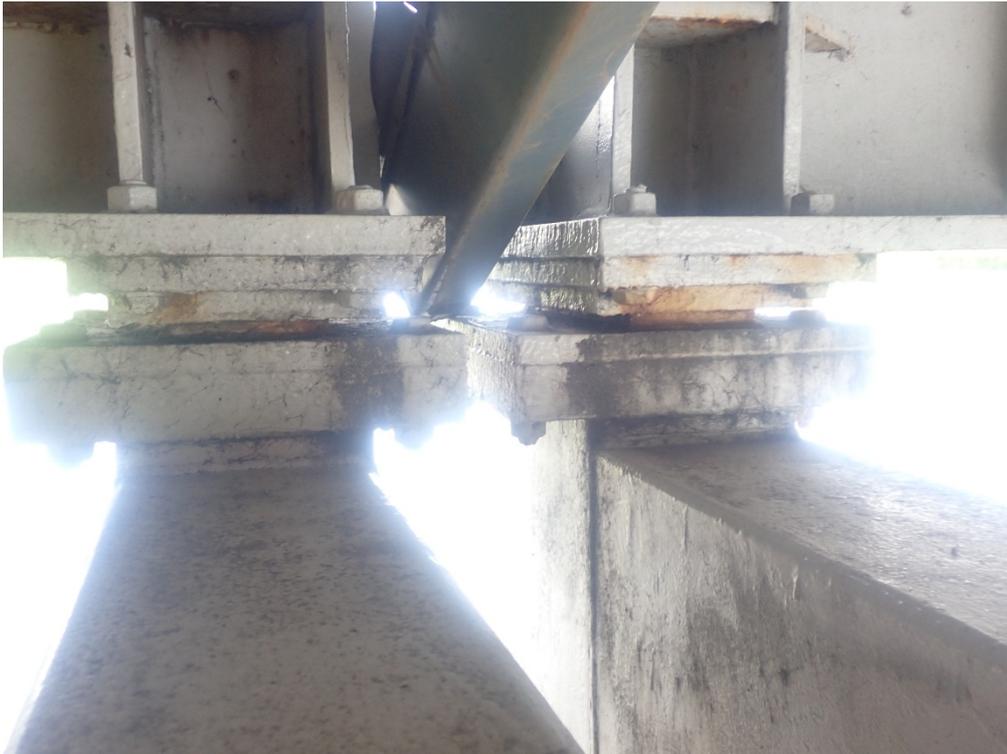
Plate 90. Rust Staining to Top Plate of Upper Bearing, West Pier

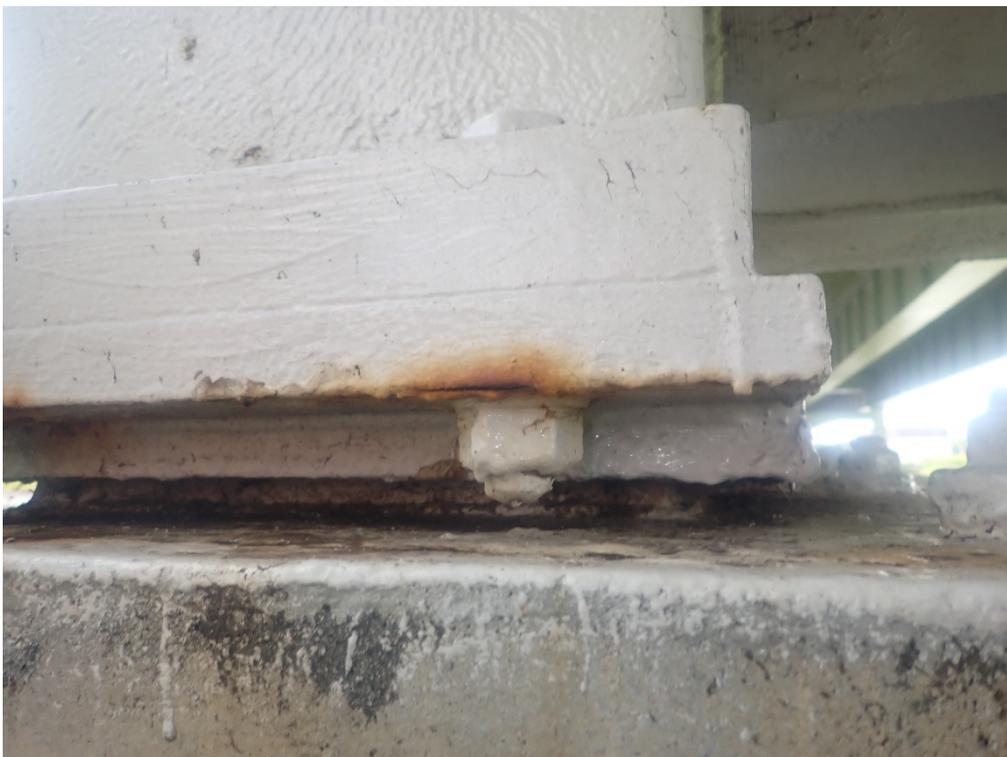
Plate 91. Minor Rust Staining to Upper Bearings Adjacent to Failed Drainage, Centre Pier

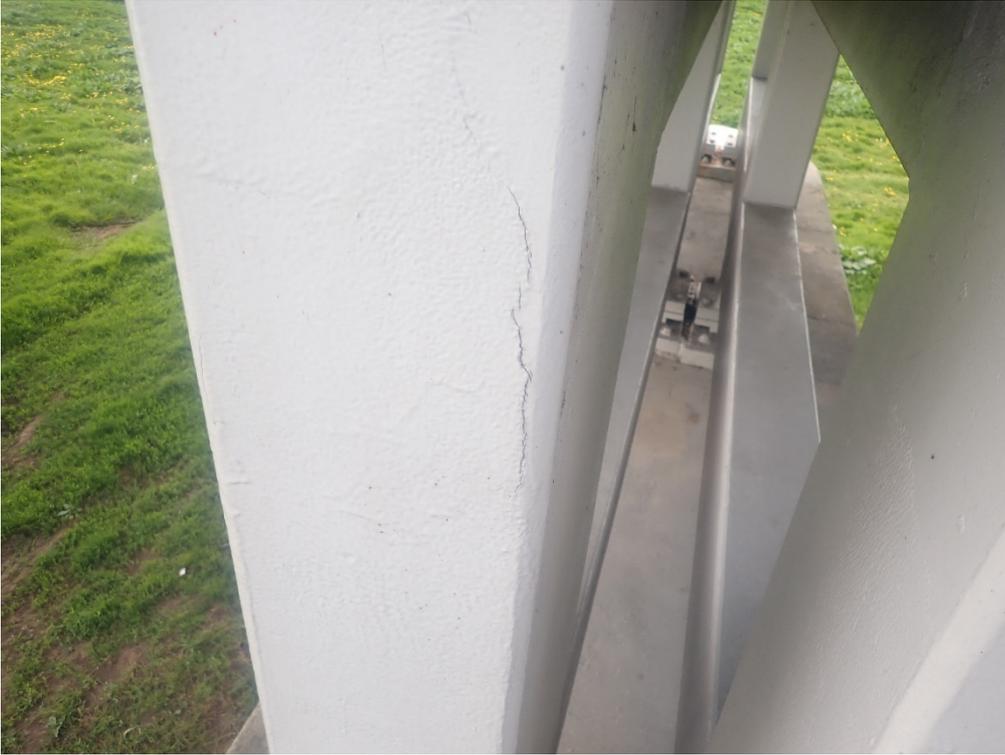
Plate 92. Cracking in Protective Paint System with Associated Rust Staining

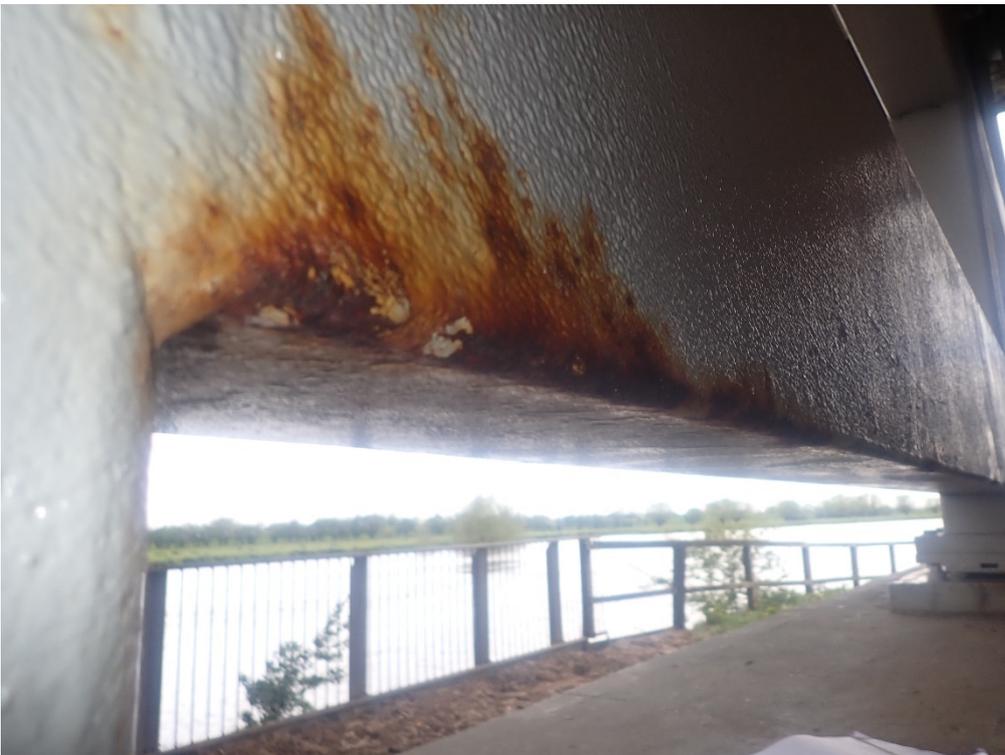
Plate 93. Cracking in Protective Paint System to West Pier Bearing Frame

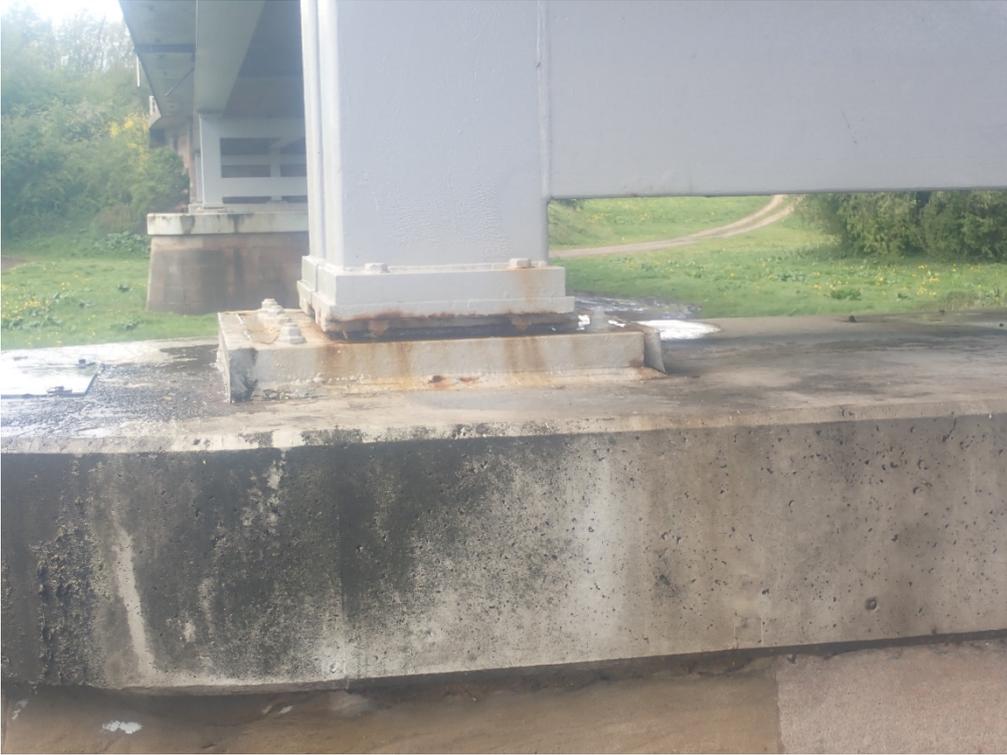
Plate 94. Rust Staining to East Abutment Bearing Frame Bottom Member

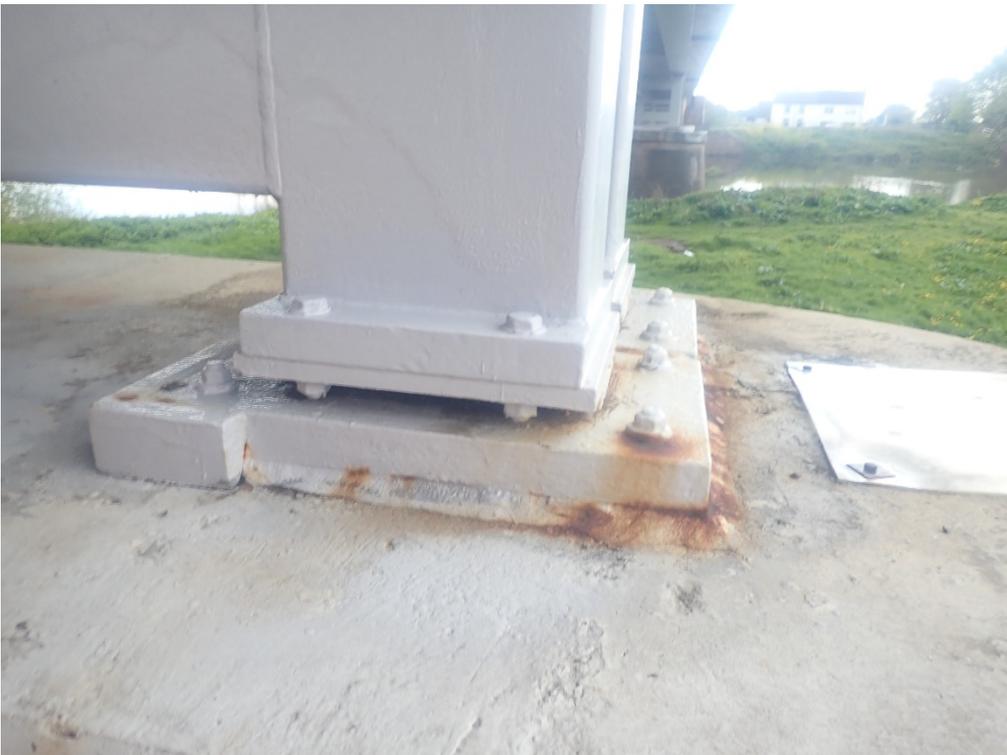
Plate 95. Spalled Grout Around Centre Pier Bearing

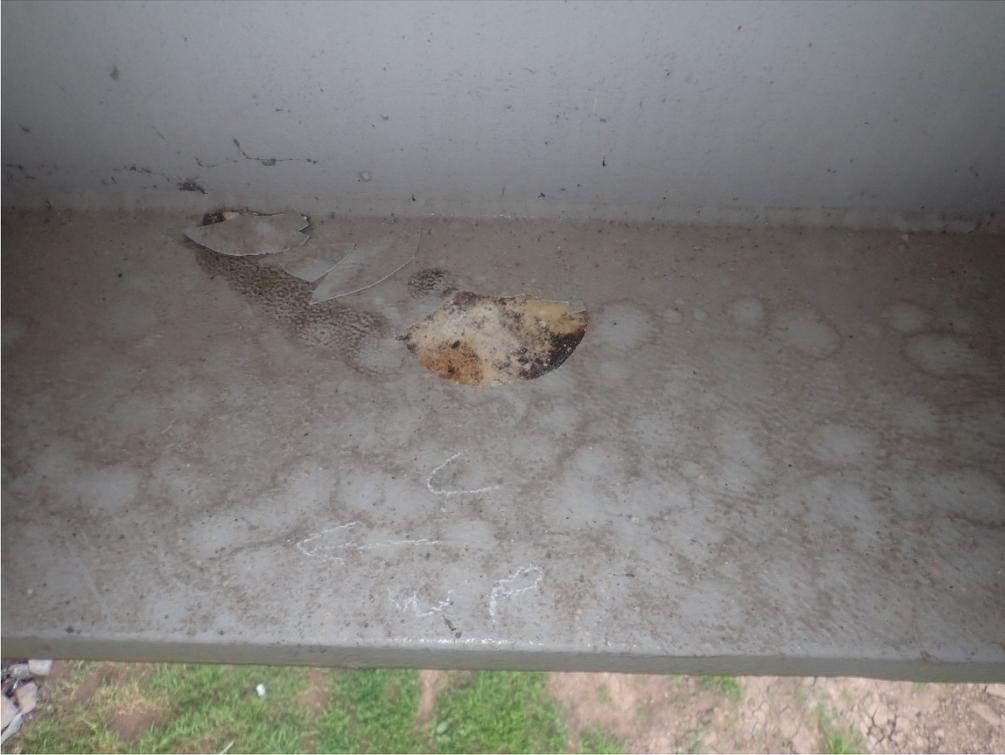
Plate 98. Blistered/Flaking Paint to North Beam, West Span

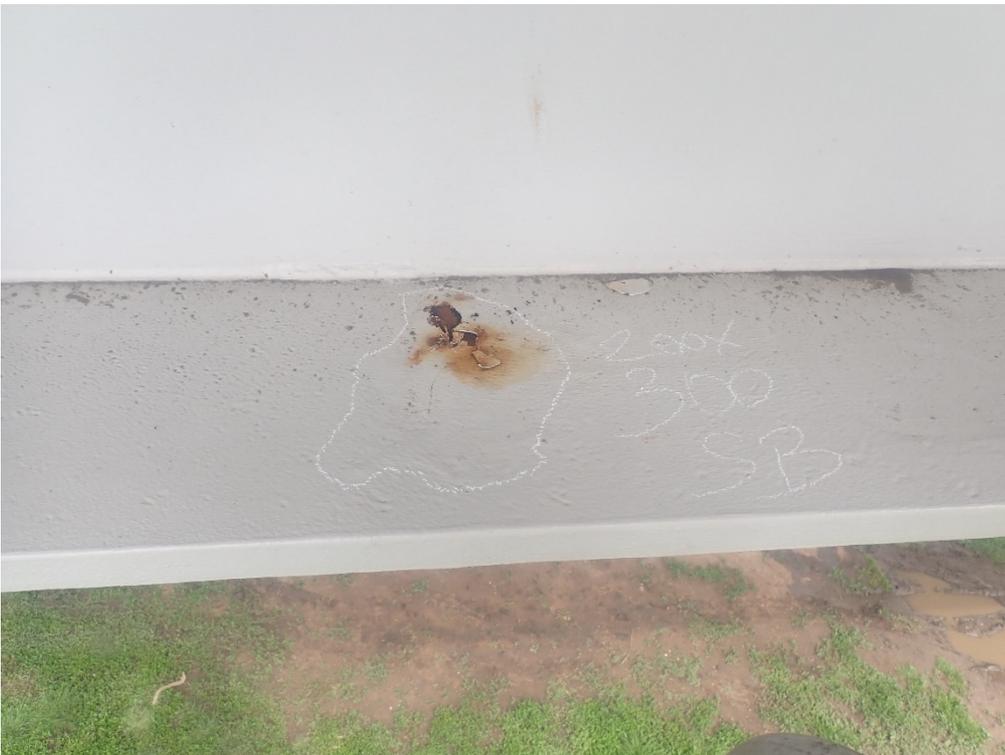
Plate 99. Flaking Paint to the Centre Beam Exposing Slight Surface Corrosion, Inner West Span

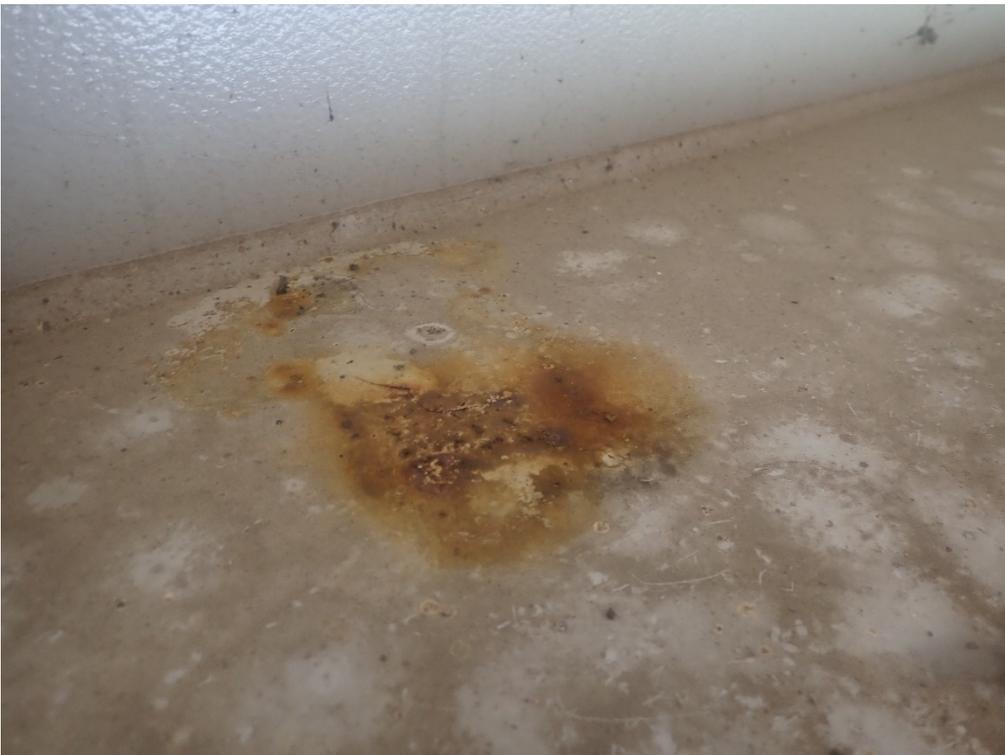
Plate 101. Blistered Paint to Bottom Flange of Inner West Span Deck Beam

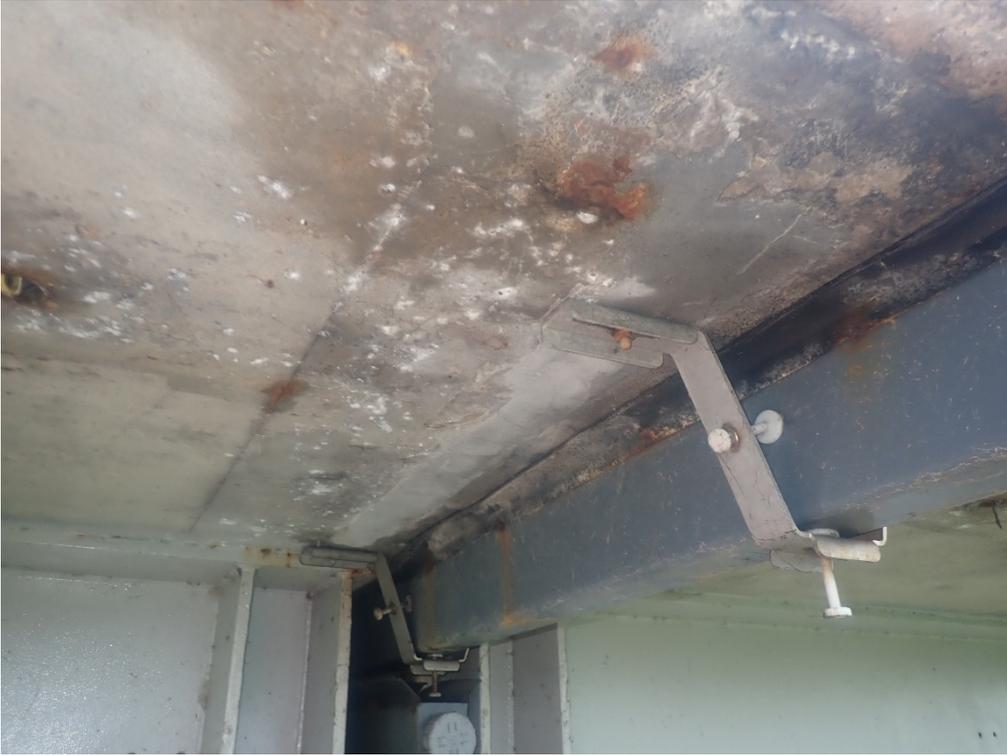
Plate 118. Rust Staining at Joint Surrounded by Water Staining, Also Un-Repaired Test Locations

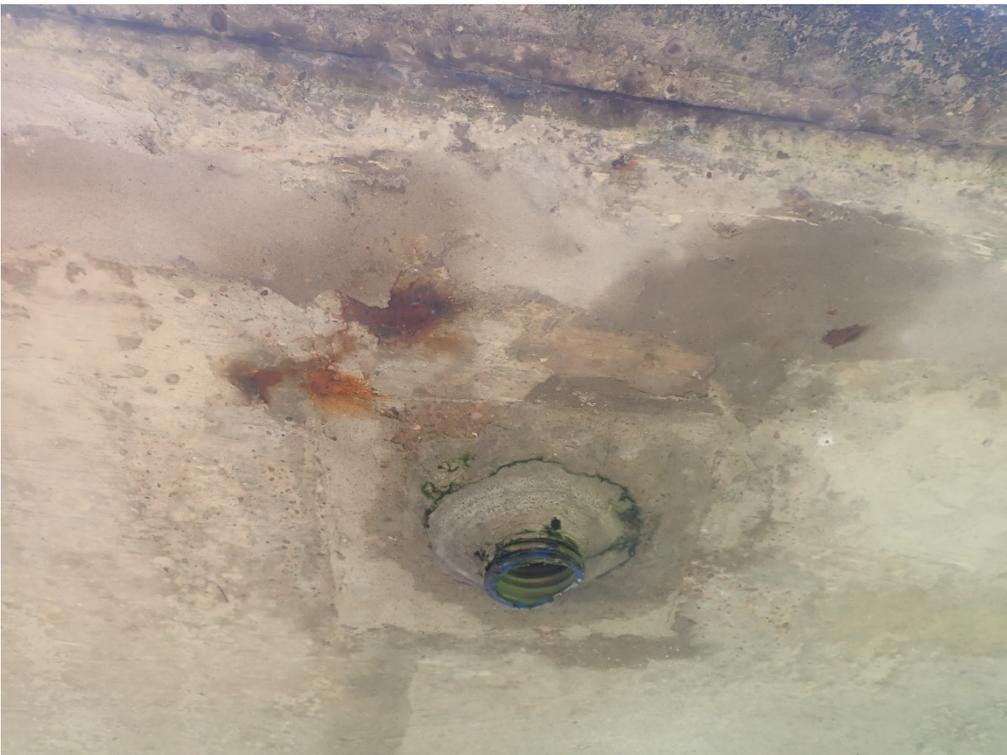
Plate 119. Rust Staining at the Edge of a Repair Adjacent to Deck Joint

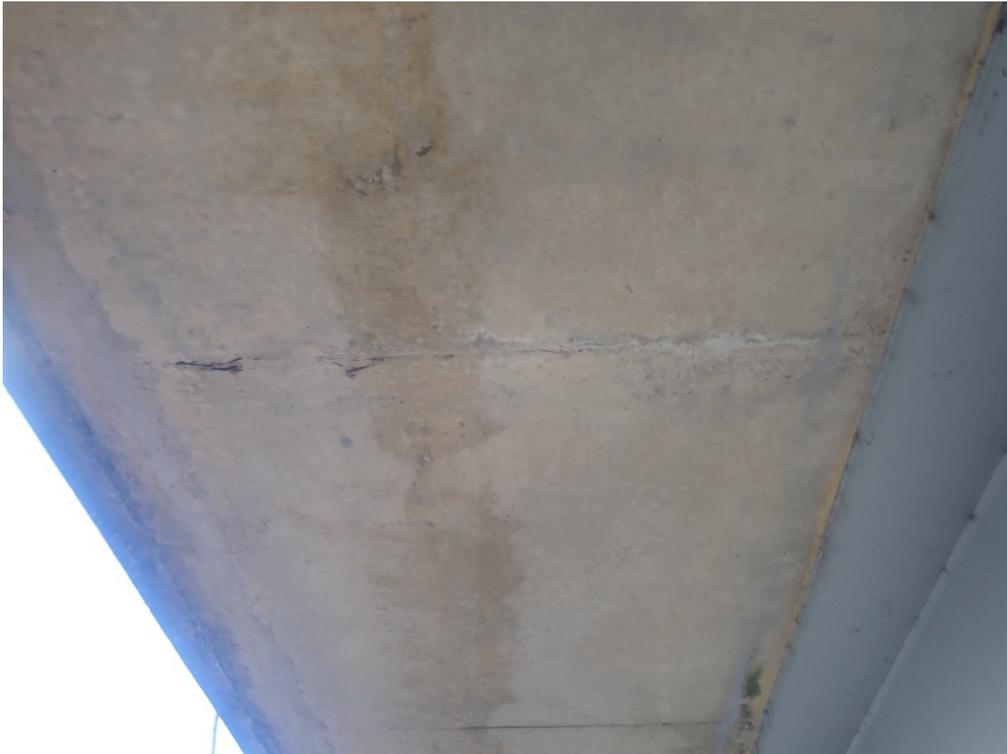
Plate 126. Corroded Ferrous Debris at Construction Joint in South Cantilever

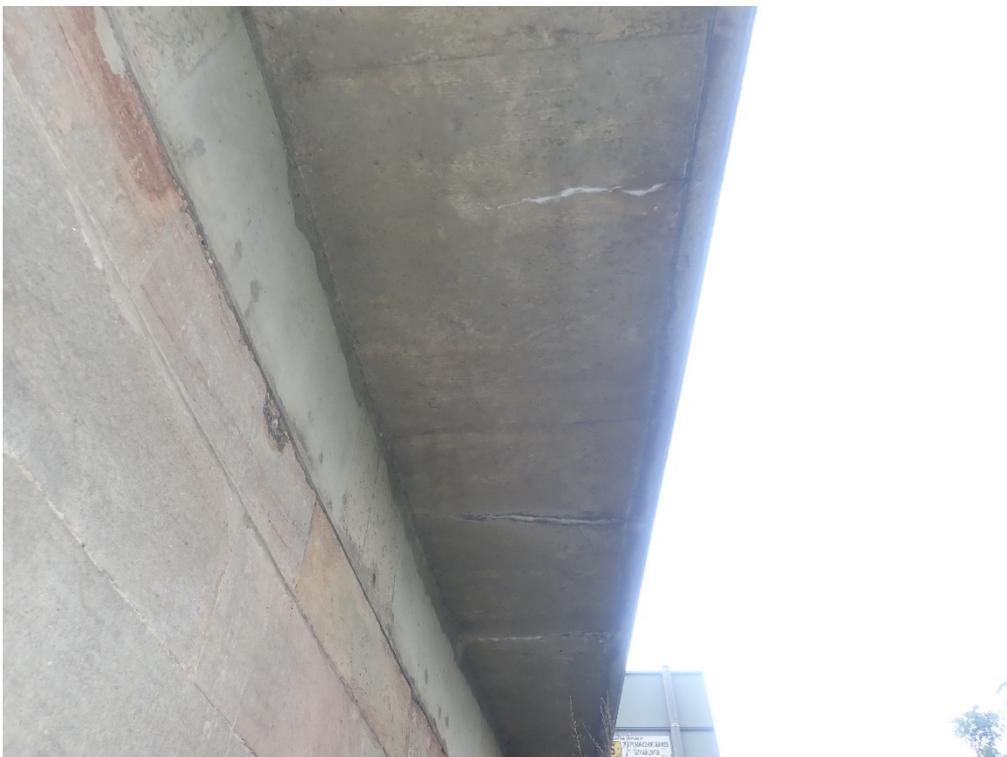
Plate 127. Corroded Ferrous Debris & Loose Repair, South Cantilever East Span, Loose Material Removed

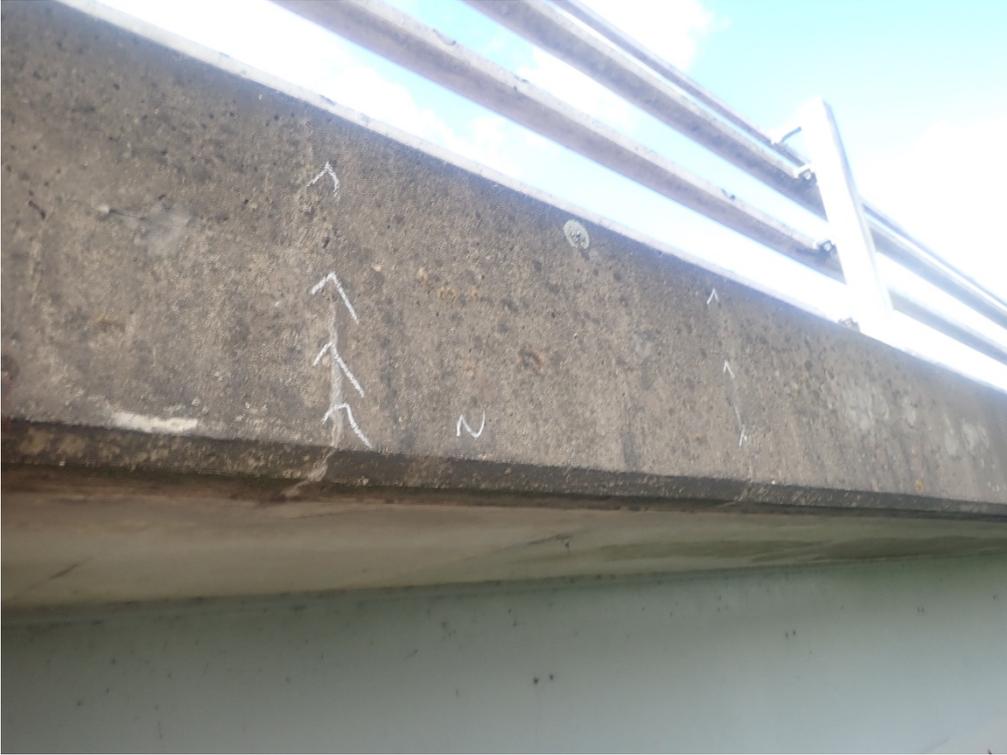
Plate 128. Regular Cracking in the North-West Wing Wall Cantilever Soffit

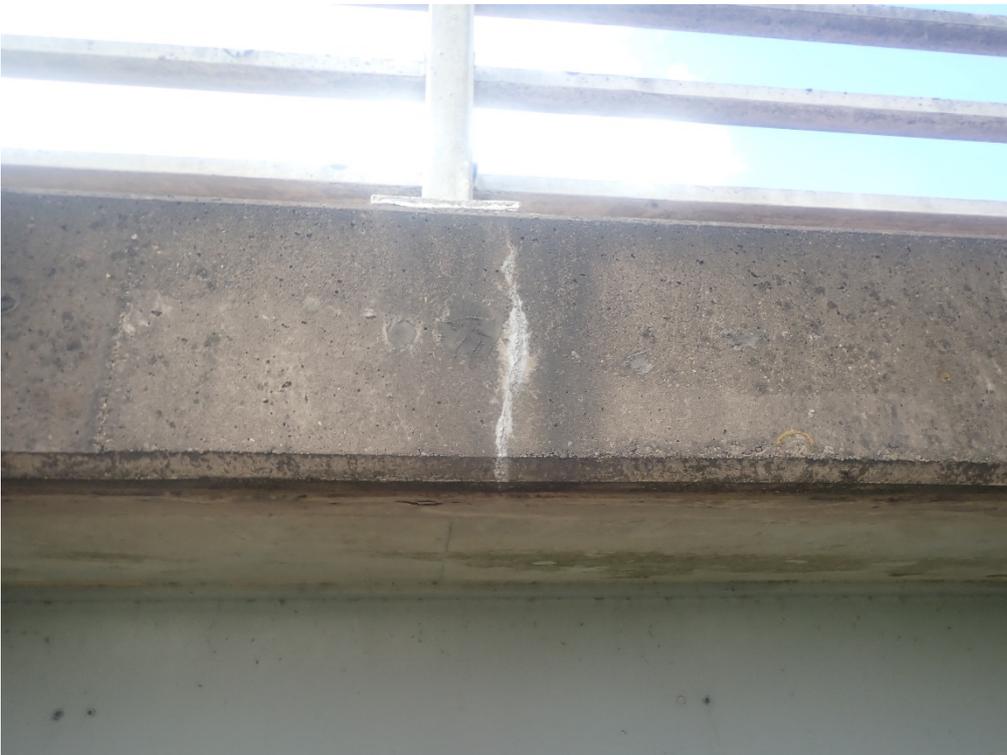
Plate 129. Typical Cracking to the Edge Beams, West Span North Edge Beam

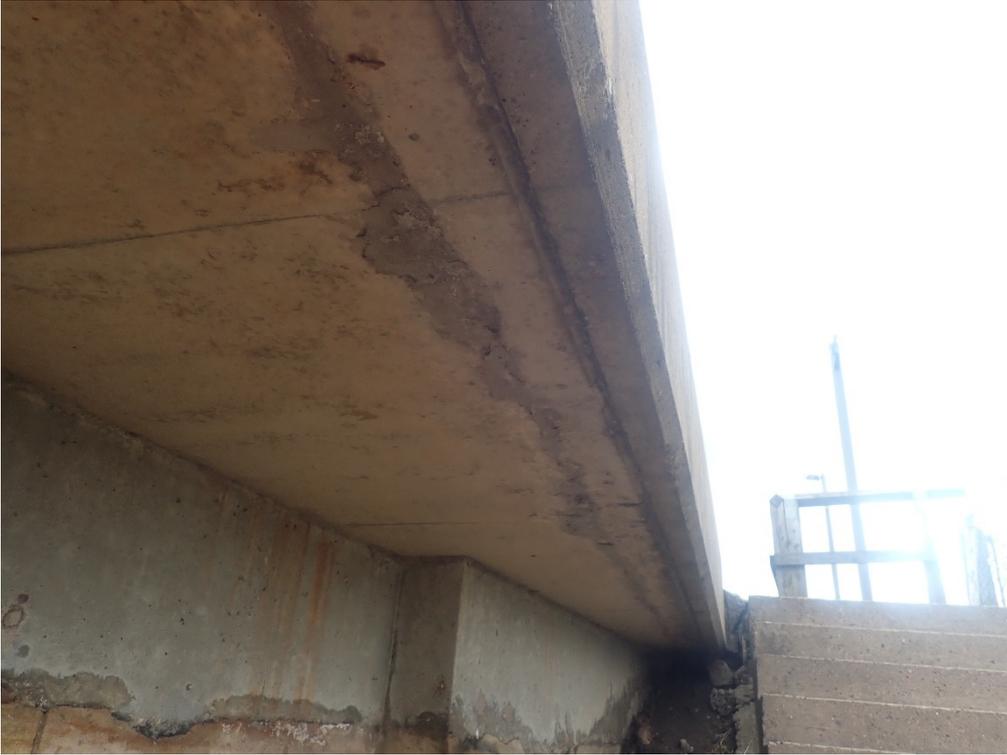
Plate 130. Leachate Filled Crack in Edge Beam, West Span

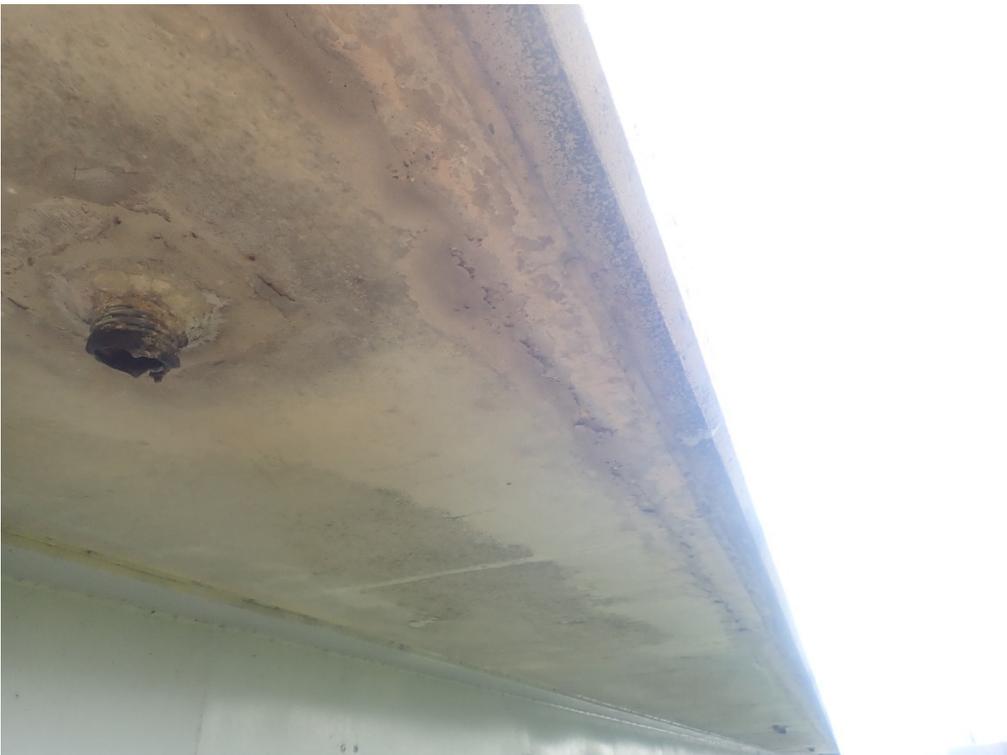
Plate 131. Typical View of Narrow Repair in Cantilever Soffit, South-East Corner

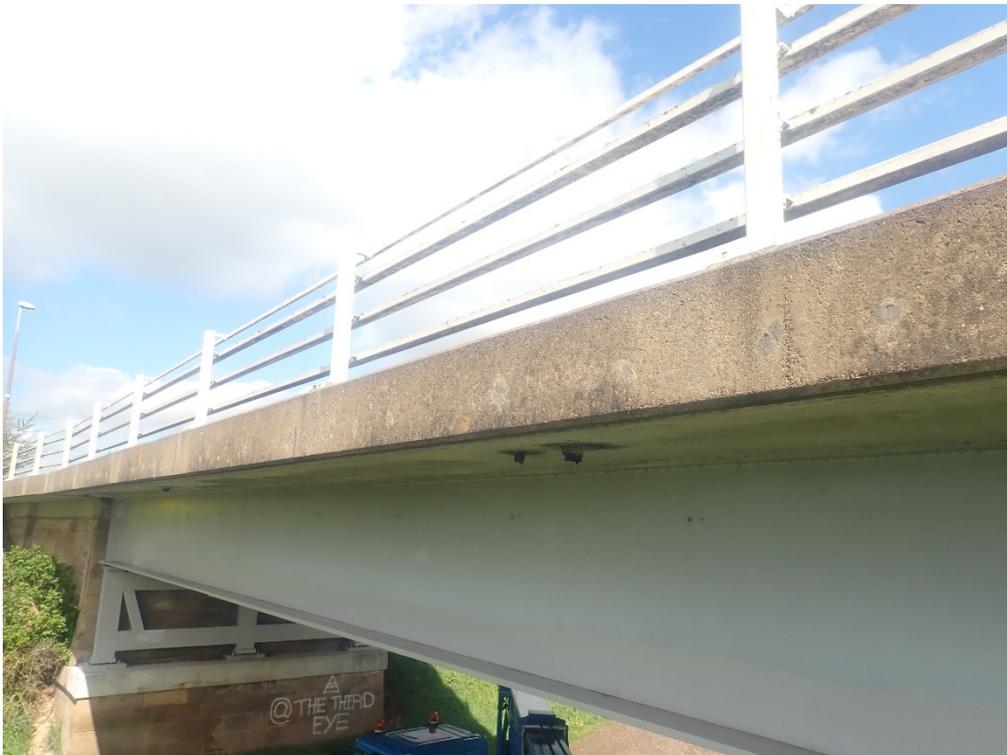
Plate 135. De-Bonding of Sealant Above the West Pier, North Edge Beam

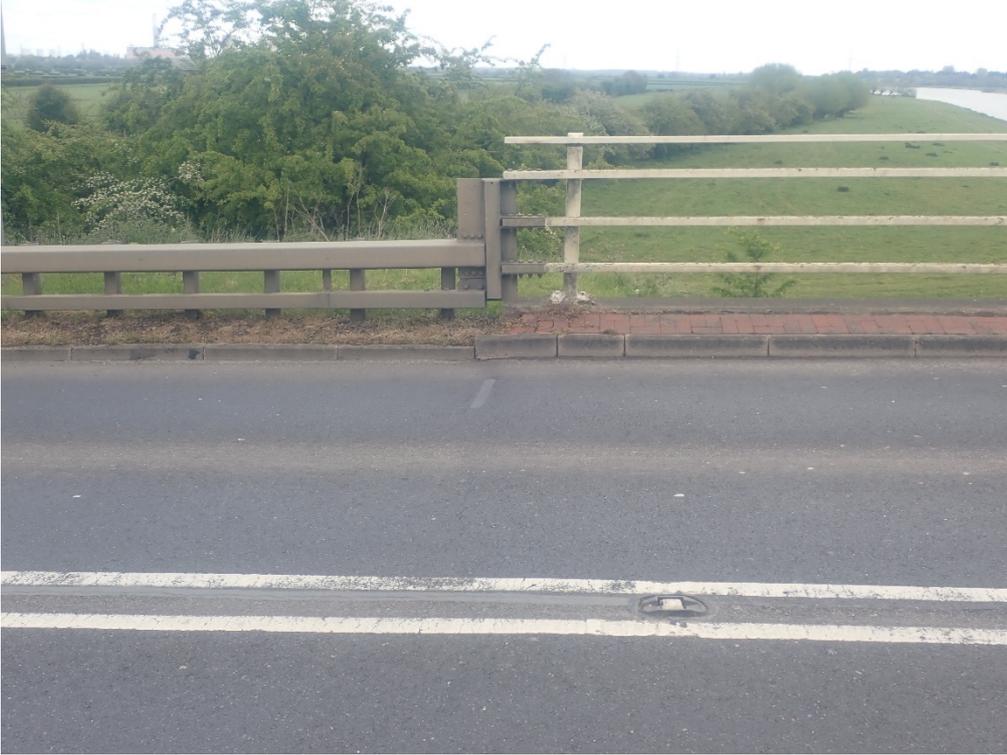
Plate 142. Transverse Cracking on the East Approach

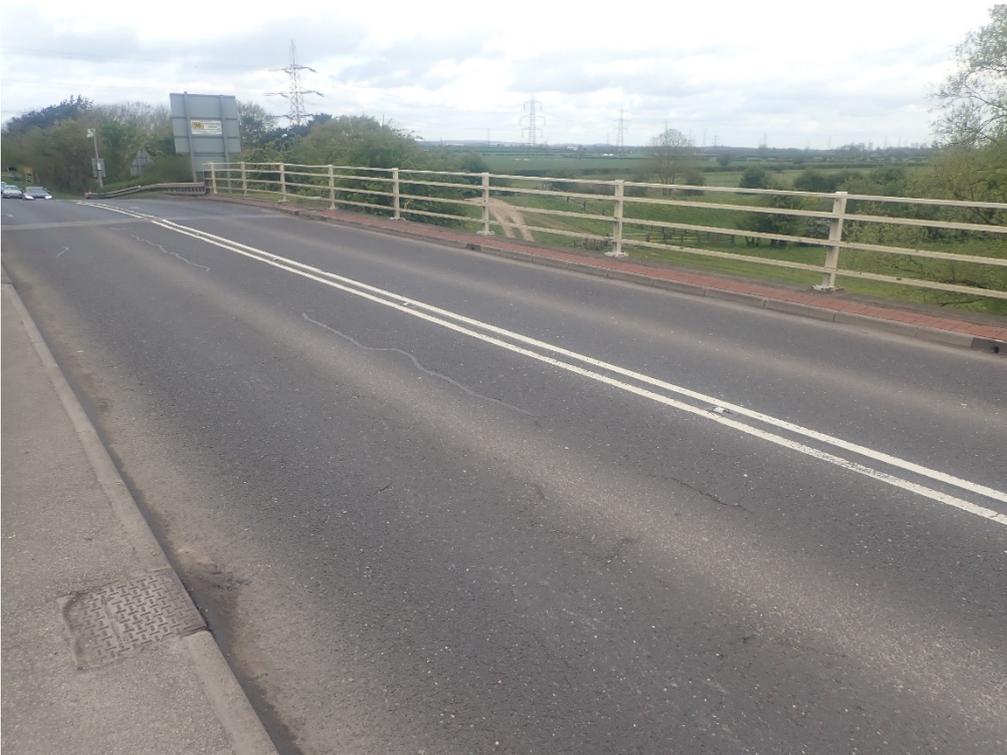
Plate 143. Repaired Crack with Obvious Step in Surfacing, West Approach

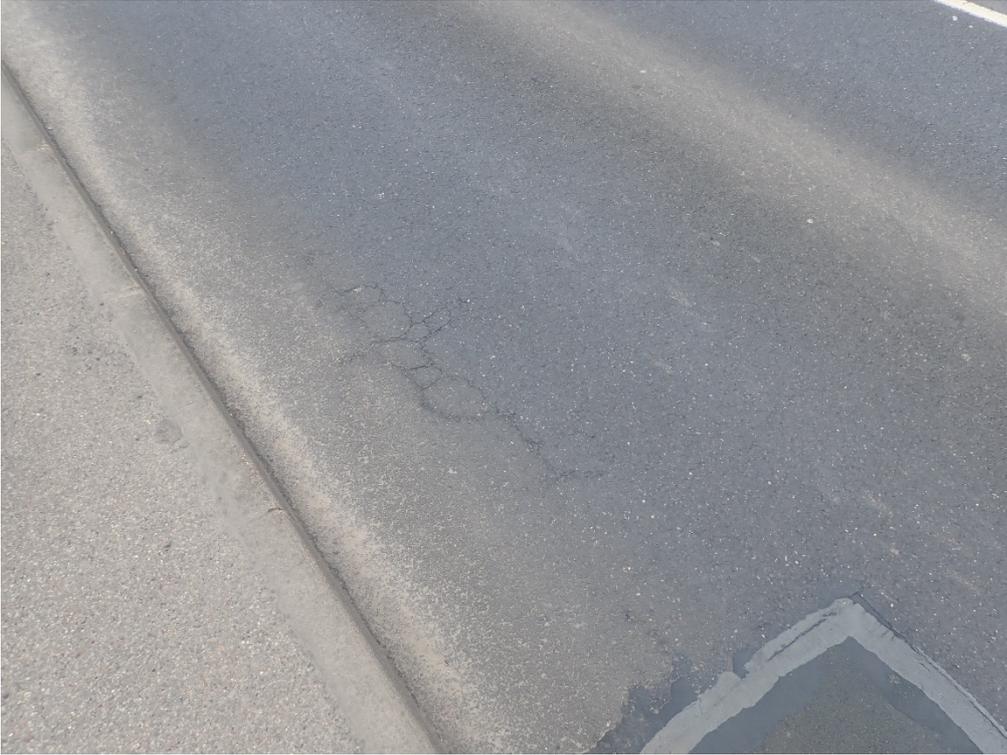
Plate 152. Typical Carriageway Condition, Inner West Span

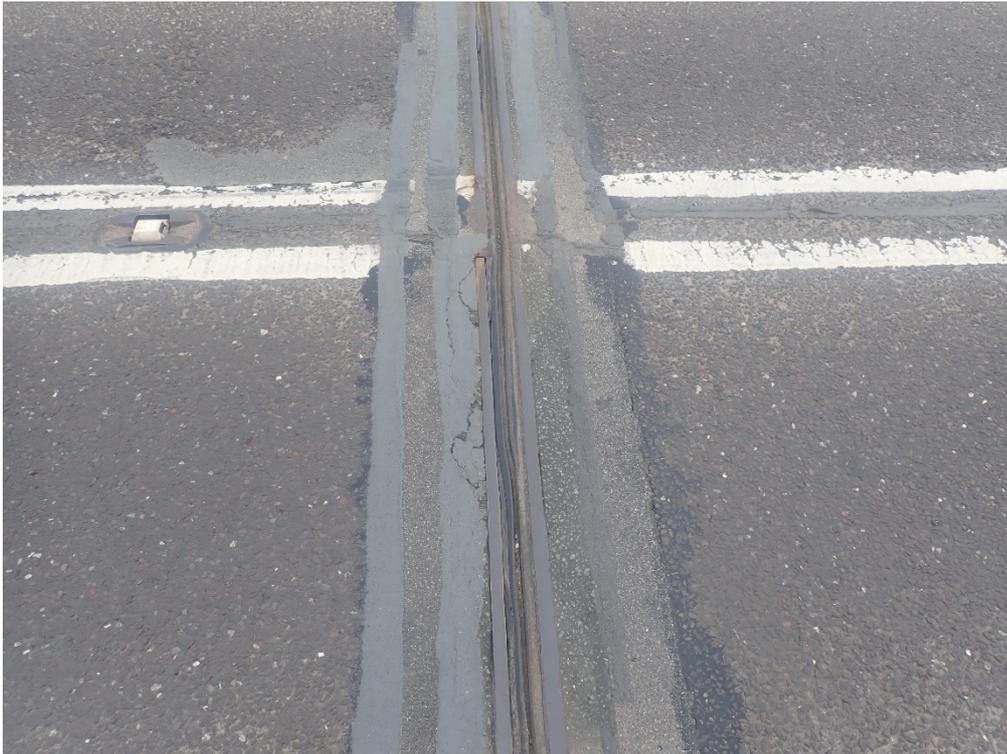
Plate 156. Debonding Between Nosing Mortar and Adjacent Carriageway Surface, West Pier Joint

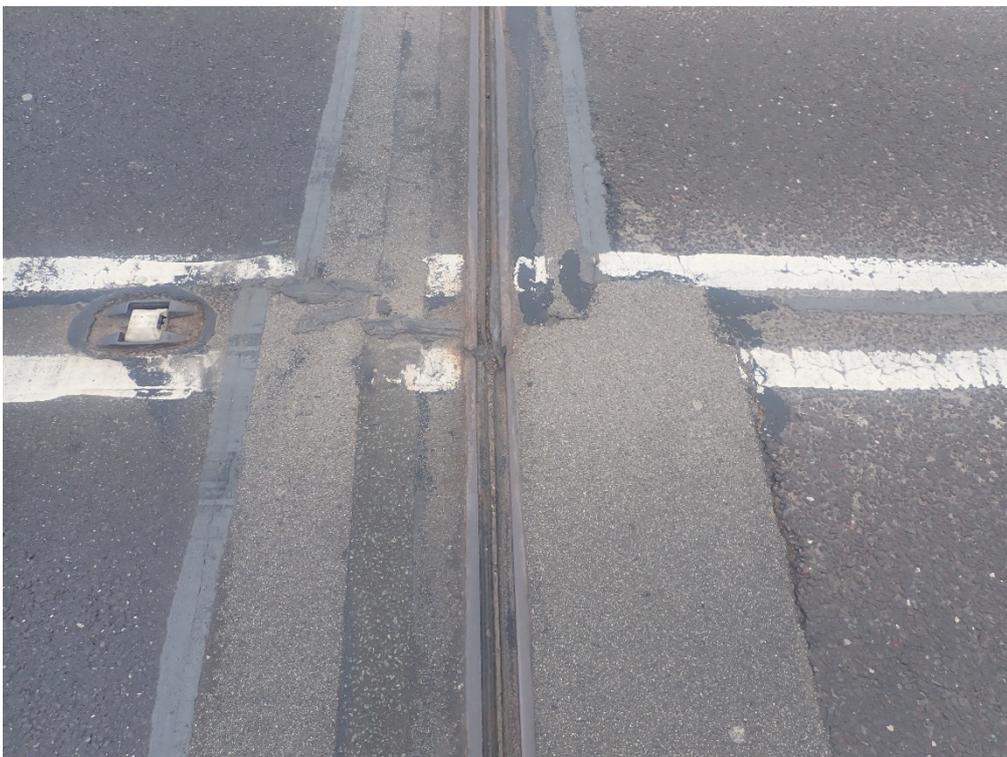
Plate 157. Cracking in the Nosing Mortar of the West Pier Joint

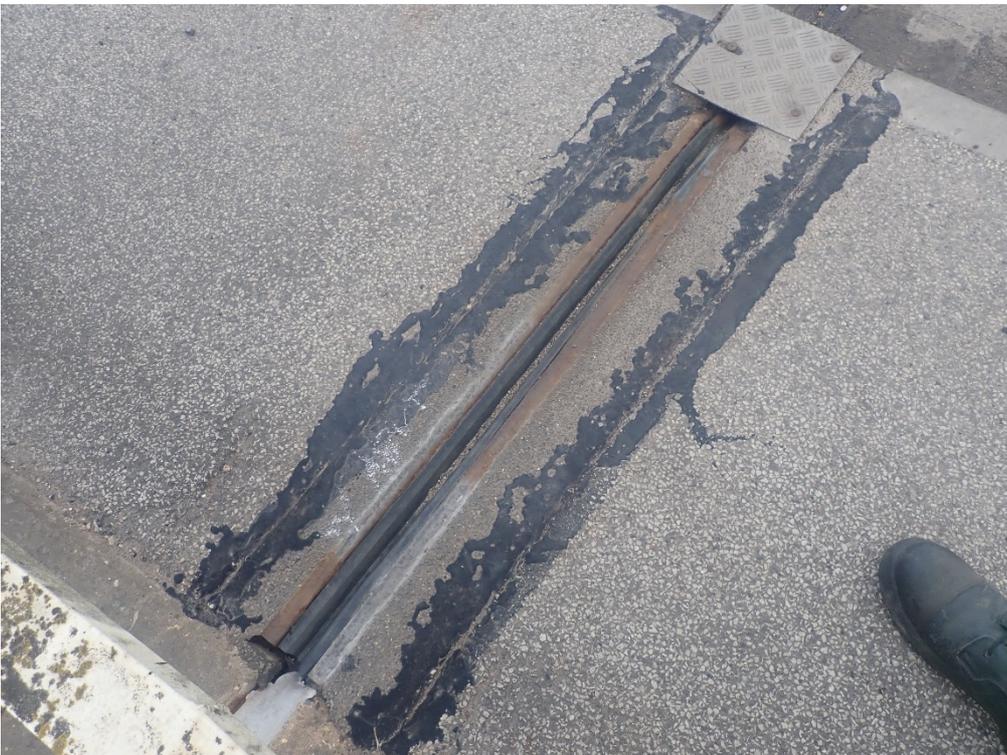
Plate 159. Non-Continuous & Mis-Aligned Nosing Rail, West Pier Joint

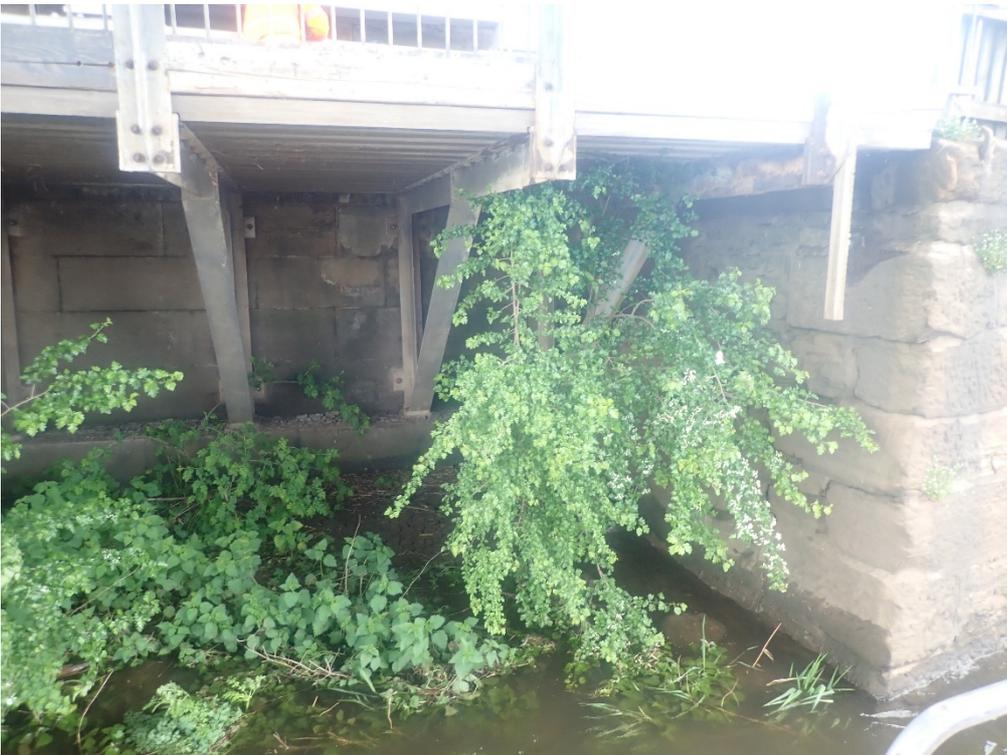
Plate 189. Tree Growth Between the Two Retaining Walls Beneath the East Abutment Walkway
