DUNHAM BRIDGE COMPANY

APPLICATION TO REVISE TOLL CHARGES

THE DUNHAM BRIDGE COMPANY

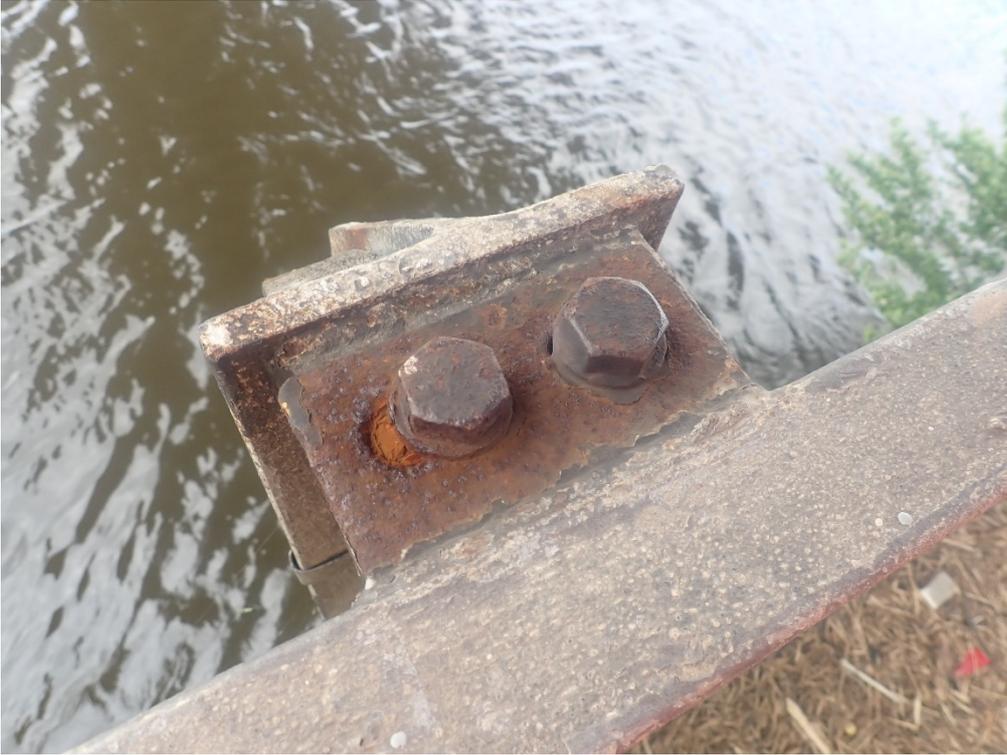
Plate 194. Split in Walkway Parapet Top Rail
