DUNHAM BRIDGE COMPANY

APPLICATION TO REVISE TOLL CHARGES

Under the Transport Charges etc. (Miscellaneous Provisions) Act 1954
Section 6 Dunham Bridge Act 1830 and Dunham Bridge (Amendment) Act 1994

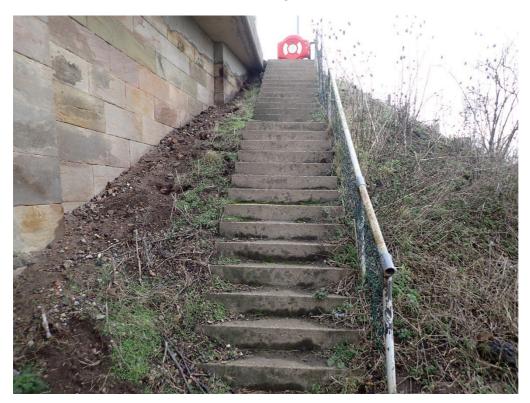
Plate 34. Access Stairs to the South-East of the structure

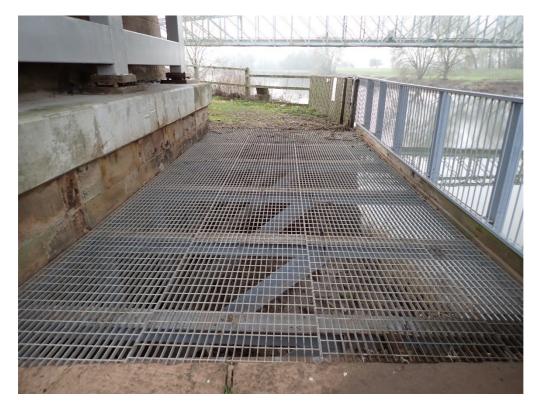
Plate 35. East Abutment walkway

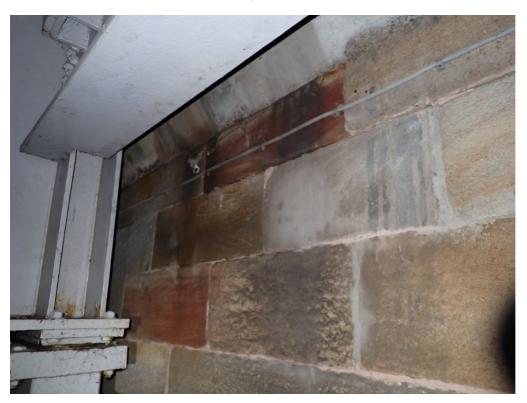
There was minor water staining noted to the back wall of both abutments. Plate 36.

Plate 36. Water staining to the West Abutment back wall

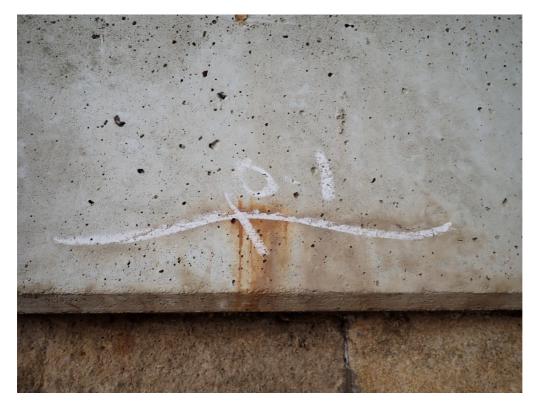
Plate 38. Reinforcement corrosion cracking to West Abutment concrete cap

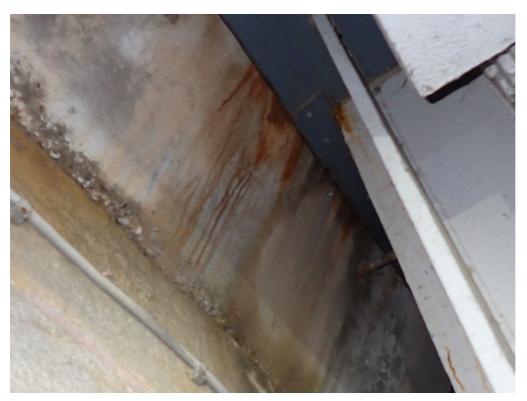
Plate 42. Rust staining emanating from the drainage deflector on the West Abutment

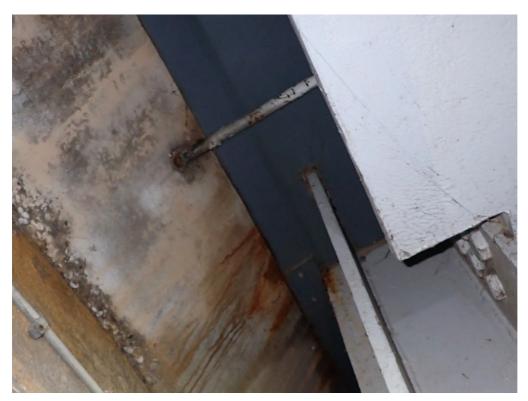
Anchorage bars embedded at the top of the back wall on the West abutment appeared to have been previously coated in a bitumen wrap. There was a residue on the anchor bolts which had been partially painted locally, with minor corrosion visible. Plates 43 – 44.

Plate 44. Minor corrosion from paint loss on the anchorage bar at West Abutment

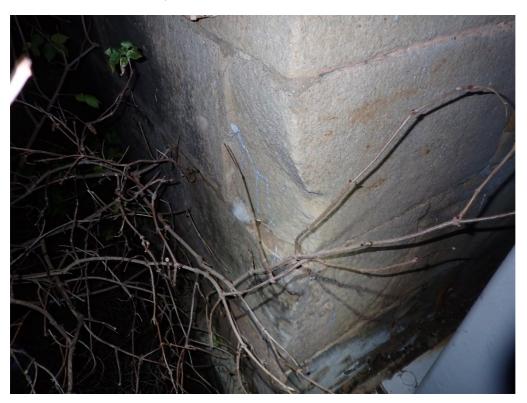
Plate 46. Shallow spall to the West Abutment, South end

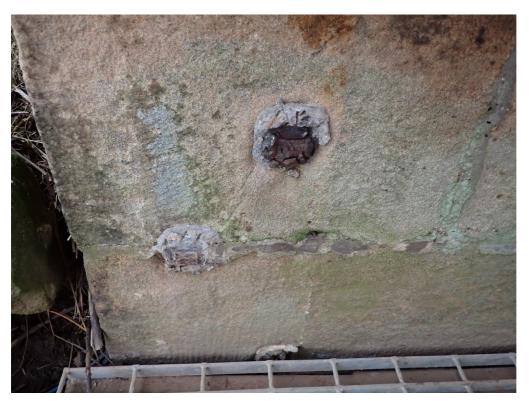
Plate 48. Corroded historic fixings in the East Abutment

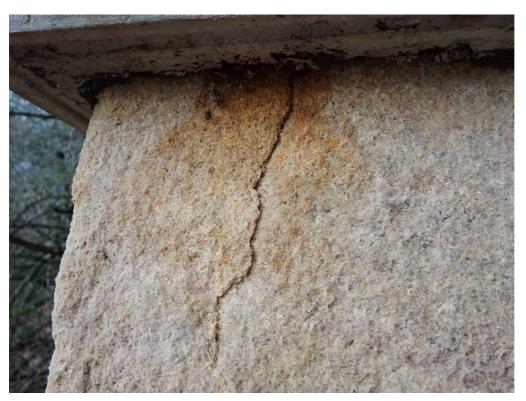
Plate 50. Cracking through stones in the West Abutment lower wall

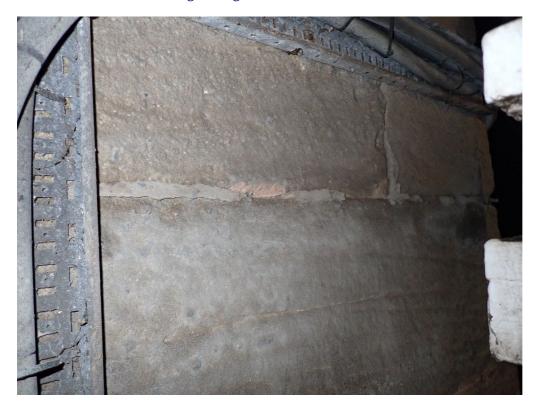
Plate 52. Typical condition of mortar on the West Abutment back all

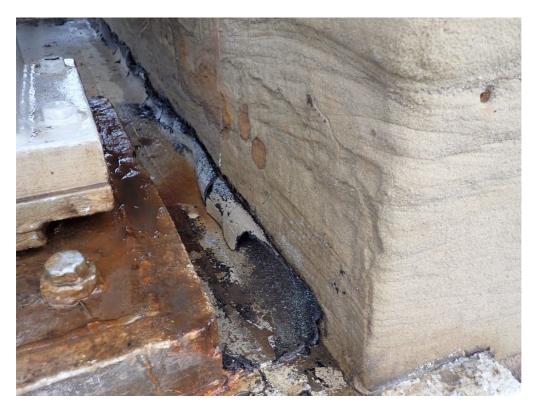
Plate 54. Damage to felt on the East Abutment

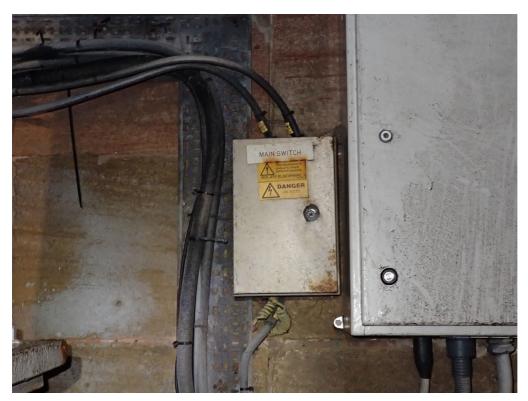
A heavily corroded cathodic protection cabinet was noted on the West abutment. The cabinet was open. It was assumed that this cabinet was an old one and now redundant with the presence of newer cabinets and cabling adjacent to it. The cathodic protection cabinet on the East Abutment exhibited some minor surface corrosion. Plates 57 - 58.

Plate 58. Minor corrosion to the cathodic protection cabinet on the East Abutment back wall

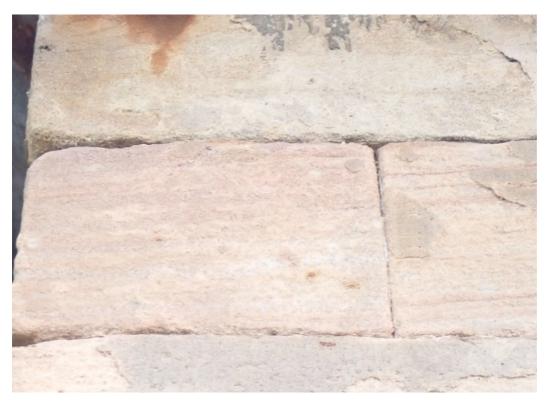
Minor mortar loss was noted across the wing walls, but all stone masonry units were secure, and loss was minimal and localised. Plate 62.

Plate 62. Mortar loss towards the top of the South-East wing wall

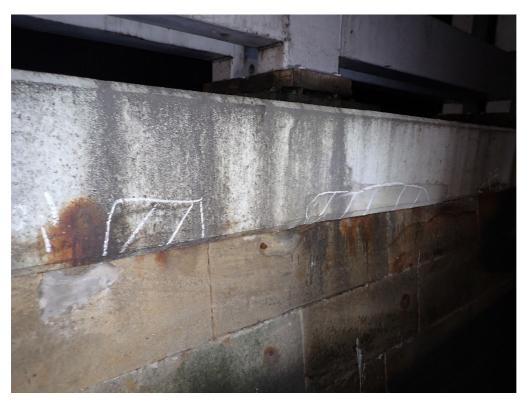
As with the reinforced concrete caps on the abutments, the caps on the piers also had visible cracking associated with reinforcement corrosion, measured up to 0.3mm wide. There were four areas of delamination to the centre pier concrete cap measured up to 920×120 mm, and shrinkage cracking. An area of repair was also visible on the centre pier with rust staining beneath it, having emanated prior to the repair. Plates 65 - 70.

Plate 66. Two areas of delamination, Centre Pier measured up to 920 x 120mm.

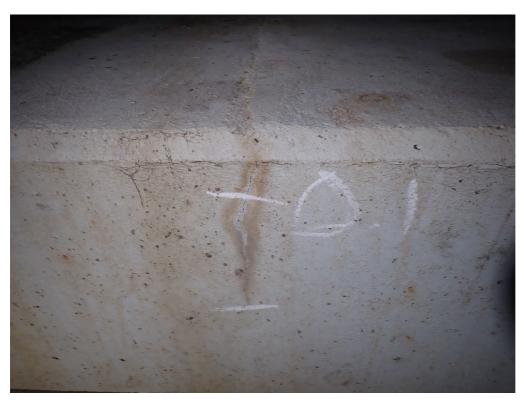
Plate 68. Cracking to the West Pier concrete cap

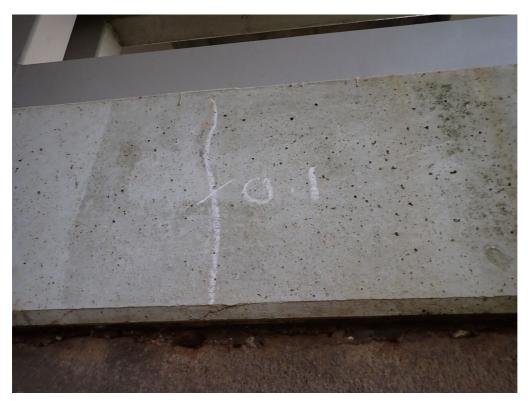
Plate 70. Typical cracking to Pier cap, East Pier

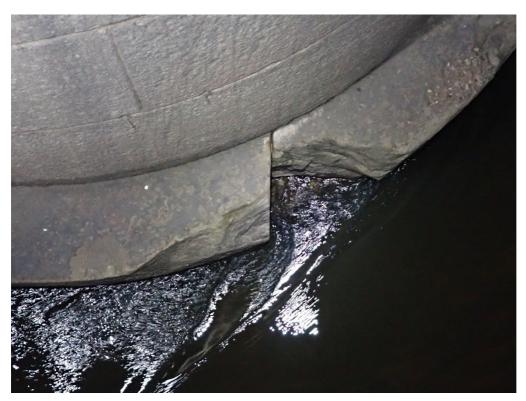
Plate 72. Impact Damage to Upstream End of the East Pier

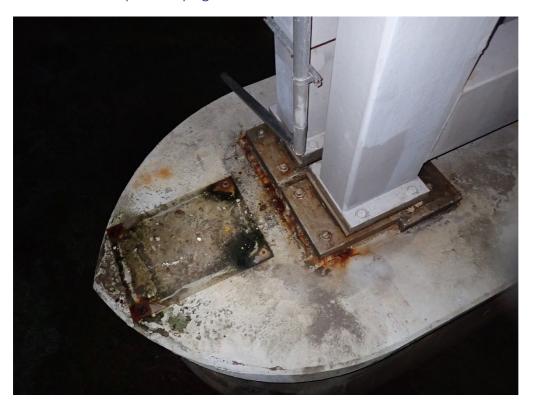
Water was dripping from the deck drainage on to the piers beneath resulting in staining but also calcite deposits. A historical attempt had been made to reduce the erosion effect of water dripping onto the pier caps by fixing acrylic sheets directly under the drainage, but these still allow for water flow beneath the sheet. Plates 74 - 77.

Plate 74. Water-stained downstream end of the West Pier

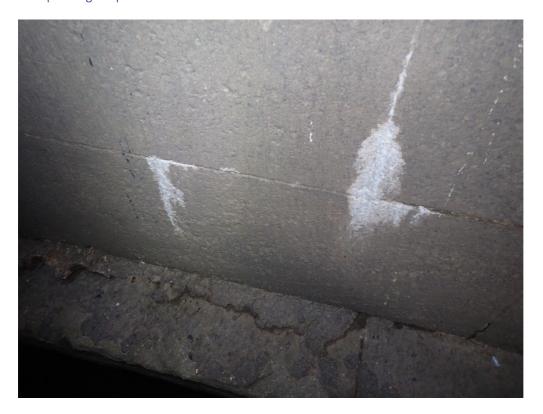
Plate 77. Leachate through mortar joints within the Centre Pier

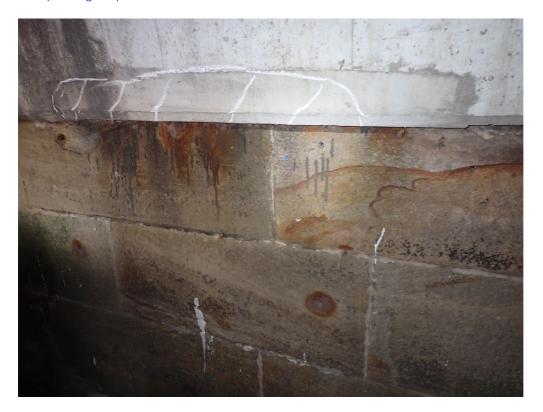
There were areas of minor mortar loss noted across the piers, but these were not significant, and stone masonry units were secure. Plates 81 & 82.

Plate 81. Typical minor mortar loss to the Centre Pier

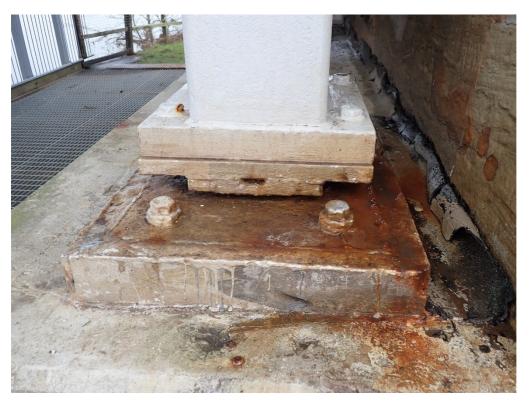
Plate 82. Rust staining to East Abutment bearing (South)

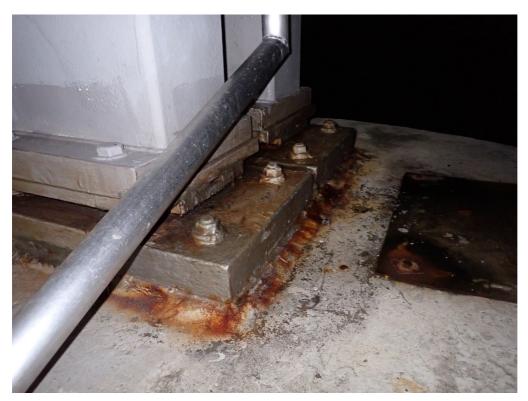
Plate 84. Rust staining to lower bearing on the West Pier

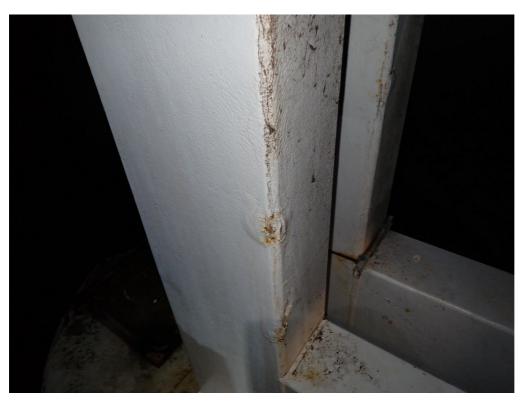
Plate 86. Paint blistering within the West Pier bearing frame

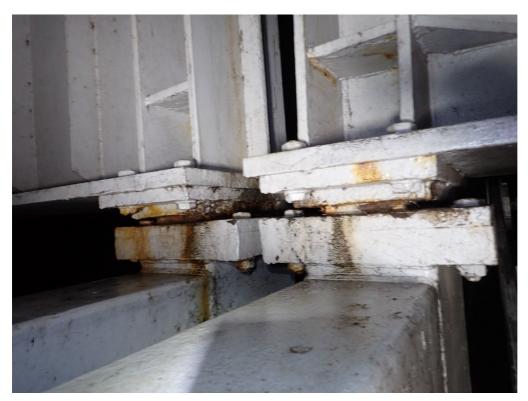
Plate 88. Spalled grout around Centre Pier Bearing

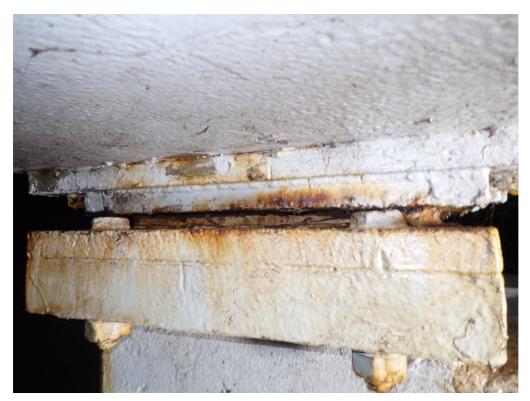
Plate 90. Paint blistering and cession to the South upper bearing on the Centre Pier

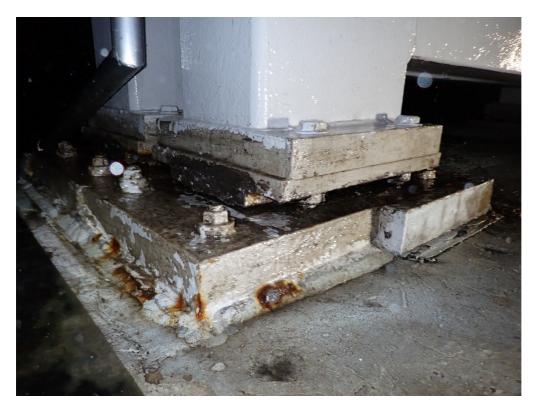
Grout surrounding the base of the bearings had cracked and spalled in several places, this was historic as none of the spalled pieces remained on the structure. Plate 92 - 94.

Plate 92. Spalling to the lower bearing plinth on the East Pier

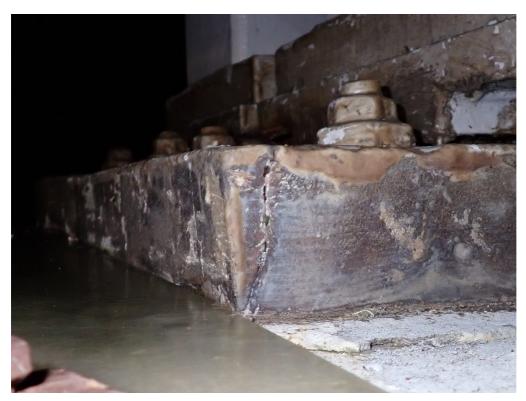
Plate 94. Cracking to the Centre Pier bearing plinth

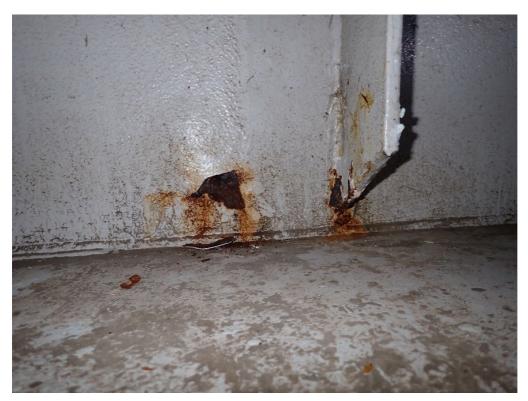
The protective paint system had failed in several localised locations, typically on top of the bottom flange and at the bottom of the web. The paint was blistered/flaking and when broken away exposed early stages of corrosion to the beams. Plates 95 – 98.

Plate 96. Flaking paint exposing underlying corrosion to South Beam, West Span

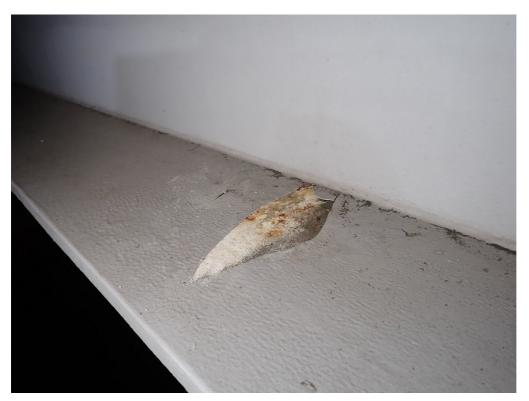
Towards the beam ends including transverse beams, minor corrosion staining was noted that is due to the proximity to the failing expansion joints above. Plate 97 - 102.

Plate 98. Flaking Paint to South Beam, Inner West Span

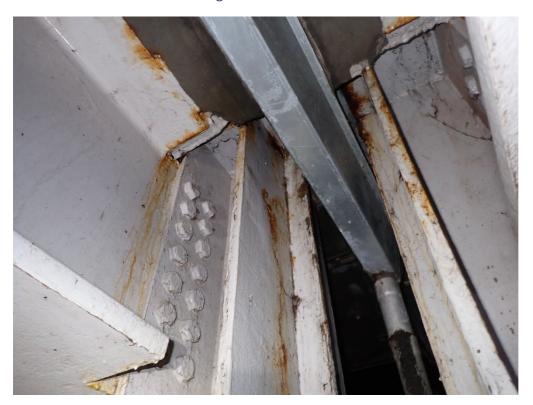
Plate 100. Corrosion staining to steelwork above the Centre Pier

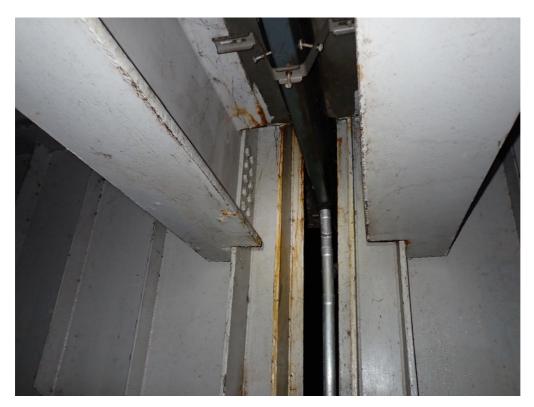
Plate 102. Corrosion staining to the transverse beam over the West Pier

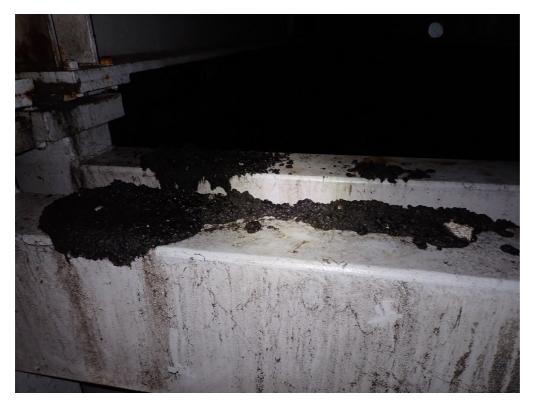
On the South transverse beam over the Centre Pier there was remnants of bitumen from repairs of the joint and carriageway. Plate 104.

Plate 104. Bitumen on the transverse beam of the Centre Pier, from repairs at the Centre Joint

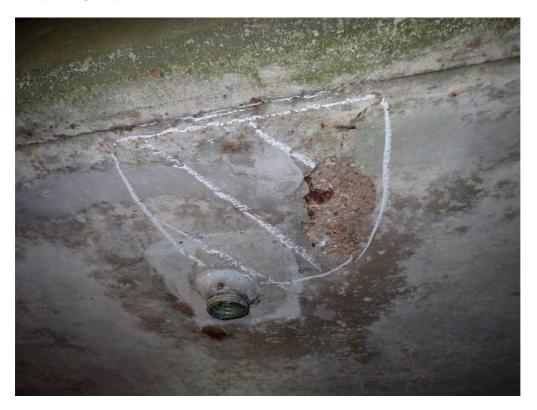
Plate 105. Delamination to the South edge beam on the West Span, 450 x 430mm

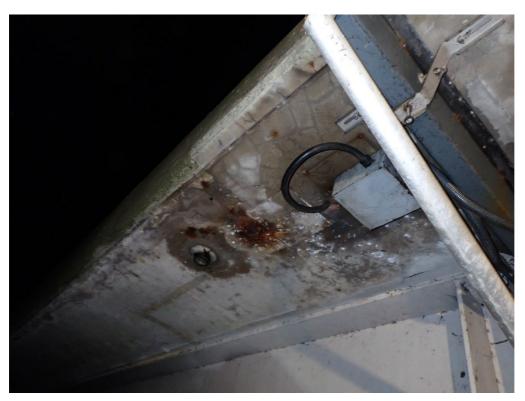
Plate 106. Minor spalled concrete and cracked repair to the North edge beam adjacent the West Joint

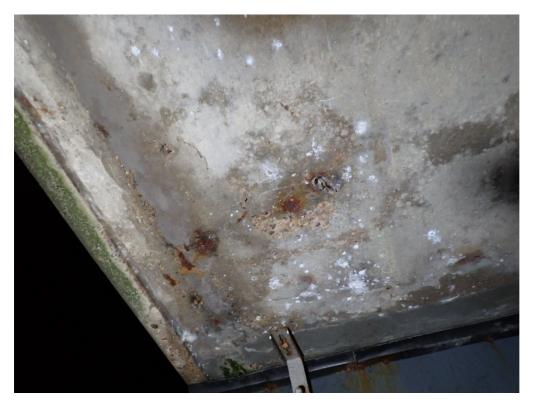
Plate 108. Minor delamination to the South edge beam adjacent the West Joint

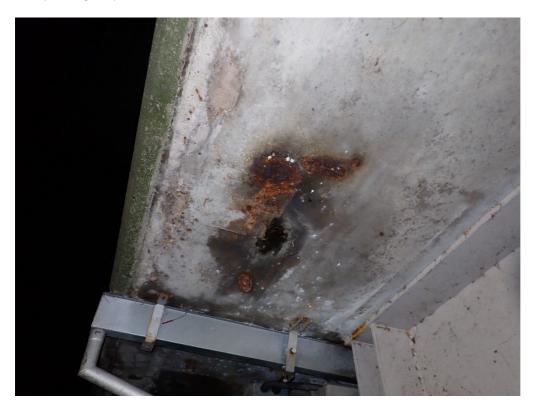
Plate 109. Minor spall to the North edge beam adjacent the Centre Joint

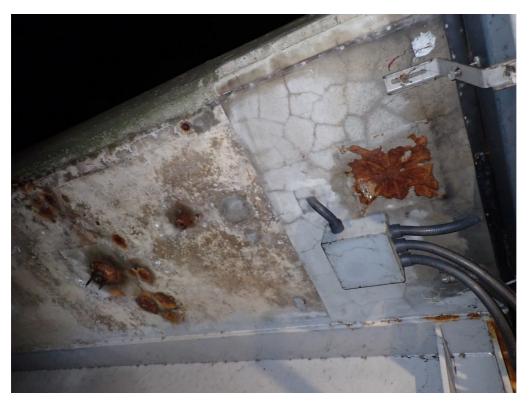
Plate 110. Minor spall and cracked repair to the North edge beam adjacent the East Joint

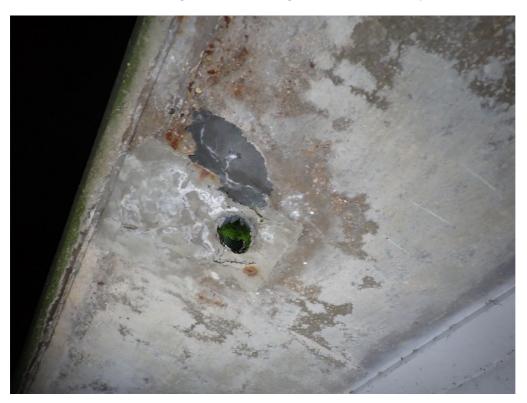
Plate 112. Rusty tie wire and repair to the North edge beam, inner West Span

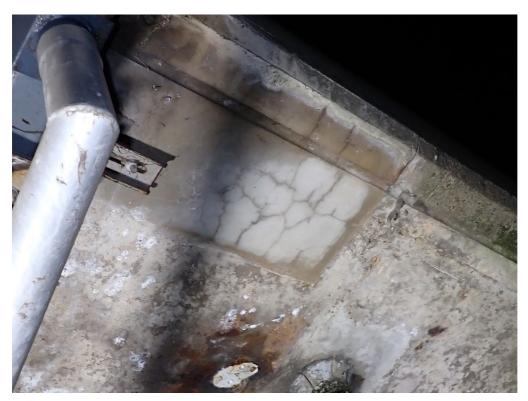
Plate 114. Cracks to concrete repair at East Joint

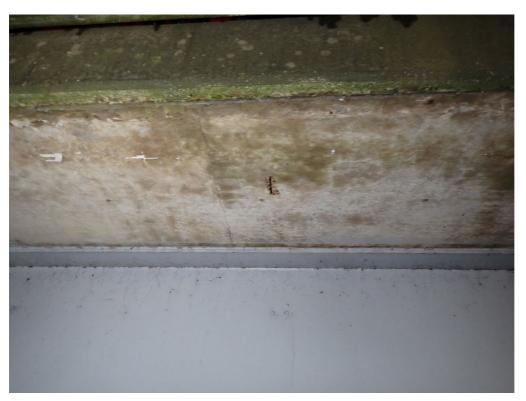
Plate 116. Spalled concrete exposing reinforcement in North Cantilever soffit, East Span

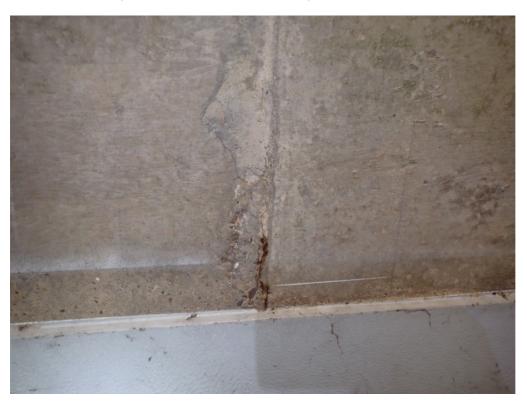
Plate 118. Corroded ferrous debris & crack, North edge beam on West Span

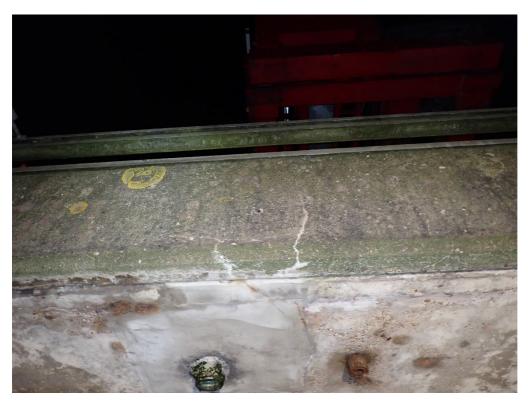
Plate 120. Typical cracking to North edge beam on inner East Span

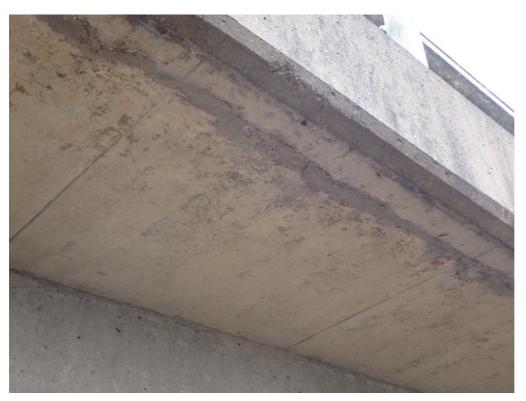
Plate 122. Typical view of narrow repair in Cantilever Soffit, South-East corner

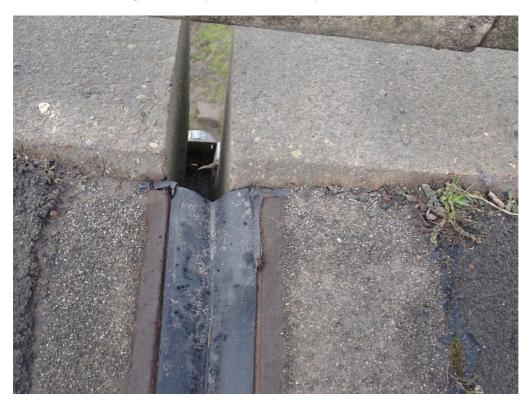
Plate 124. No sealant in joint above the Centre Pier

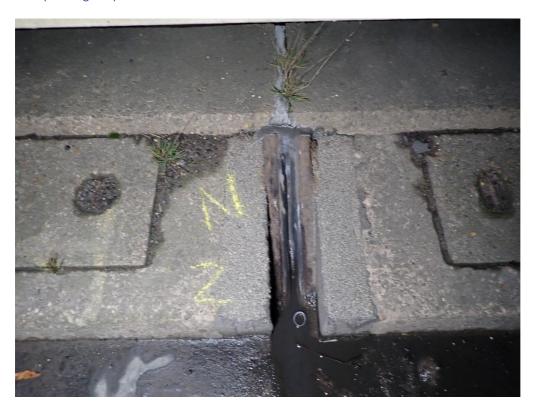
Plate 125. De-bonding of sealant above the West Pier, North edge beam

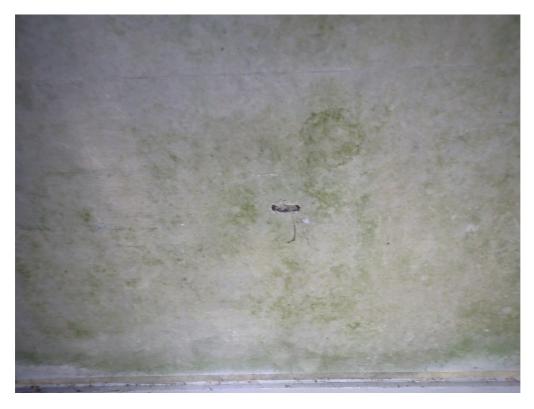
Plate 126. Void in Deck Soffit, Inner West Span

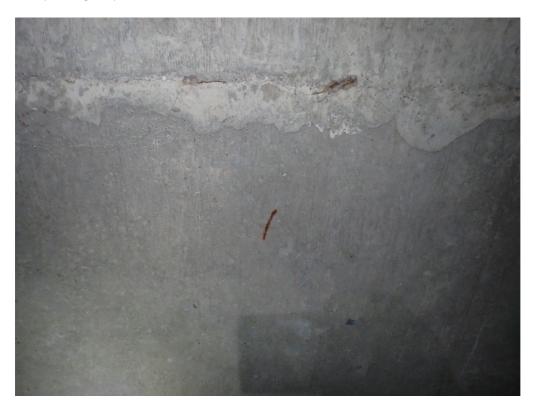
A small amount of corroded ferrous debris was found in the deck slab soffit this was more prevalent in the cantilever soffits and adjacent to construction joints. Plate 127.

Plate 127. Minor corroded ferrous debris found in Deck Soffit, West Span

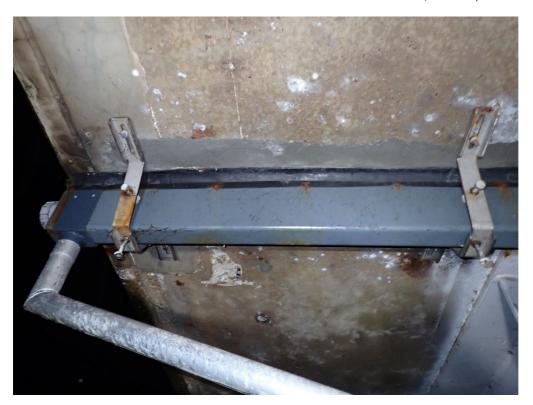
Plate 128. Minor corrosion to fixings on the East Joint

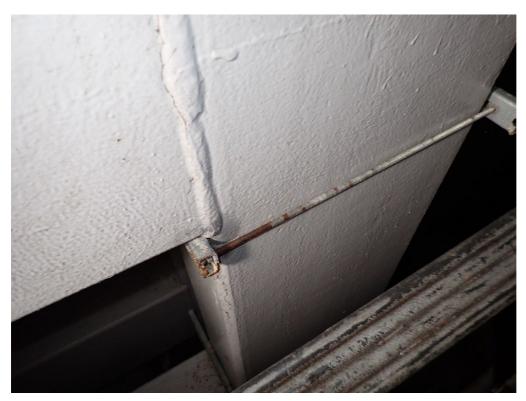
Plate 130. Minor corrosion to downpipe fixing on the Centre Pier

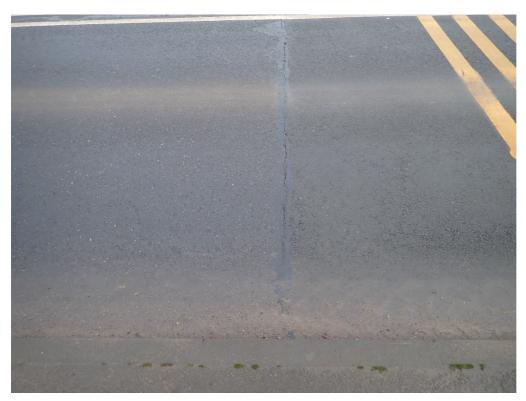
There were settlement cracks at either end of the structure on the approaches to each abutment, the cracking was more significant to the West end of the structure. Plates 132 & 133.

Plate 132. Transverse cracking on the East Approach

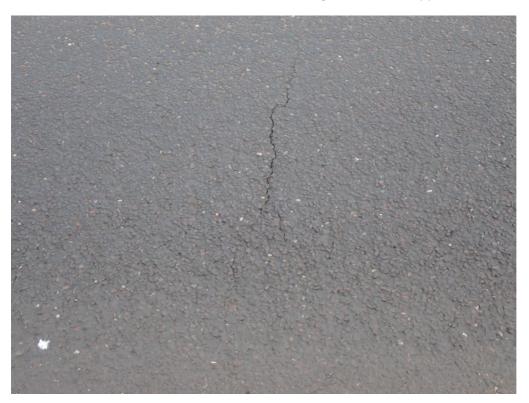
There were several cracks across the structure that were open, sealed or where a repair had failed. Plates 134 - 137.

Plate 134. Open crack in surfacing on the West Span

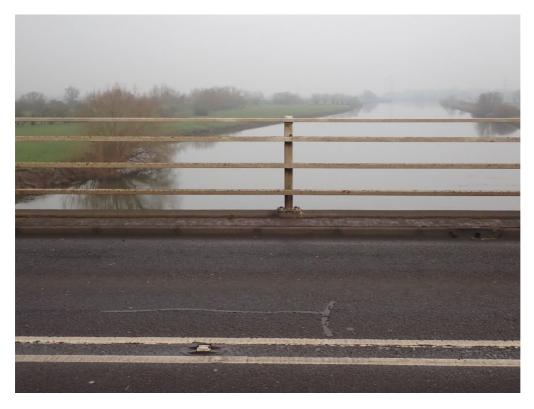
Plate 136. Sealed cracks in surfacing on the Inner East Span

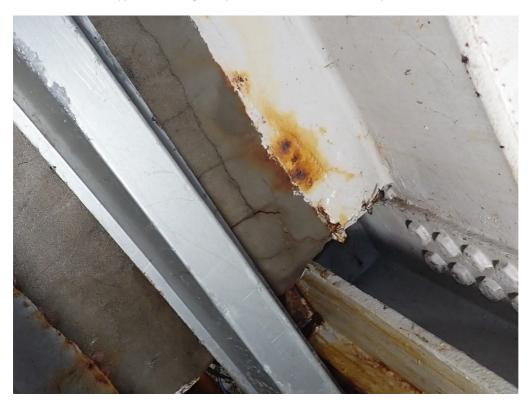
The expansion joints were in fair to poor condition with notable recurring defects across the five joints. The joints have continually deteriorated since the previous inspection, requiring patch repairs on the surfacing and the repairs to the pier joints beneath the deck were cracked and beginning to delaminate. Which in numerous places were wet, indicating there was water ingress from the joint above. Plates 138 - 141.

Plate 138. Cracking and delamination to the repair beneath the Centre Pier joint

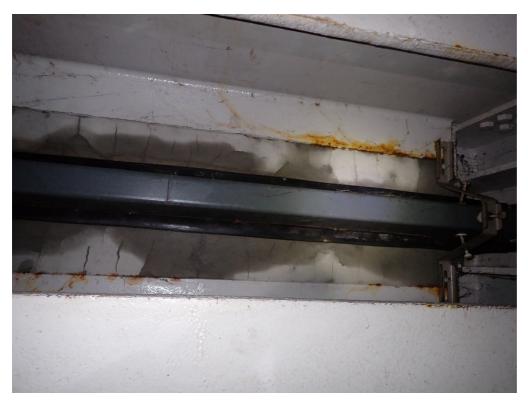
Plate 140. Water seepage and cracking to the repair beneath the Centre Pier joint

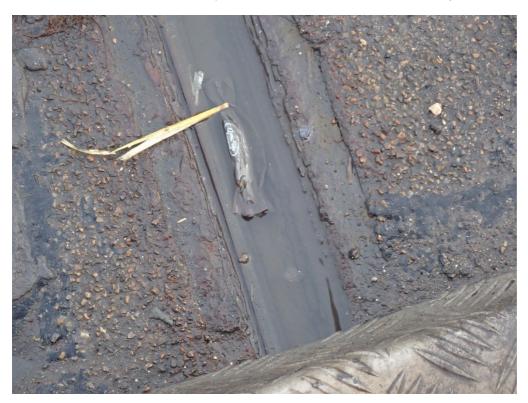
The joints leak, but the drainage channel installed beneath prevented most water leaking onto elements beneath. There was some ponding across the seals at the time of the inspection. Plates 142 & 143.

Plate 142. Active water ponding in the West Joint

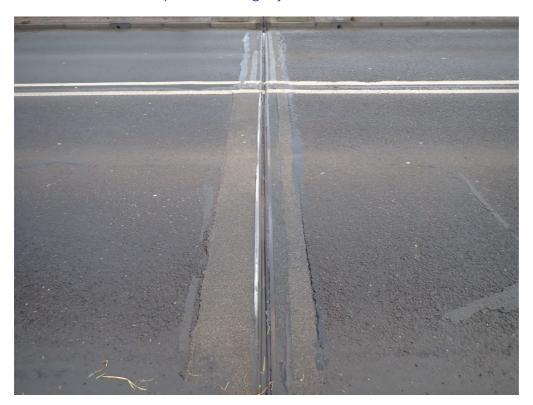
There was some debonding between the joint nosing material and the carriageway wearing course, adjacent to the joints. Cracking had occurred in the adjacent surfacing. There were numerous patch repairs adjacent the joints that were debonding and cracking. Plates 144 - 147.

Plate 146. Debonding between the nosing surfacing and carriageway, West Pier joint

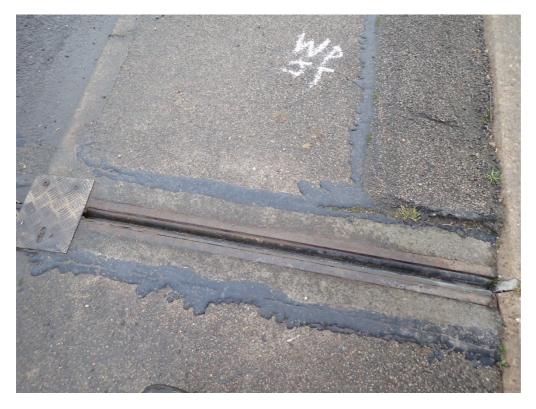
The steel rails were commonly corroded with some minor lamination forming, particularly in the verges where not polished by tyre wear. Plates 149 - 152.

Plate 150. Corrosion to the West Pier Joint nosing rails

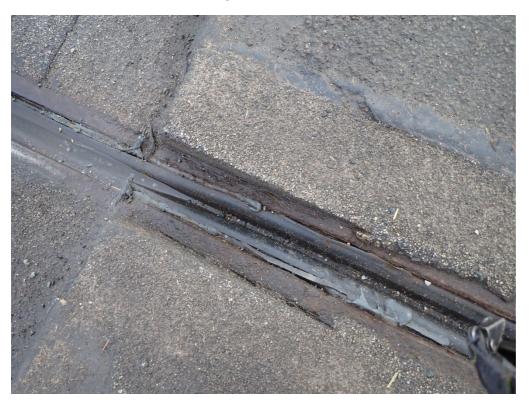
Plate 152. Corrosion with lamination to the East Joint rails

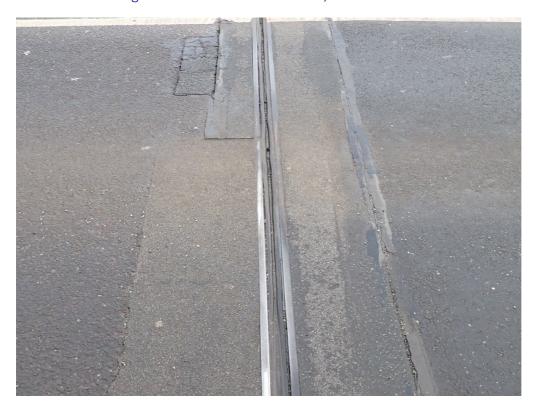
The joint seals were deformed in places across all five joints with areas visibly appearing to be detached allowing water ingress through the joint, as seen within the repairs beneath the joint. Plates 153 - 155.

Plate 154. Deformed Seal in the East Abutment Joint

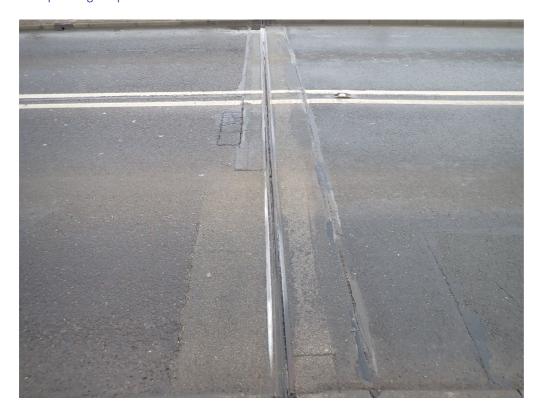
Plate 155. Deformed seal on the East joint

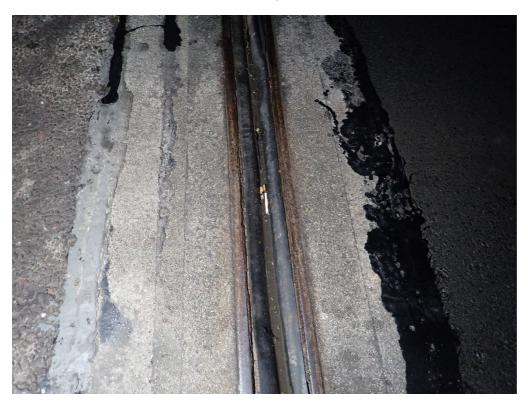
Dirt and debris were trapped in the seal between the joint rails which affected the performance of the joints. Plate 156.

Plate 156. Debris within the Centre Pier joint seal

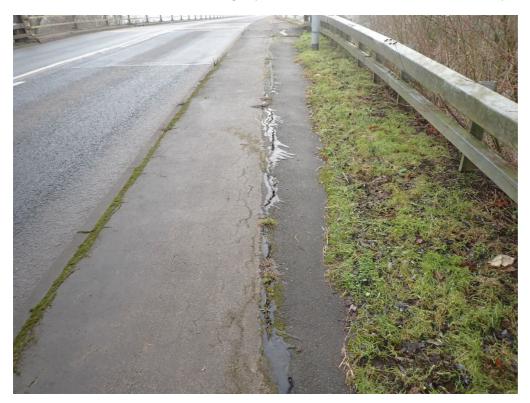
There were surfacing and crack repairs at both ends of the structure in the South footpath where historic settlement had occurred, this does not appear to have significantly worsened since repairs were made. At the West end of the South footpath there has been some settlement since the repairs, cracking has widened on the West verge at the South end. Some distortion of the bricks in the North verge was noted at either end of the structure. Plates 157 - 160.

Plate 158. Cracking to a repair on the West end of the South verge on the approach

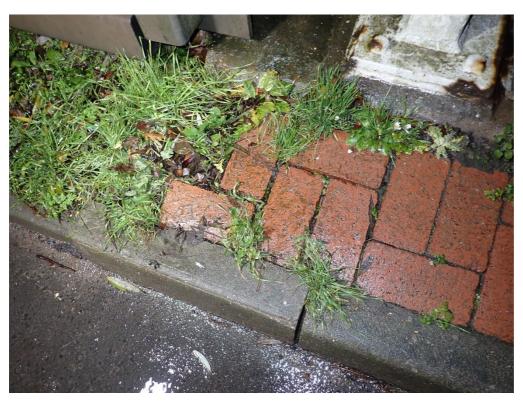
Plate 160. Misaligned bricks at the West End of the North Verge

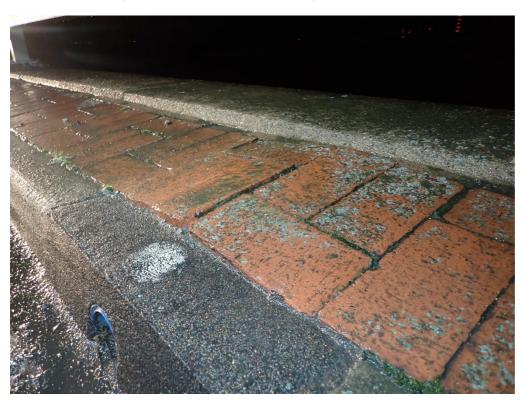
A longitudinal crack extended much of the length of the structure and was offset from the parapet edge beam by around 250mm. This gap extended at the West end where the footpath widens. Transverse cracks were found at drainage hole positions and raised bricks were also noted at drainage hole locations in the North verge. Plates 161 & 162.

Plate 162. Movement of bricks at drainage locations in North Verge

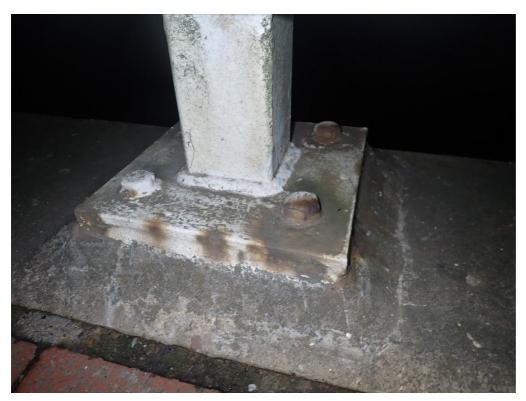
The parapets were in fair to good condition. Rust staining was common where the paintwork had failed. These areas were most common to the base plates of the parapet posts. A small number of fixings were corroded, and paint loss was noted at parapet expansion joints. Plates 163 - 167.

Plate 164. Typical corrosion and rust staining to North Parapet post base plate

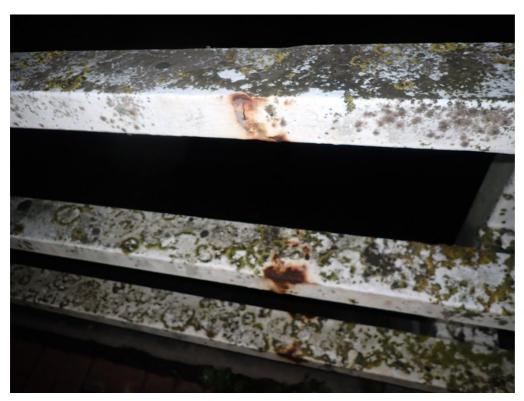
Plate 166. Typical corrosion to North Parapet rails where paintwork has failed

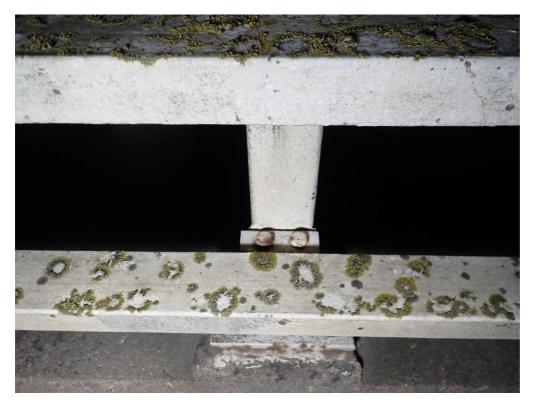
Lichen growth was common over much of the length of the parapet rails. Plate 168.

Plate 168. Typical lichen growth on the Parapets

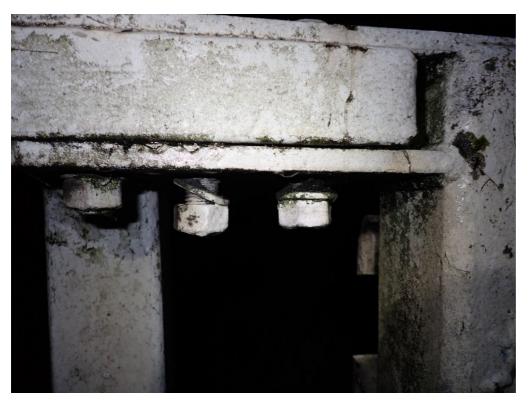
All the barriers and fences were in good condition and secure. Bolt assemblies were not fully tightened at the connection between the North parapet and the North-East barrier. Plate 170.

Plate 170. Loose nuts on the connection at the North-East corner

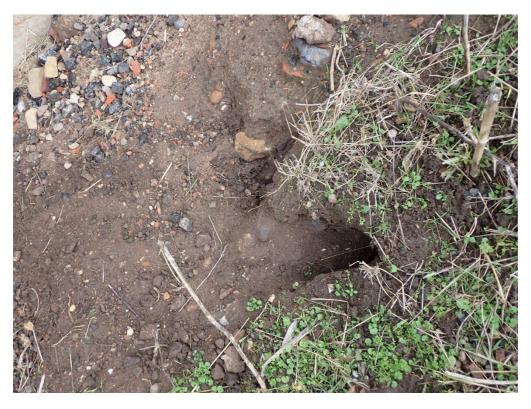
Animal burrows were regularly found on the banks adjacent to the wing walls of the structure, particularly adjacent to the North-East and South-West wing walls. Plates 171 & 172.

Plate 172. Animal burrows on the bank adjacent to the North-East Wing Wall

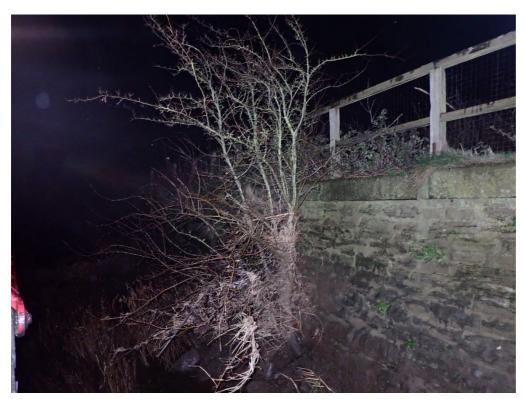
There was vegetation growth at the foot of the walls and growing from mortar joints. Plates 174 - 176.

Plate 174. Tree growth at the base of the North-East Retaining Wall

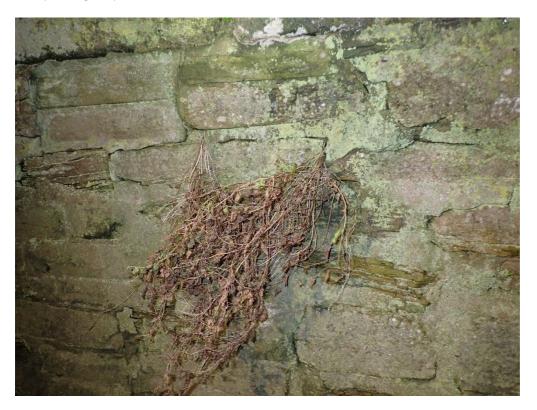
Plate 175. Vegetation growth from the mortar joints of the East Retaining Wall

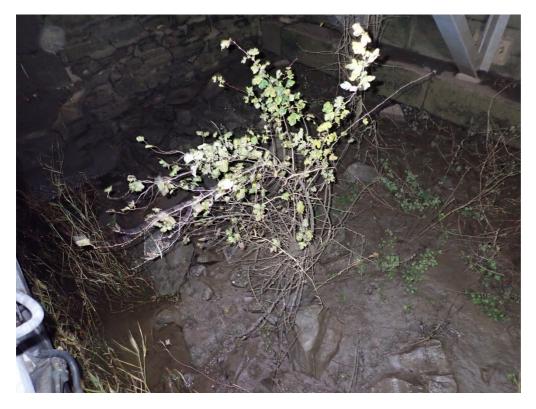
Plate 176. Tree growth between the two Retaining Walls beneath the East Abutment Walkway

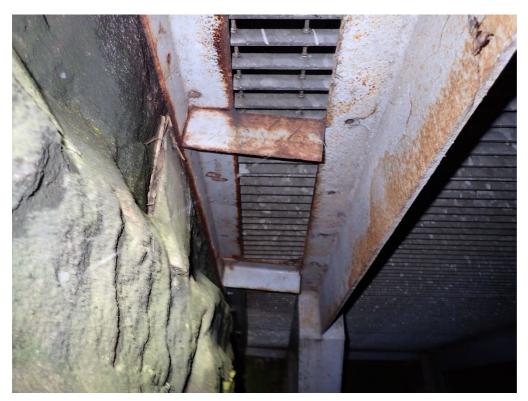
The steel support structure was in fair to good condition although minor surface corrosion was common across the frame and fixings where the protective paint system had failed, but no section loss was noted. Plates 177 - 179.

Plate 178. Minor corrosion to the underside of the Walkway
