DUNHAM BRIDGE COMPANY

APPLICATION TO REVISE TOLL CHARGES

THE DUNHAM BRIDGE COMPANY

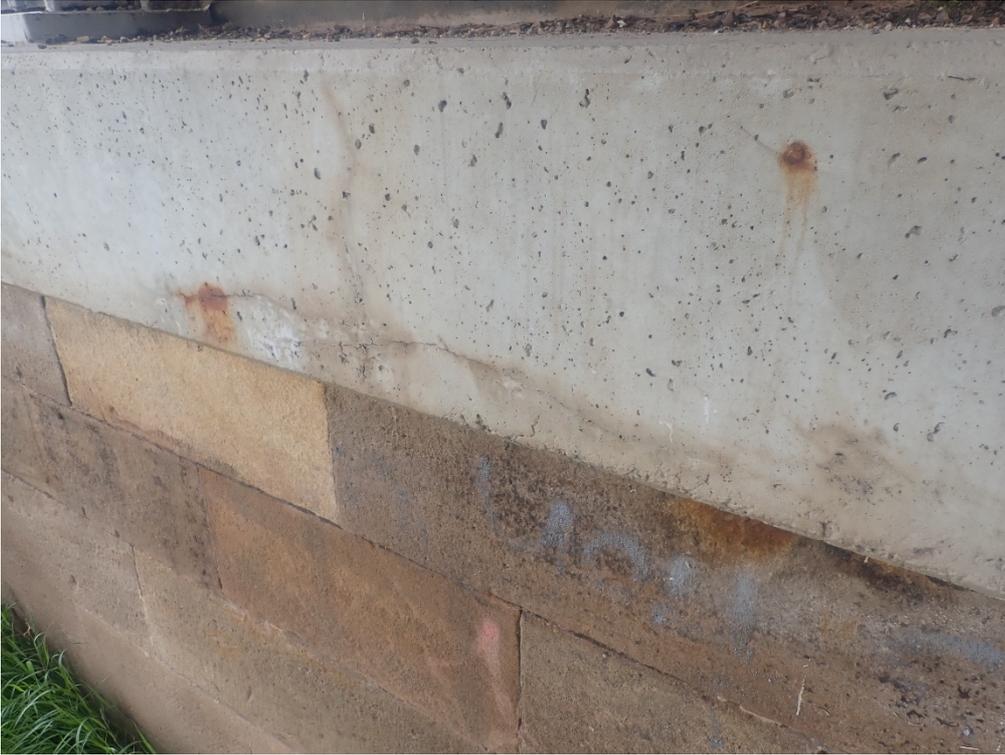
East abutment crack being much shorter. Rust staining was noted on the stone beneath the cracking in the West abutment cap. There was no hollow sounding concrete around the cracks when struck with an inspection hammer at the time of the inspection. Other vertical cracks were also noted but were much finer and likely to be shrinkage cracking. Plates 37 – 40.

Plate 37. Reinforcement Corrosion Cracking to West Abutment Concrete Cap

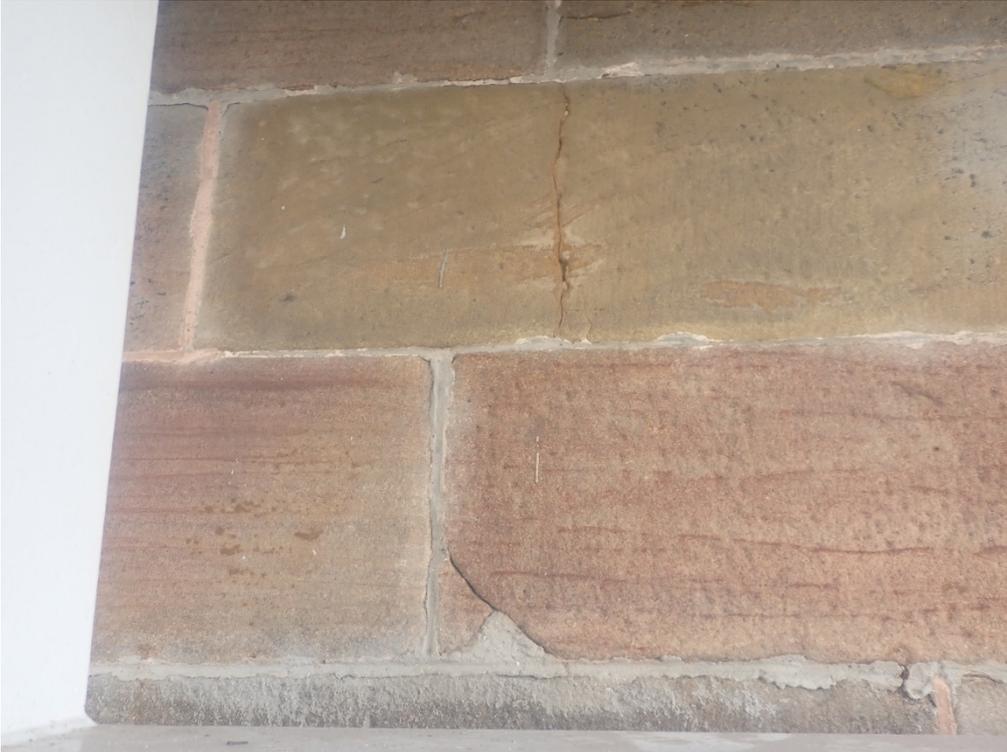
Plate 50. Corroded Historic Fixings in the East Abutment

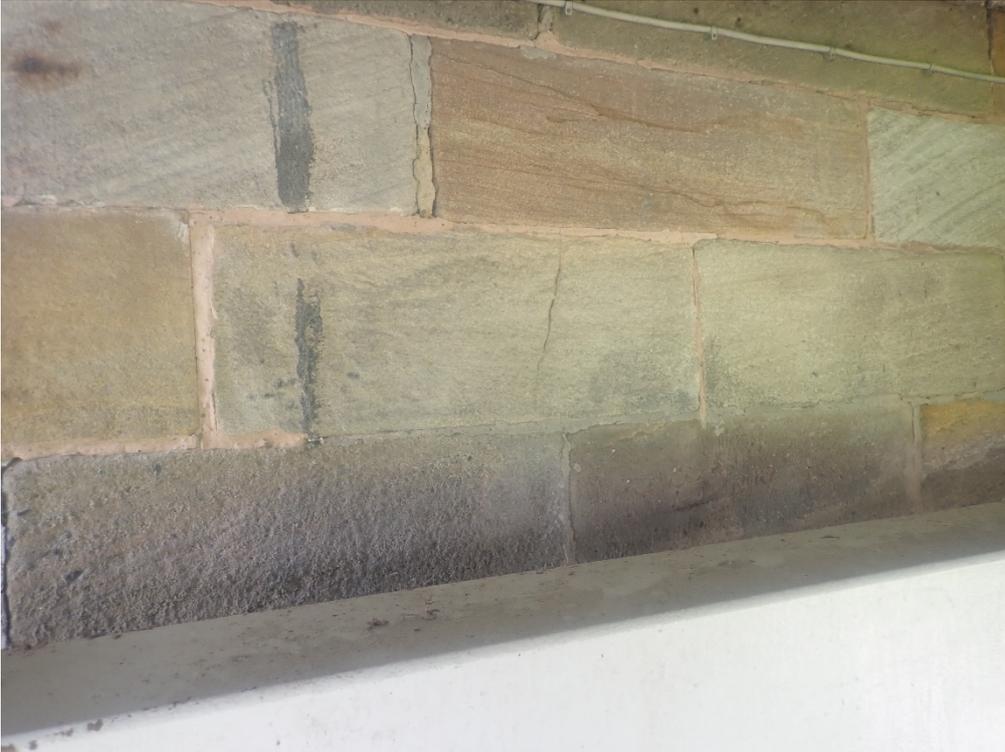
Several cracks were also found in the stone masonry units of each abutment. The cracks appeared to non-continuous and limited to individual stones. Plates 51 – 53.

Plate 52. Cracking Through Stones in the West Abutment Back Wall

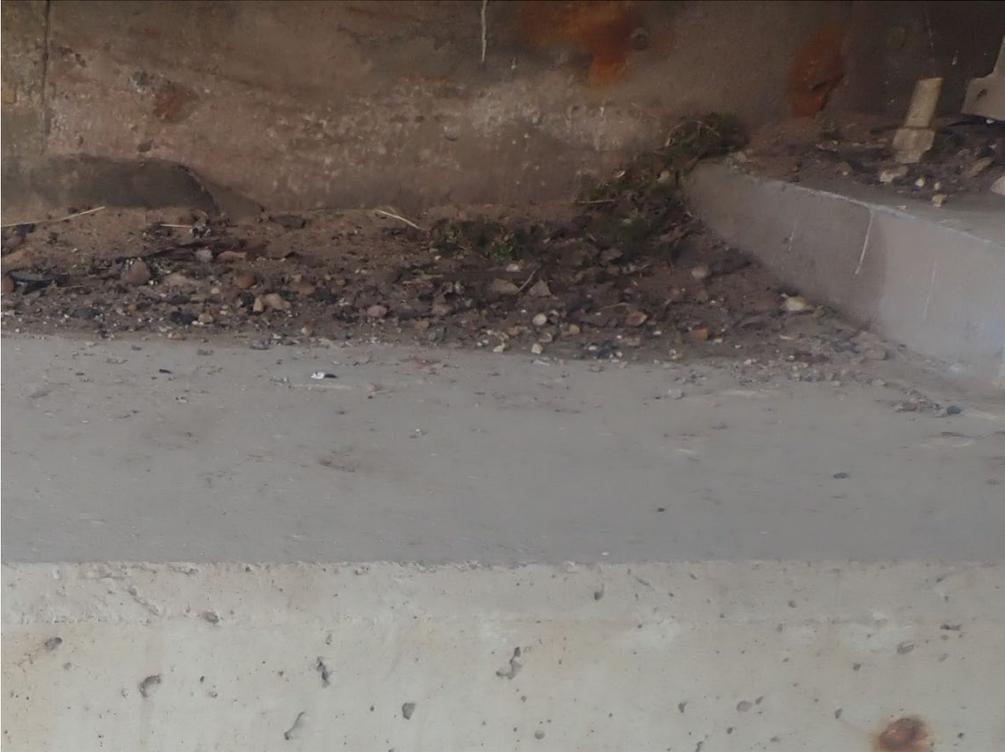
Plate 56. Damage to Felt on the East Abutment

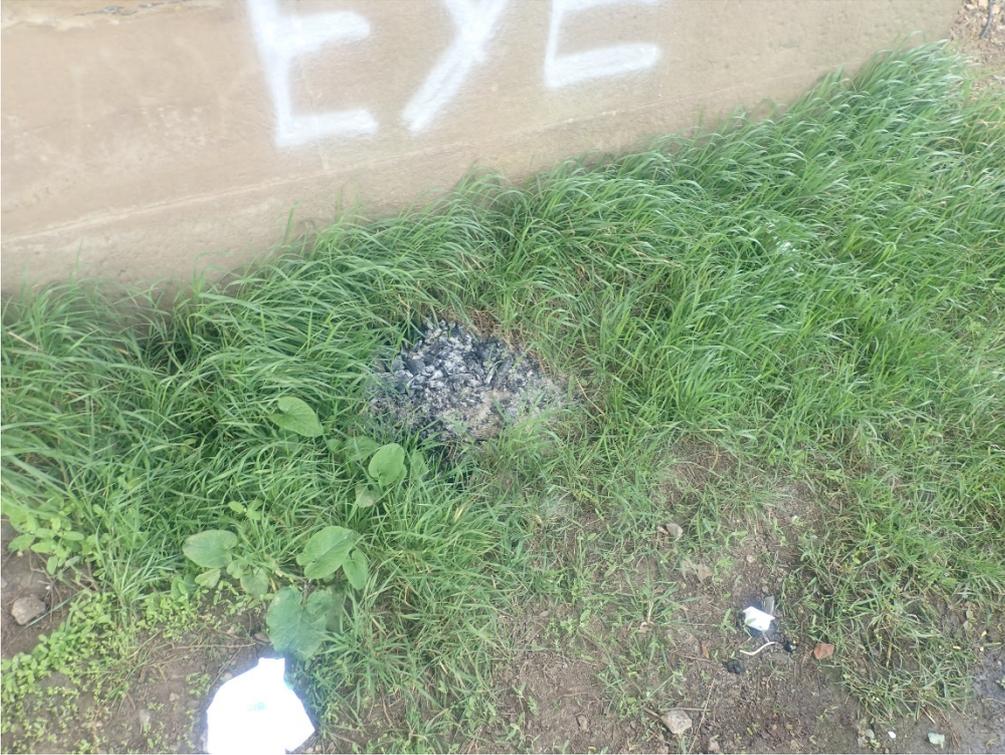
Two areas of graffiti were found on the West abutment, one large area of painted non-offensive graffiti and a smaller non-offensive piece written using a type of mastic sealant. Plate 59 – 60.

Plate 60. Graffiti Written on the West Abutment

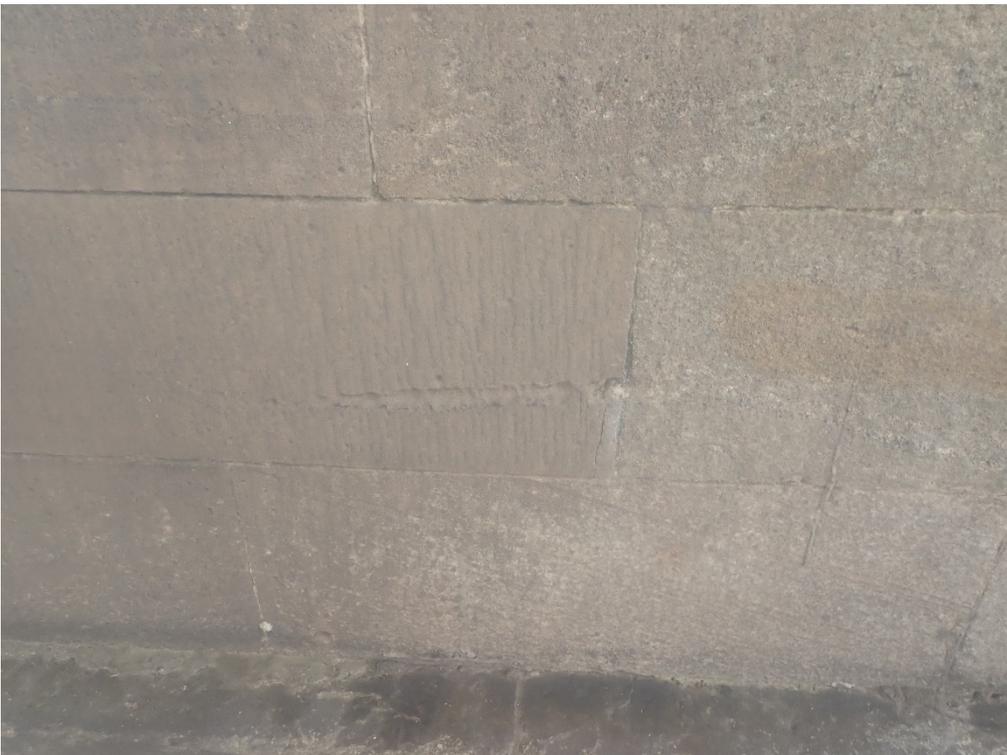
Plate 77. Impact Scraping to the West Pier

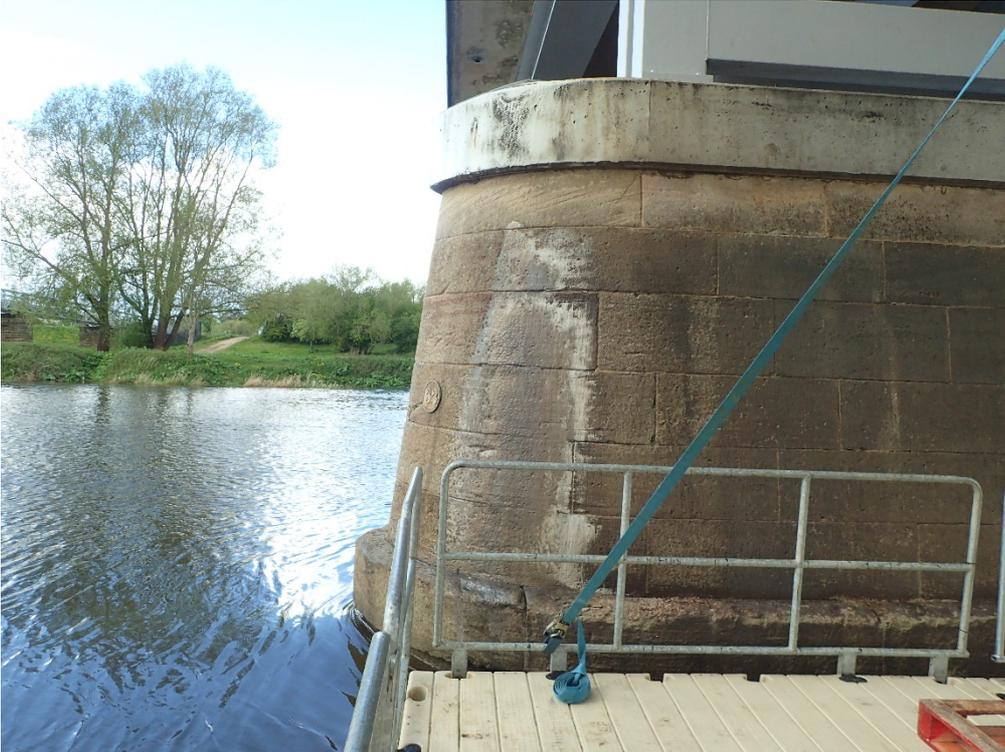
Plate 80. Water Staining to Upstream End of the Centre Pier

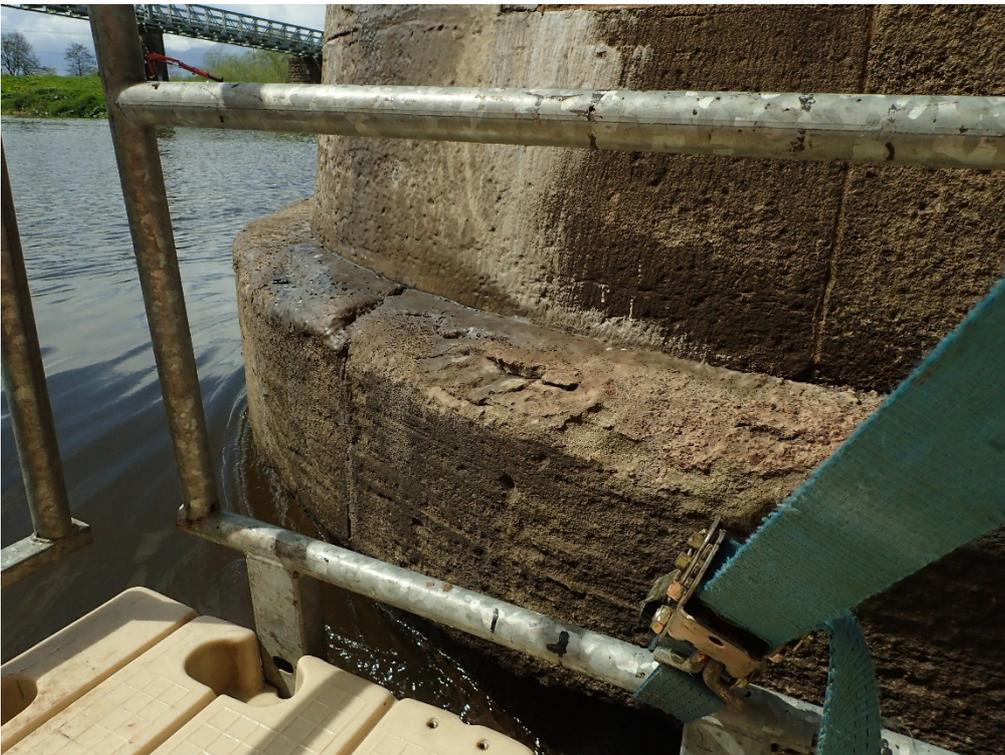
Plate 81. Calcite Deposits to the Upstream End of the East Pier

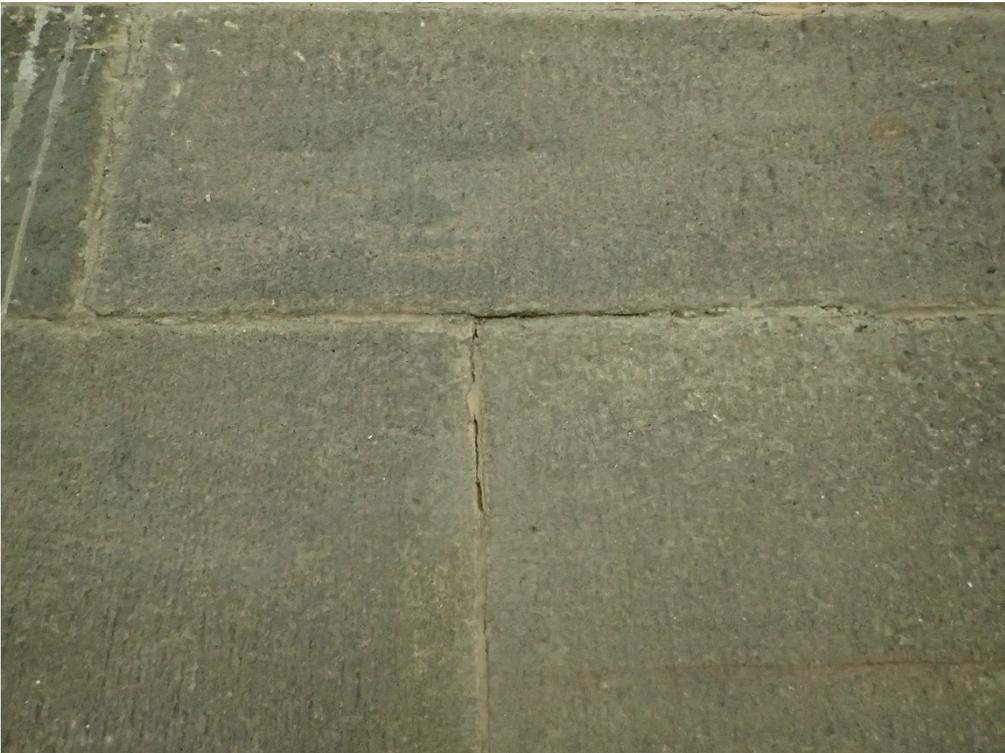
There were areas of minor mortar loss noted across the piers, but these were not significant, and stone masonry units were secure. Plates 85 & 86.

Plate 85. Pocket of Mortar Loss in the West Pier

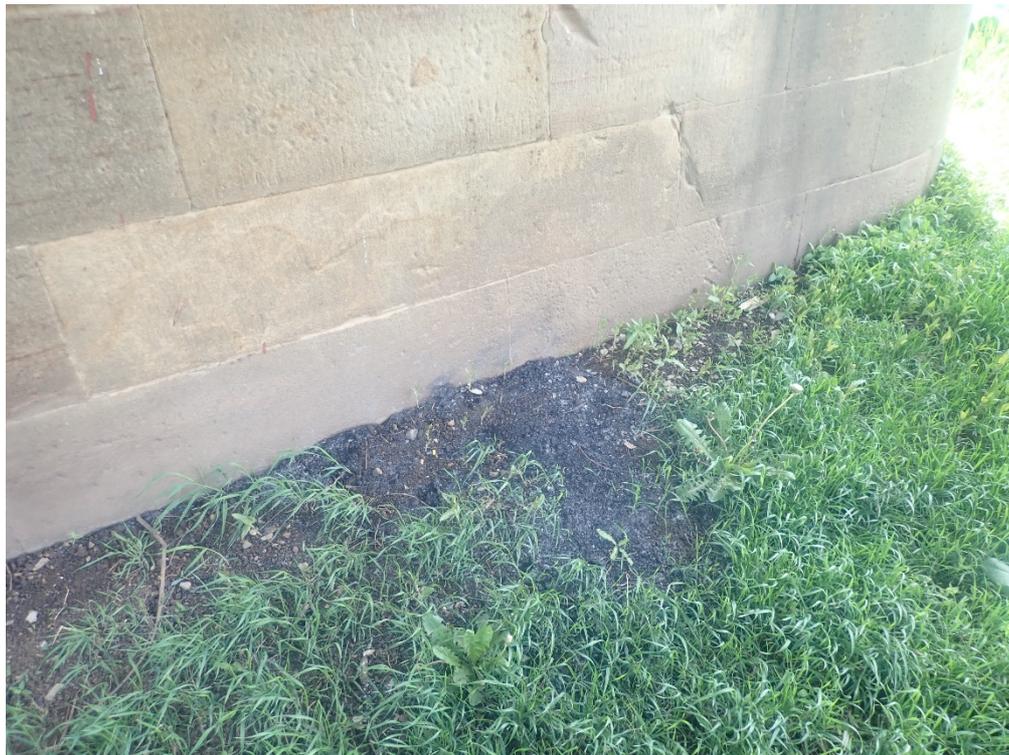
There was evidence of fires being lit at the base of the West pier. There was no soot staining or associated damage found on the piers. Plates 87 & 88.

Plate 87. Evidence of Fire Against the East Side of the West Pier

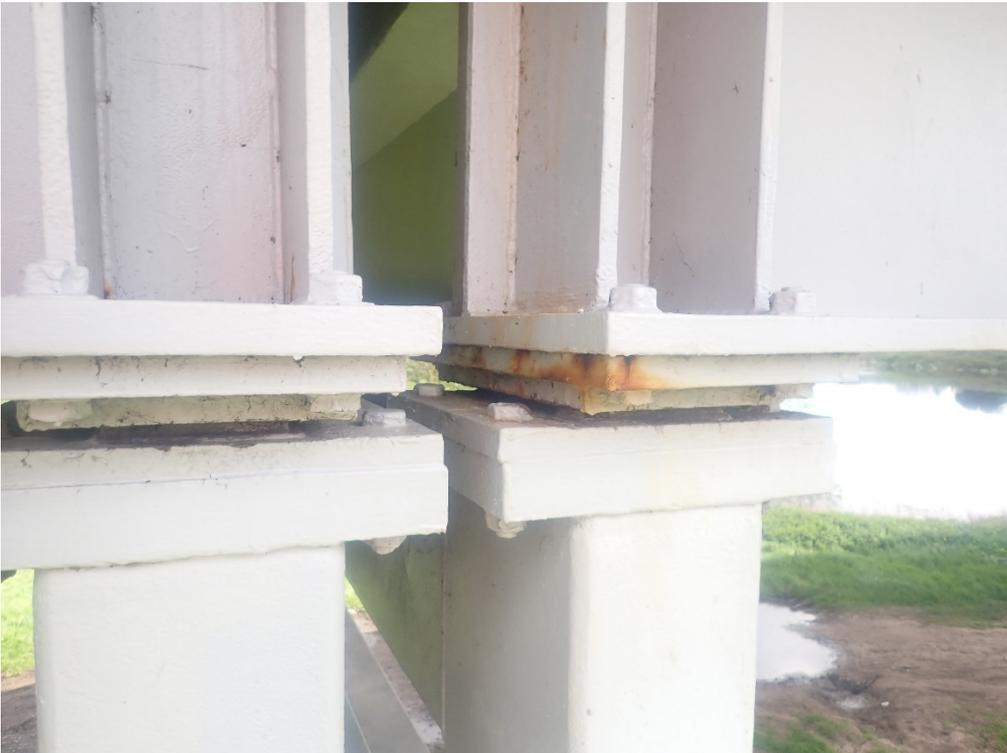
The protective paint system had failed in several small, isolated areas. Rust staining was common in small amounts in areas adjacent to the bearing plates, but little to no exposed corrosion was found. There was very little corrosion noted across the bearing frames/trestles although a few cracks were found in the paintwork. Plates 89 – 94.

Plate 89. Rust Staining to East Abutment Bearing

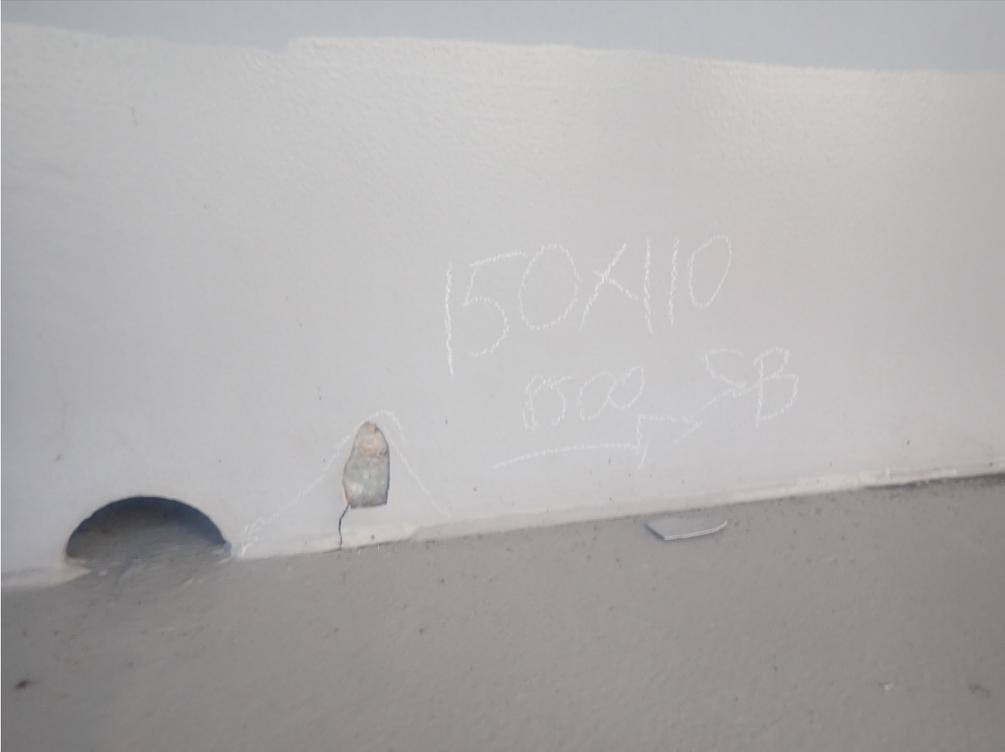
Plate 96. Spalled Grout Around Bearing, West Pier

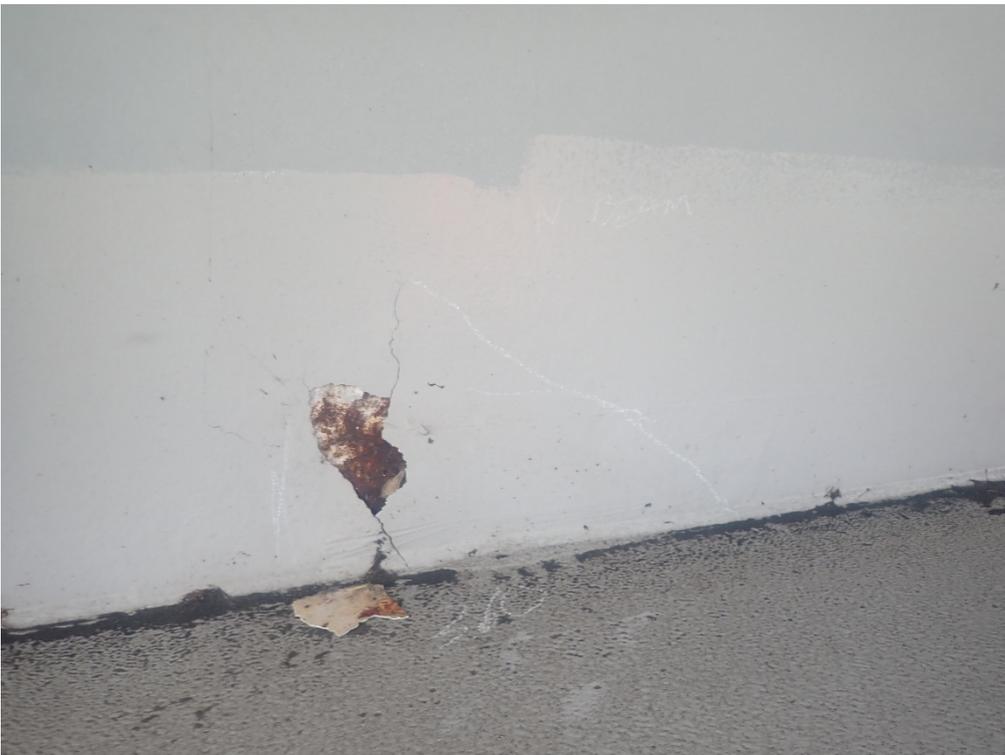
The protective paint system had failed in several localised locations, typically on top of the bottom flange and at the bottom of the web. The paint was blistered/flaking and when broken away exposed early stages of corrosion to the beams. A small amount of ponding was noted on the bottom flanges after a heavy rain shower. Plates 97 – 103.

Plate 97. Flaking Paint to South Beam, West Span

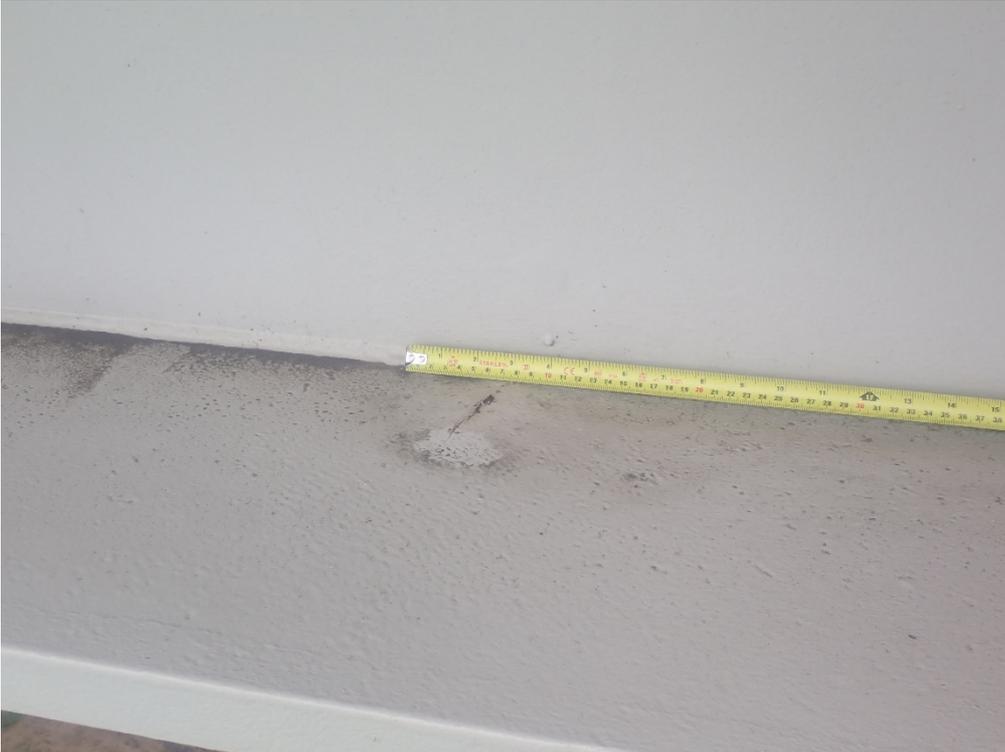
Plate 100. Blistered/Flaking Paint to South Beam, Inner West Span

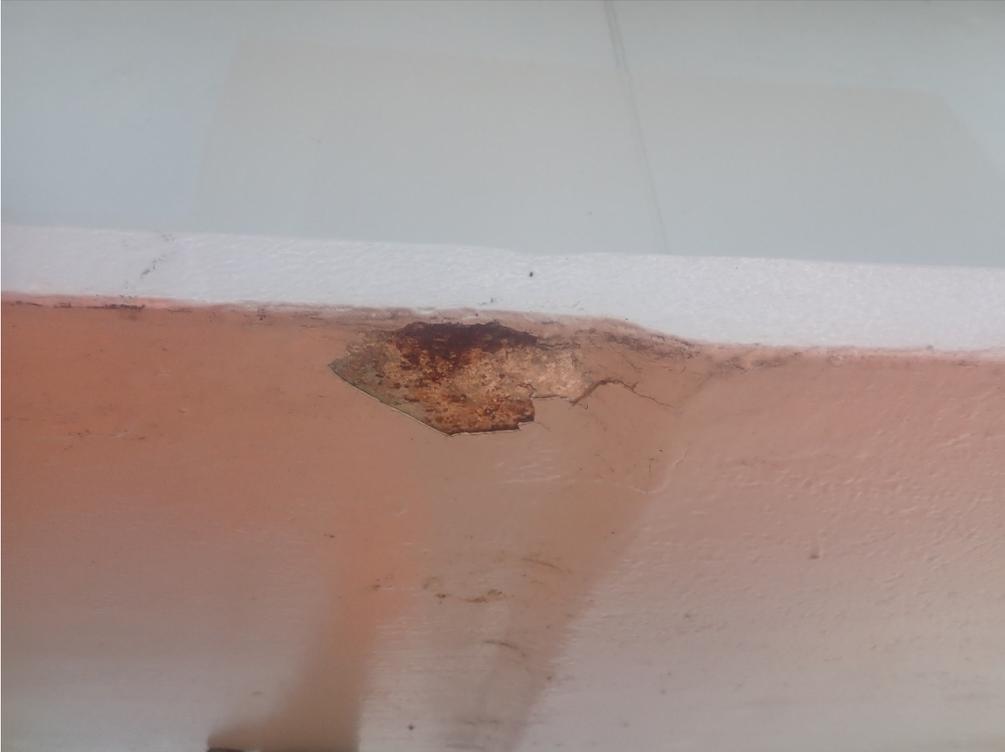
Plate 102. Blistering Paint with Corrosion Staining, Inner East Span

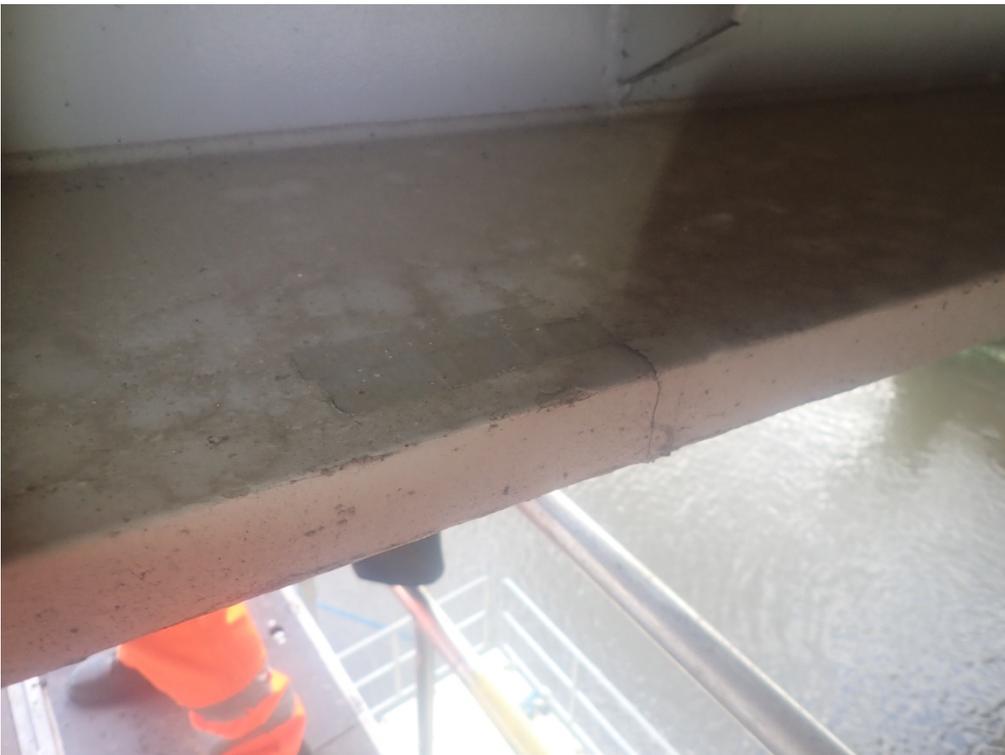
Plate 103. Exposed Minor Surface Corrosion to Underside of Bottom Flange, Inner East Span

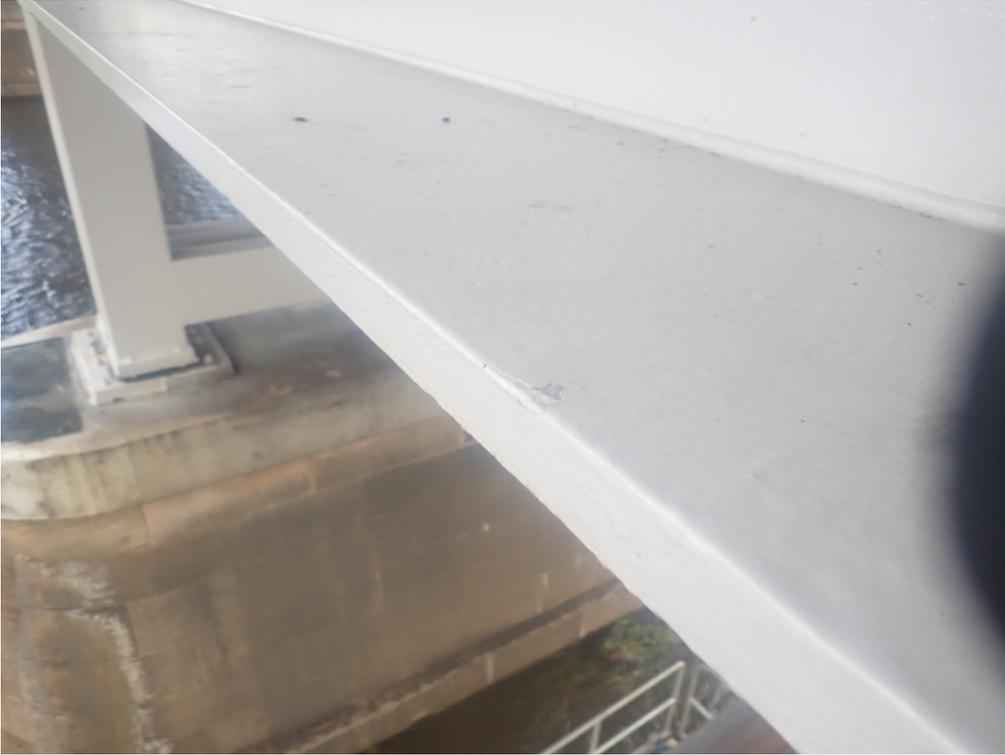
Small chips in the paintwork were relatively common along the edges of the bottom flanges. Plates 104 – 108.

Plate 104. Typical Chipped Paint, East Span

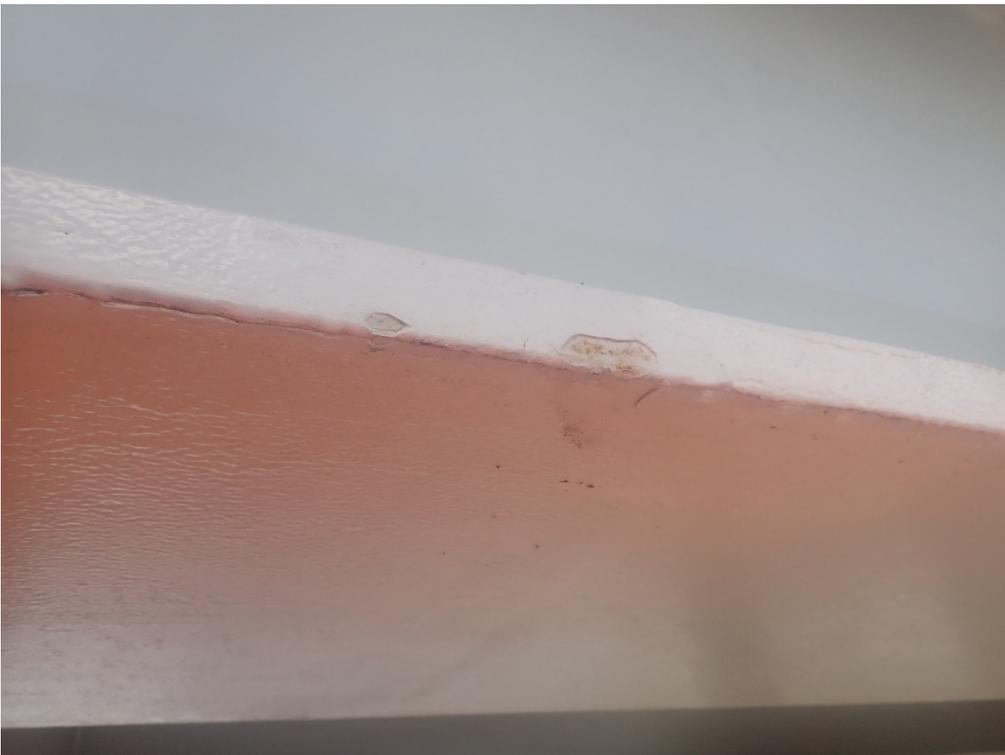
Plate 105. Chipped Paint, South Beam, East Span

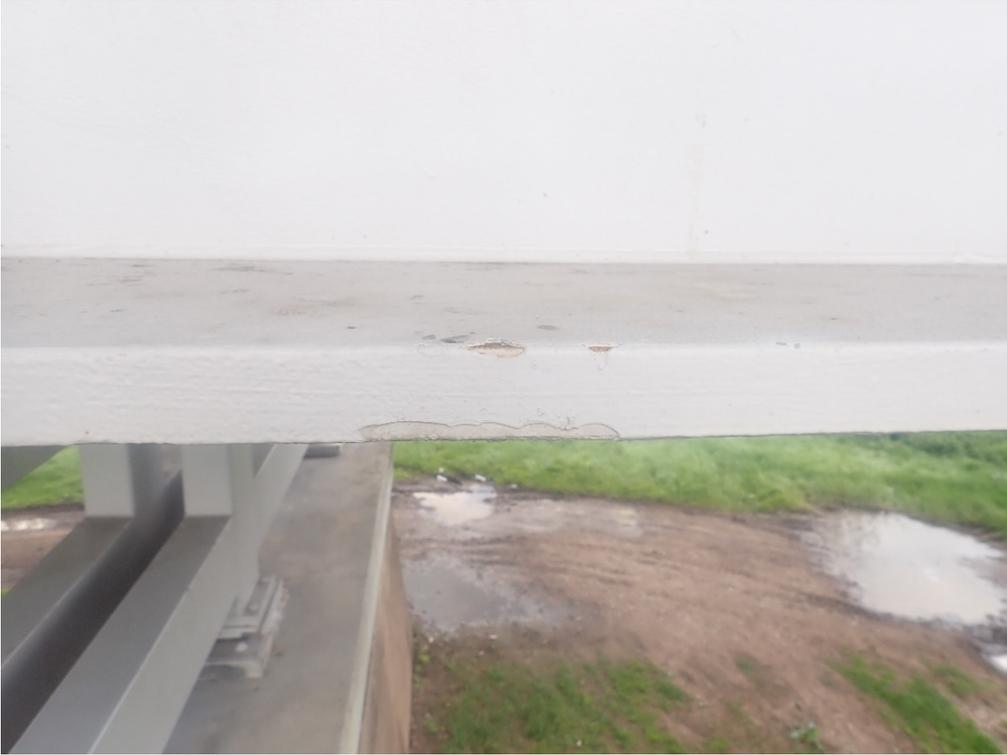
Plate 106. Chipped Paint, South Beam, Inner East Span

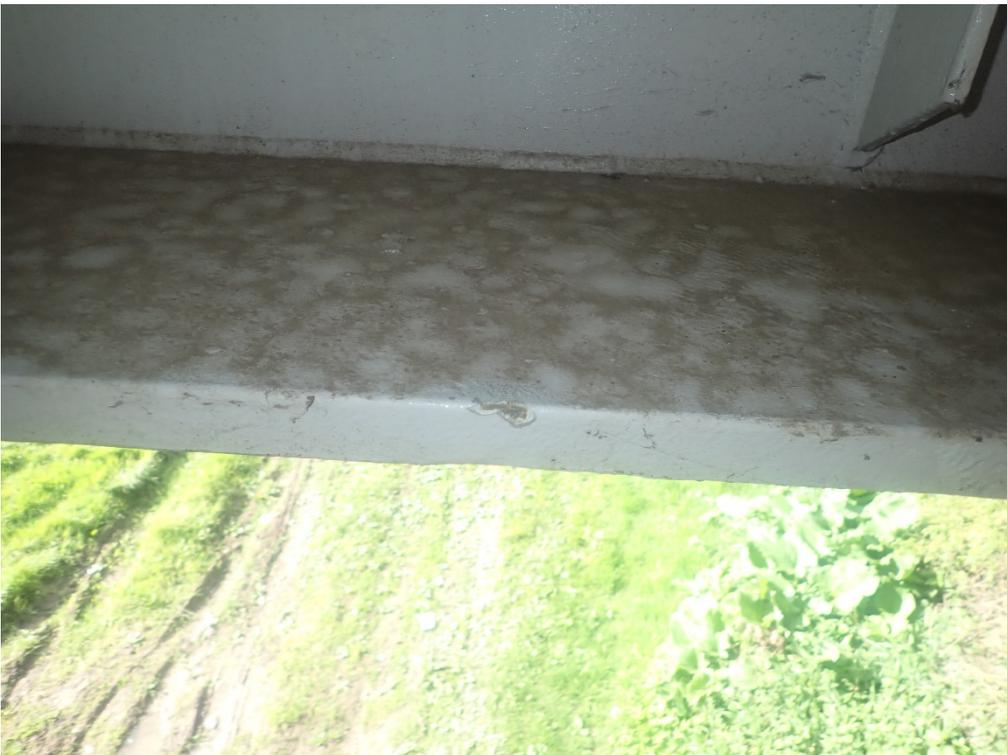
Plate 107. Chipped Paint, South Beam, Inner West Span

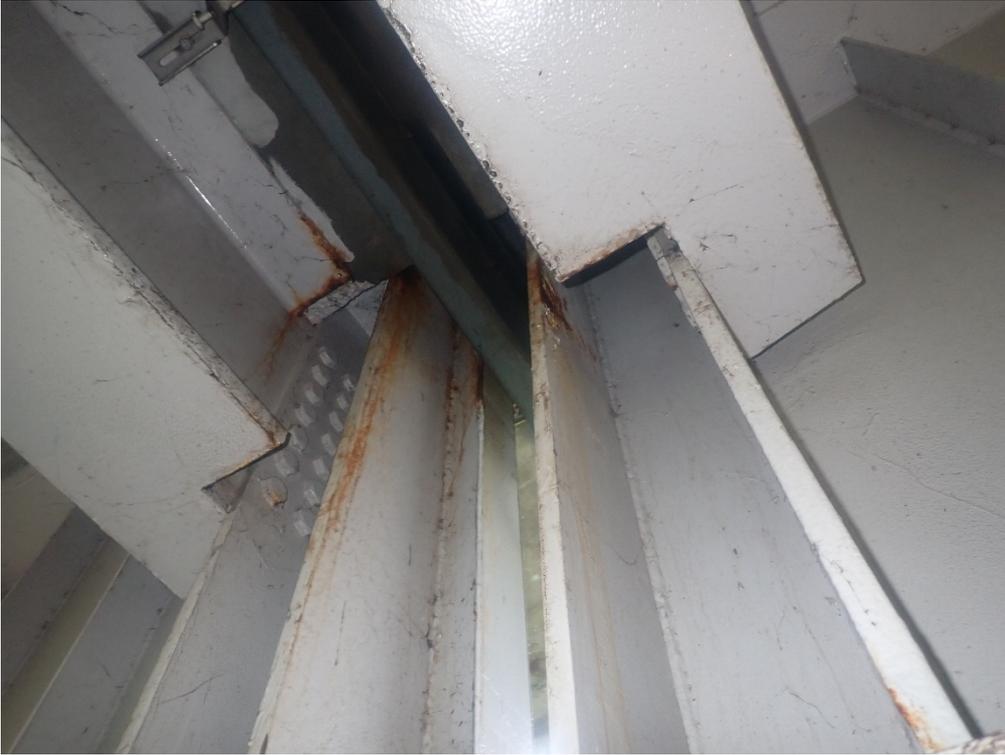
Plate 108. Chipped Paintwork, West Span

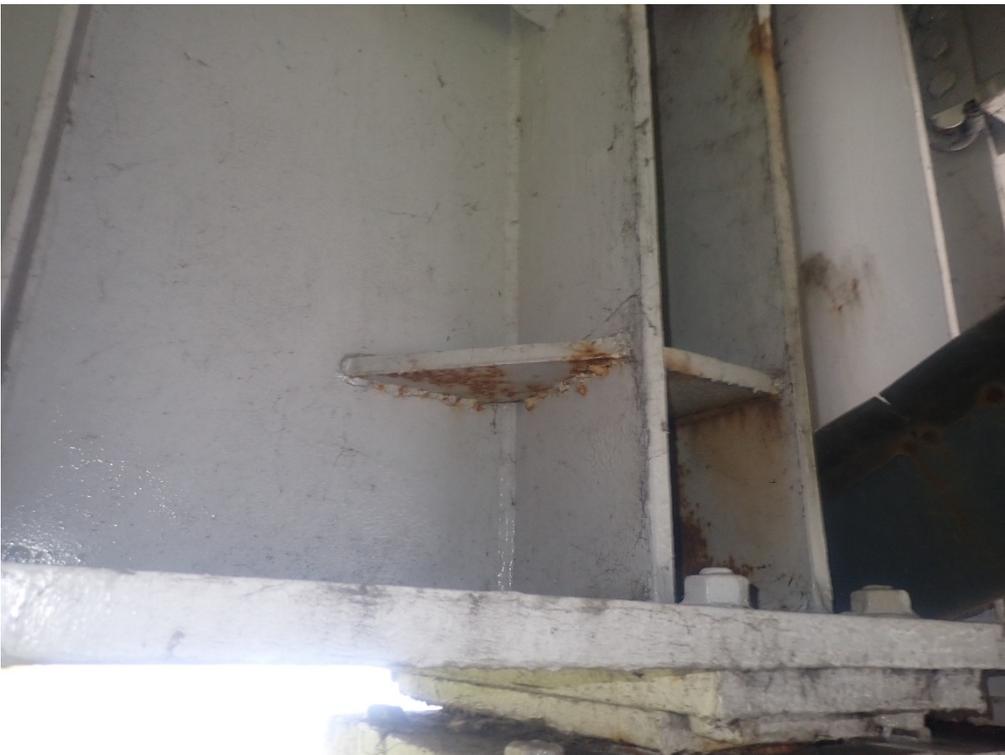
Towards the beam ends including transverse beams, minor corrosion staining was noted that is likely due to the proximity to the expansion joints above. Plate 109 – 111.

Plate 109. Corrosion Staining to Steelwork above the West Pier

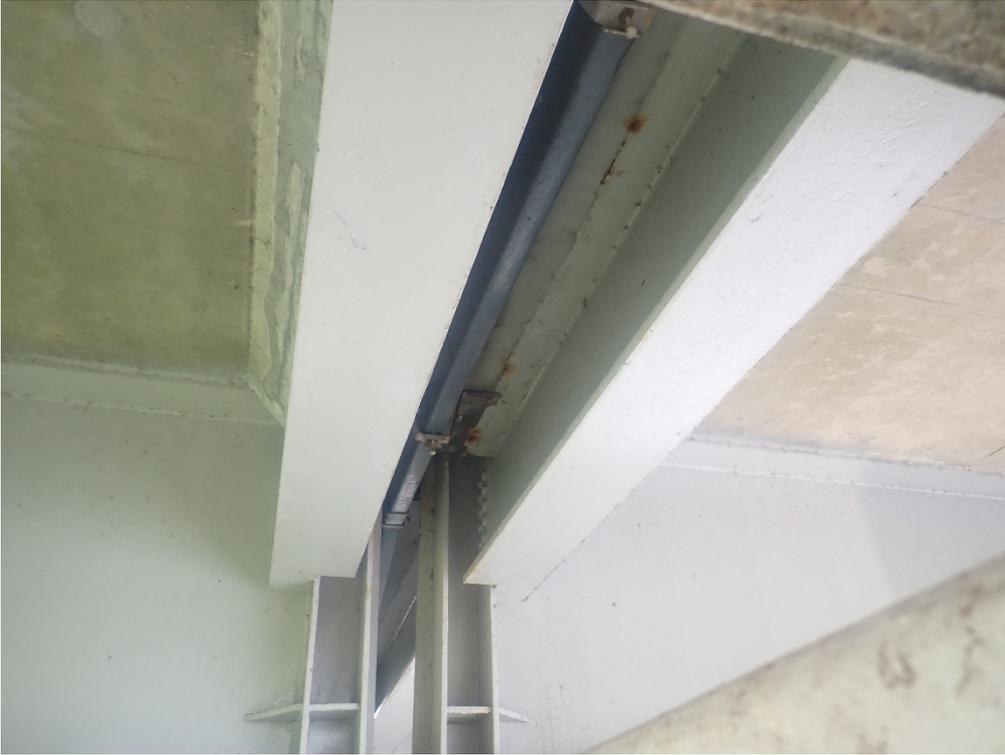
Plate 110. Corrosion to Stiffeners at the Centre Pier

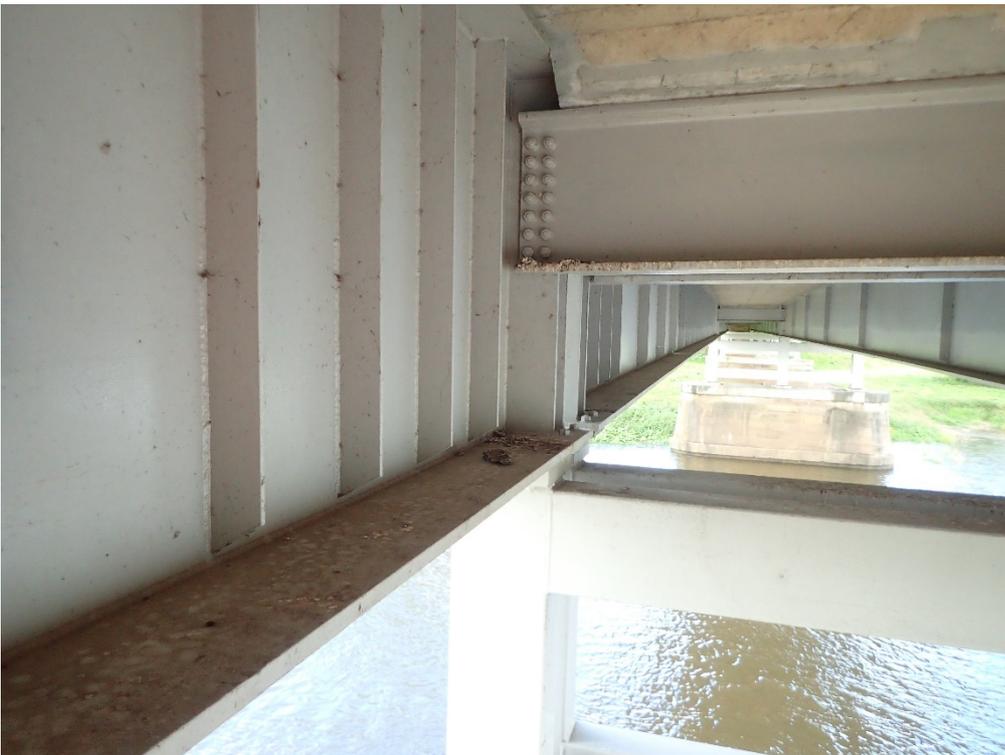
Plate 111. Corrosion to Transverse Beam at the Centre Pier

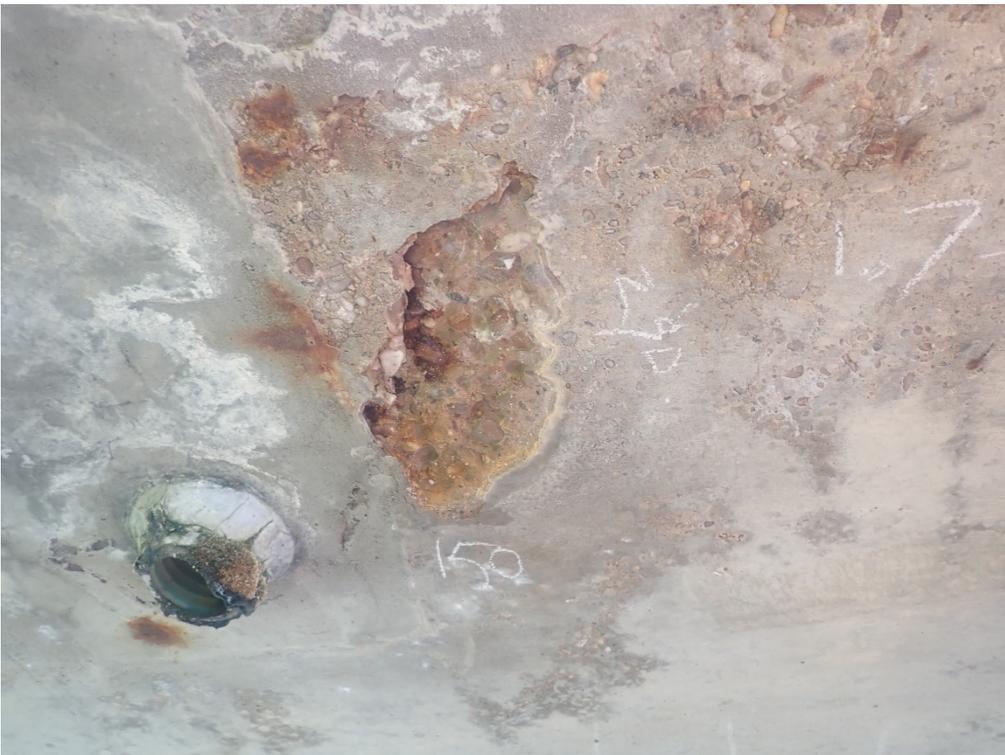
Concrete around drainage outlets and adjacent to deck joints had notable water staining which appeared to have led to further defects including some minor spalling, Delaminated concrete, rust staining and ultimately has led to repairs in these areas. Most repairs were in sound condition. The largest areas of delaminated concrete with associated spall noted were 290x150mm and 23x210mm. Plates 113 – 122.

Plate 113. Areas of Spalling & Delaminated Concrete Adjacent to Joint

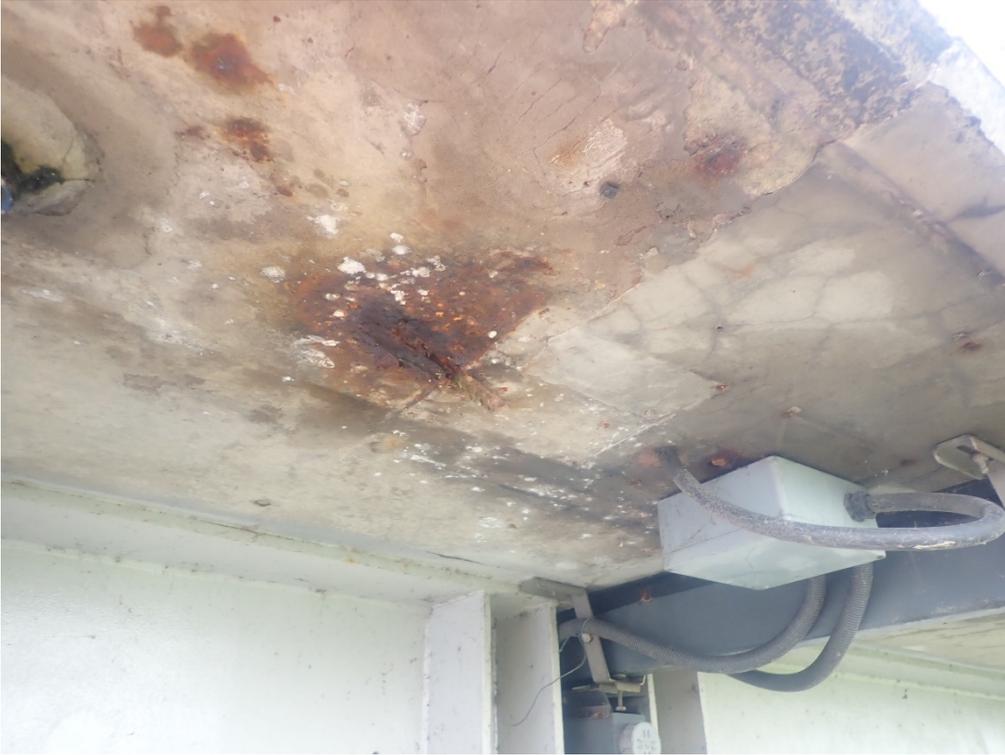
Plate 114. Spalled & Delaminated Concrete Towards Centre Joint

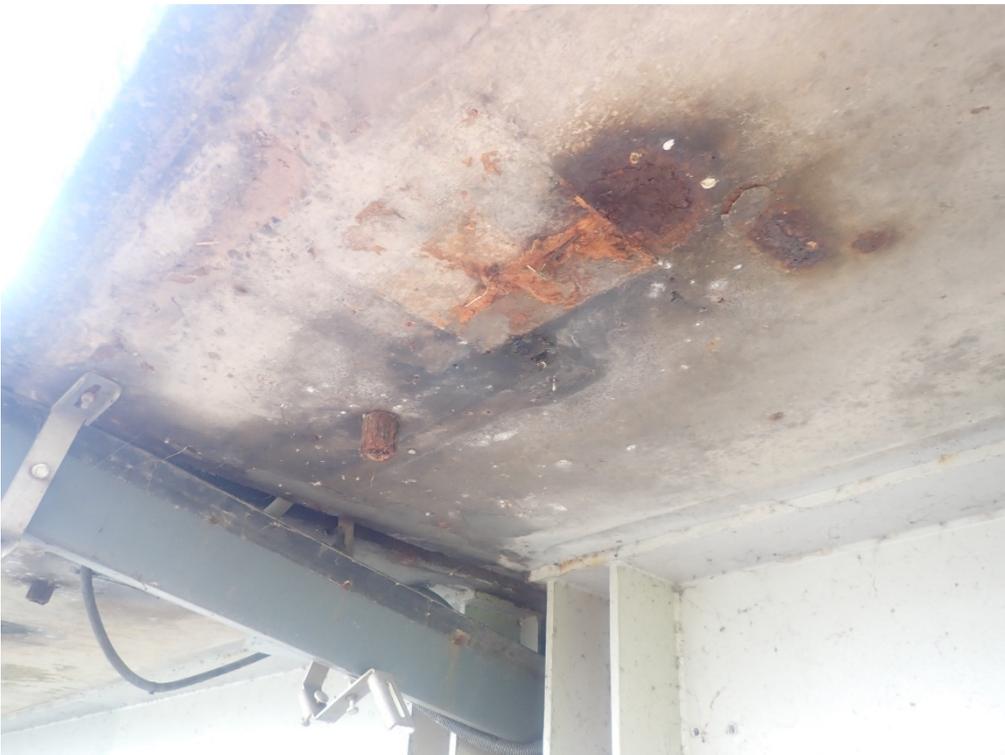
Plate 115. Historic Repair with Adjacent Rust Staining & Delamination

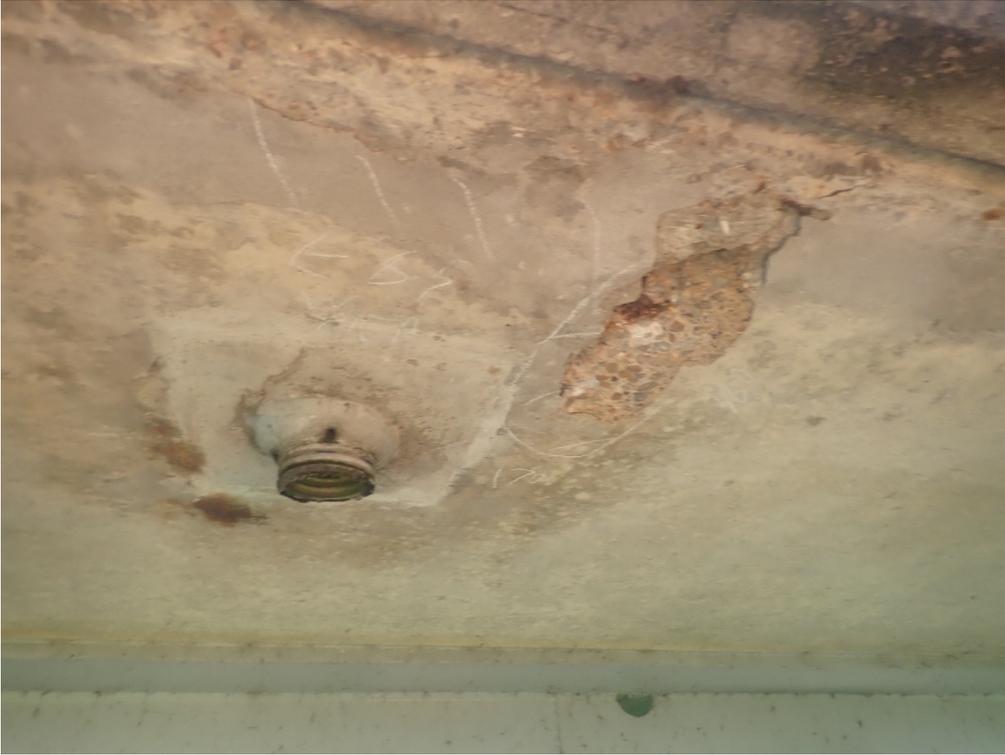
Plate 116. Historic Repair with Adjacent Rust Staining & Delamination, Centre Joint

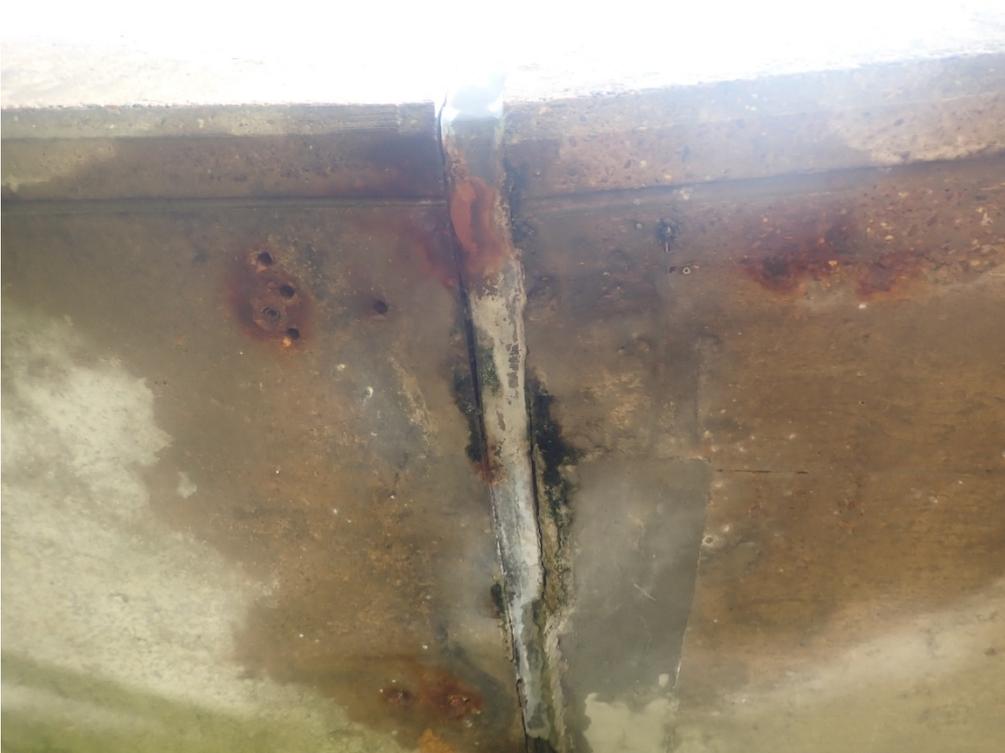
Plate 117. Shallow Spalled Concrete & Delamination Adjacent to Drainage Outlet
