DUNHAM BRIDGE COMPANY

APPLICATION TO REVISE TOLL CHARGES

THE DUNHAM BRIDGE COMPANY

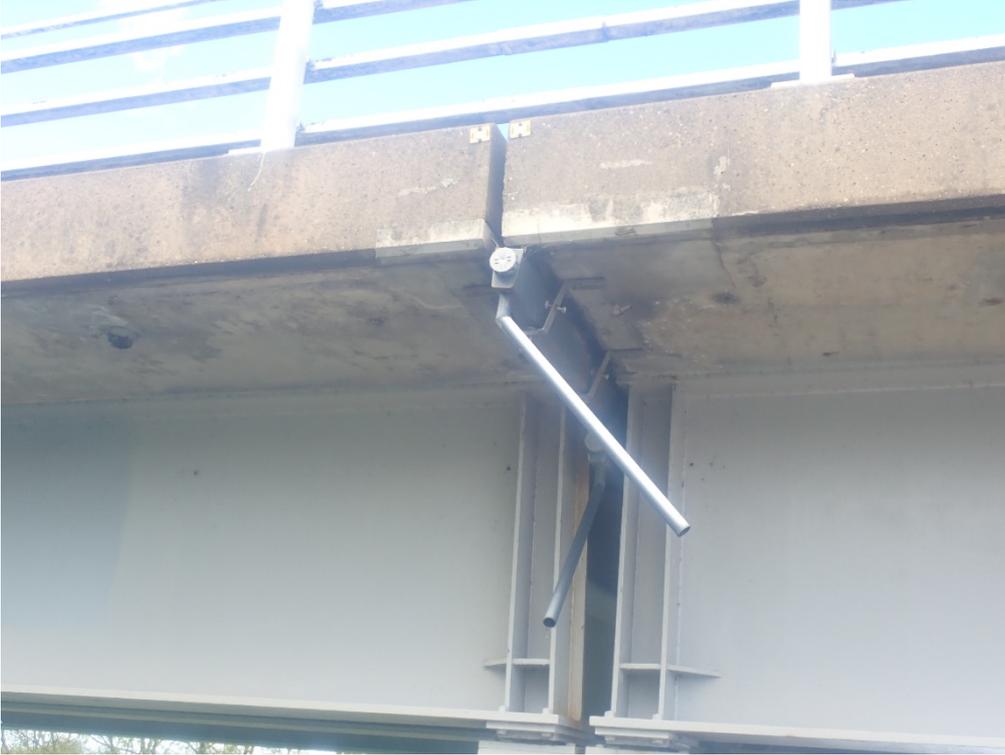
Concrete around drainage outlets and adjacent to deck joints had notable water staining which appeared to have led to further defects including some minor spalling, Delaminated concrete, rust staining and ultimately has led to repairs in these areas. Most repairs were in sound condition. The largest areas of delaminated concrete with associated spall noted were 290x150mm and 23x210mm. Plates 113 – 122.

Plate 120. Rust Staining Adjacent to Deck Drainage Outlet

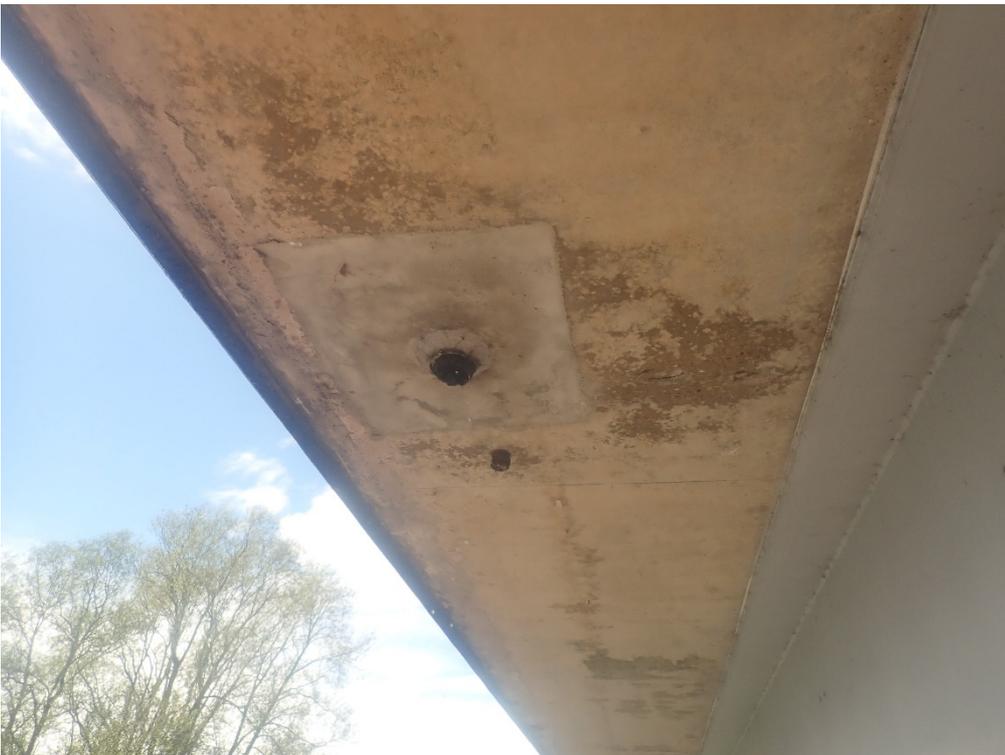
Plate 121. Concrete Repair at East Joint

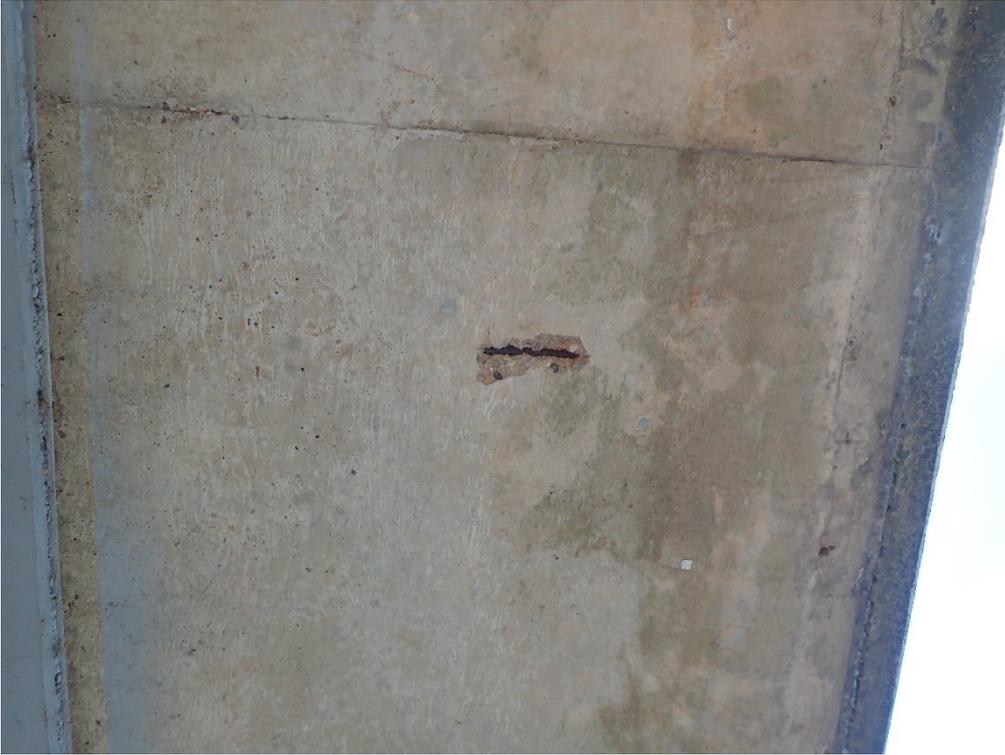
Plate 122. Sound Repair Surrounding Deck Drainage Outlet

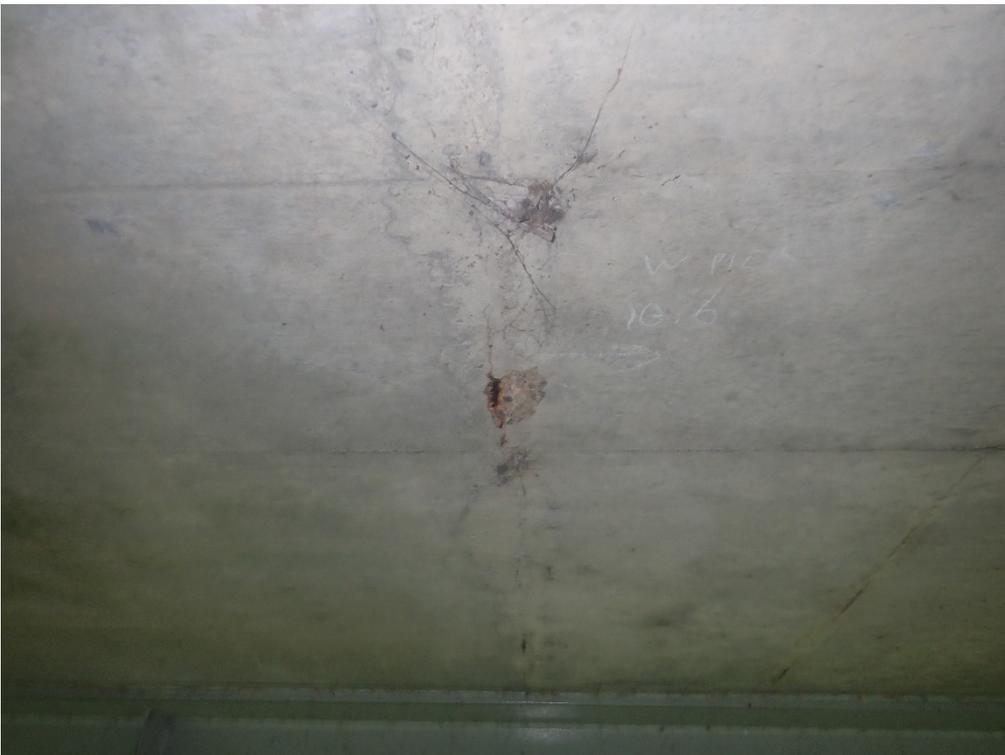
Two small areas of exposed reinforced were found in the deck soffit. This was located away from joints and drainage locations and was likely due to low cover. Plates 123 & 124.

Plate 123. Spalled Concrete Exposing Reinforcement in North Cantilever Soffit

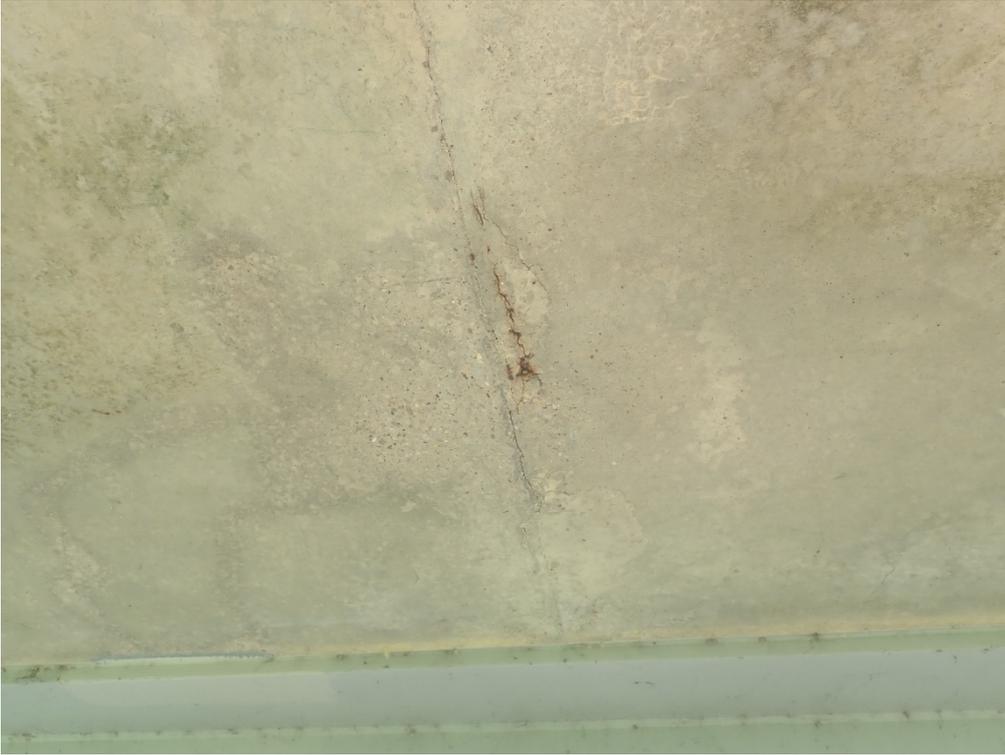
Plate 124. Exposed Reinforcement in West Span

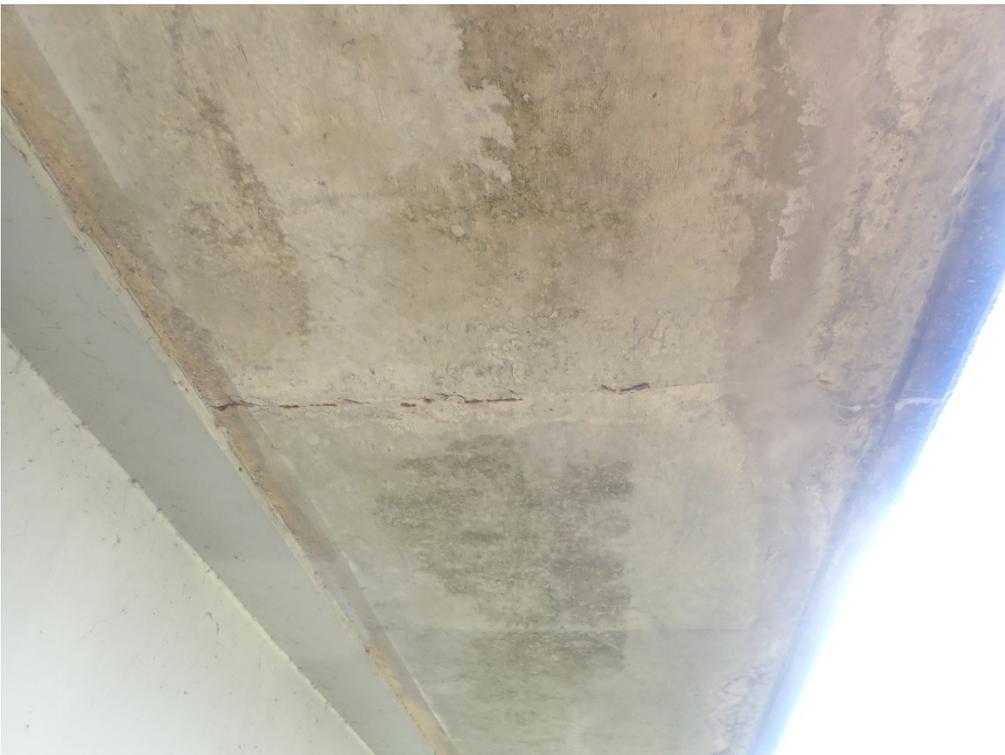
A small number of poor construction joints were visible that appeared to have low cover with rust staining and corroded ferrous debris. Plates 125 to 127.

Plate 125. Reinforcement Corrosion Cracking at Construction Joint, Inner West Span

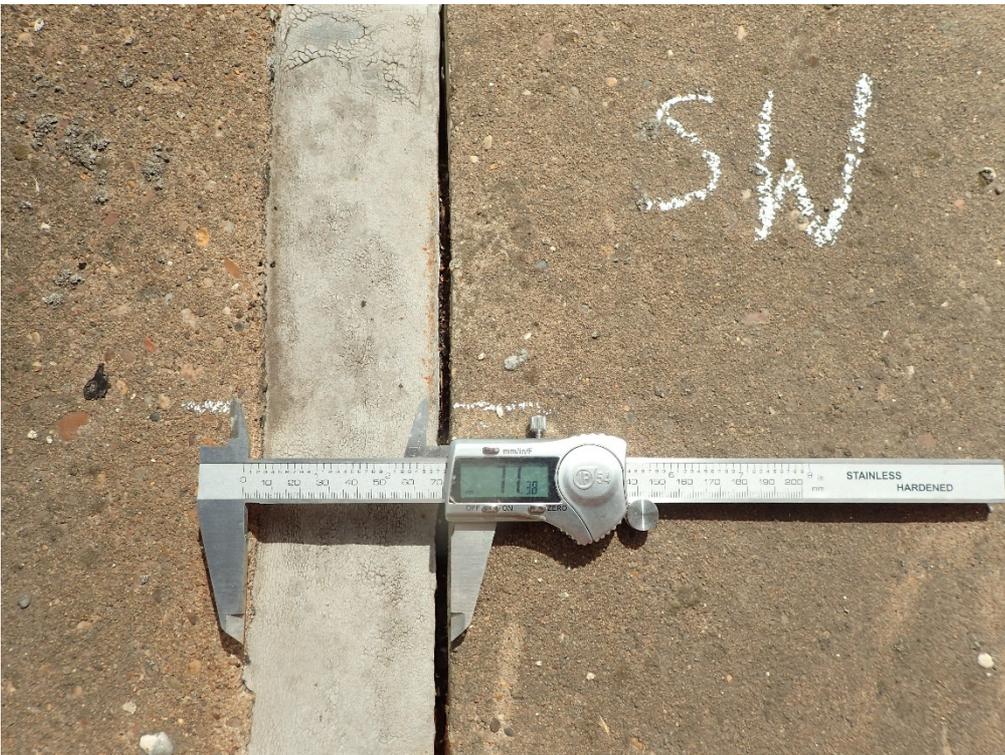
There was no joint sealant found on the edge beams on either side of the deck at the centre joint above the centre pier. The centre joint was considerably wider than the others, measuring 68mm wide at the parapet edge beams compared to a typical measurement of around 30mm at the other joints except for the West abutment joint which is assumed to be fixed and had a measurement of 70mm. It is not clear whether the centre joint was originally sealed in the parapet beams or if it had failed historically. The joints in the edge beams with sealant all had varying levels of debonding between the sealant and adjacent concrete. Plates 133 – 135.

Plate 133. No Sealant in Joint above the Centre Pier

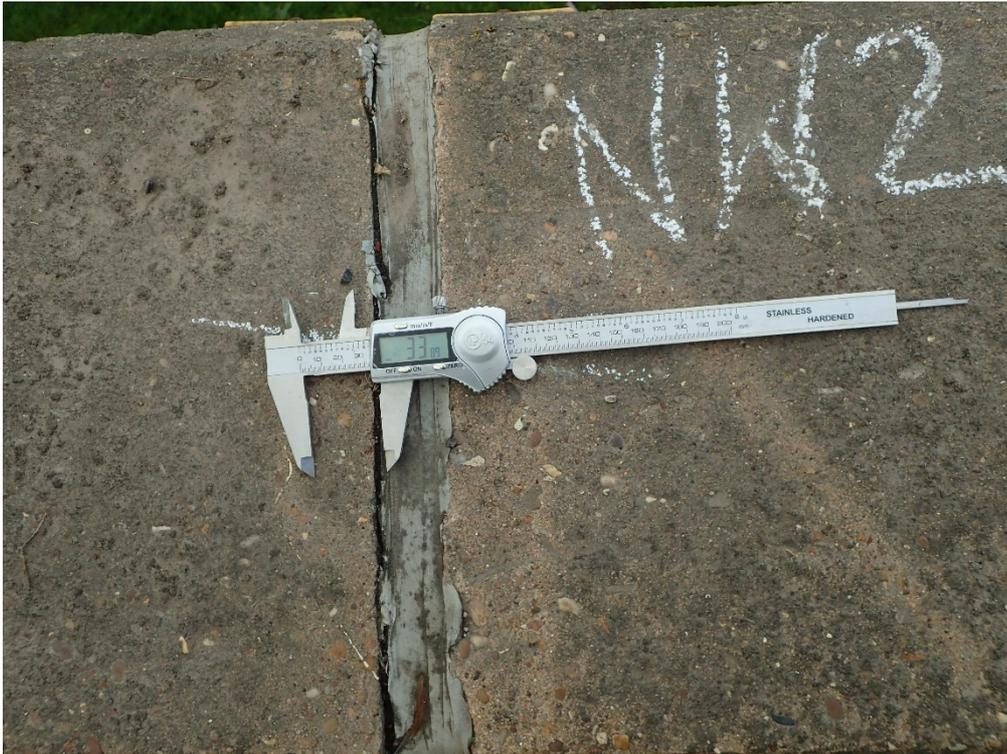
Plate 134. De-Bonding of Sealant Above the West Abutment, South Edge Beam

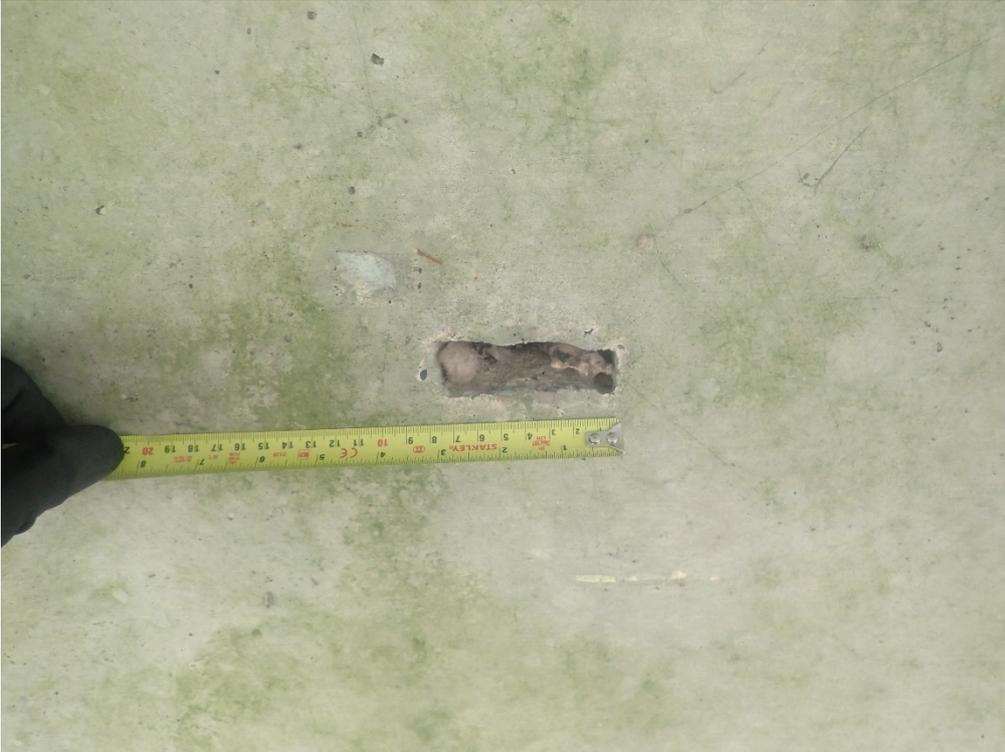
Repaired holes were noted along the vertical outside face of the edge beams. It was not clear what the purpose of these holes were but may have been sample locations for non-destructive testing. The repairs were in good condition. Plate 136.

Plate 136. Repaired Holes in the South Edge Beam, West Span

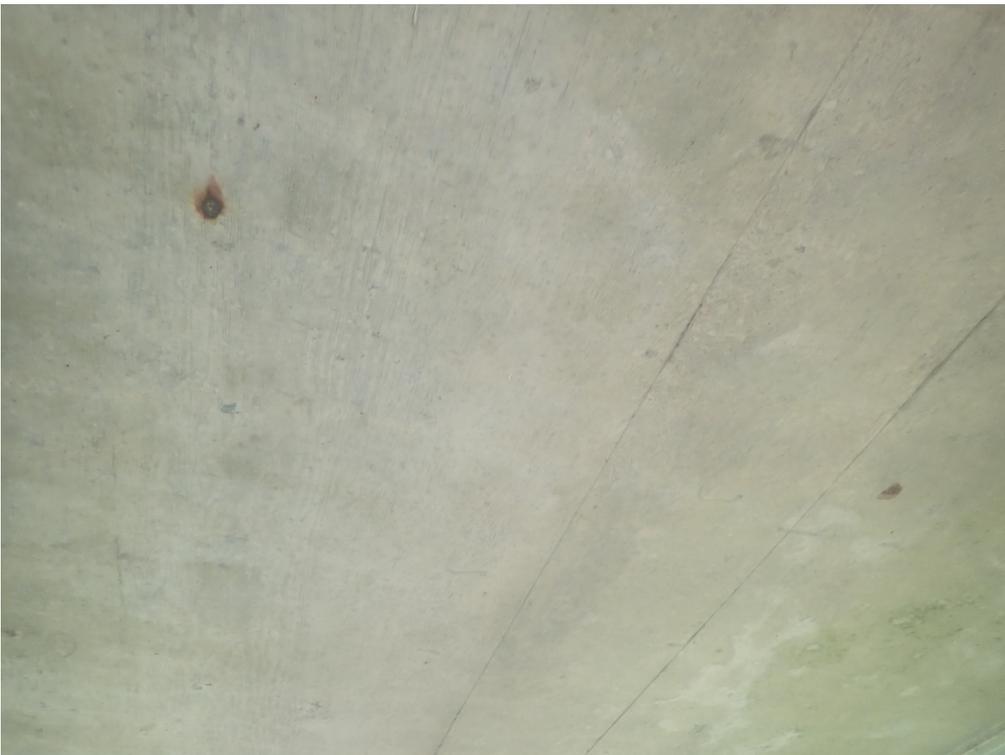
A small void was found in the deck slab in the inner West span, it was assumed that this was a construction defect and has been present since construction. Plate 137.

Plate 137. Void in Deck Soffit, Inner West Span

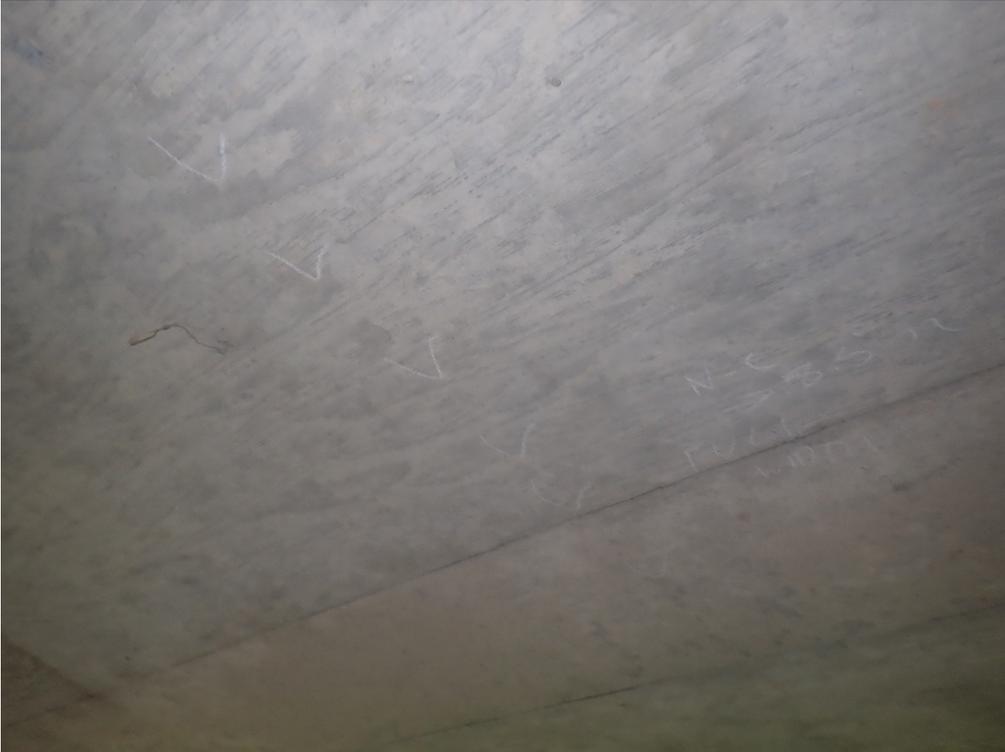
A small amount of corroded ferrous debris was found in the deck soffit this was more prevalent in the cantilever soffits and adjacent to construction joints. Plate 138.

Plate 138. Minor Corroded Ferrous Debris Found in Deck Soffit, West Span

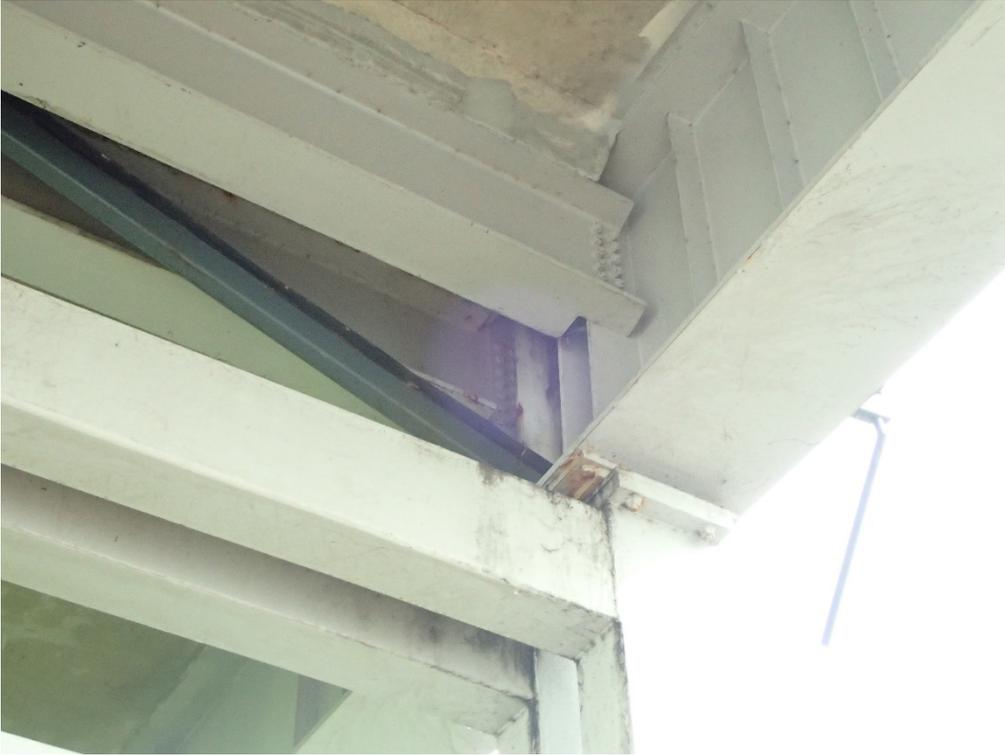
Joint drainage was largely in good condition although the detail discharges onto the piers beneath. A section of the centre pier joint drainage had failed and collapsed at the North end. Plates 140 & 141.

Plate 140. Failed Bracket to Centre Joint Drainage

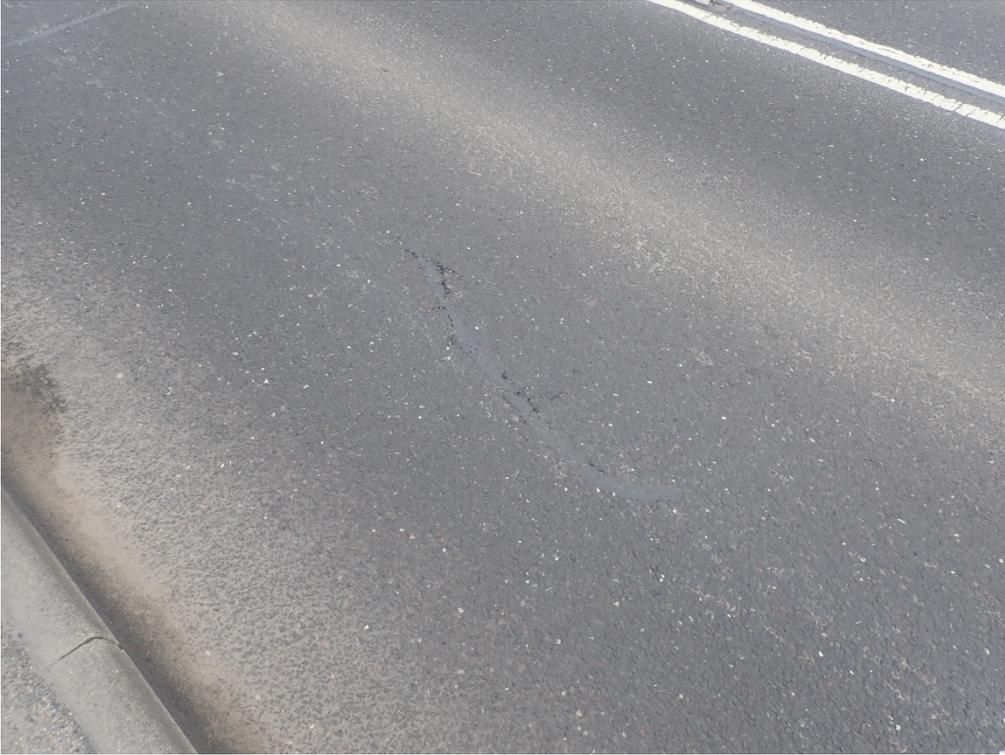
There were several cracks across the structure and on the approaches that were open, sealed or where a repair had failed. Plates 144 – 151.

Plate 144. Open & Sealed Cracks on the West Span

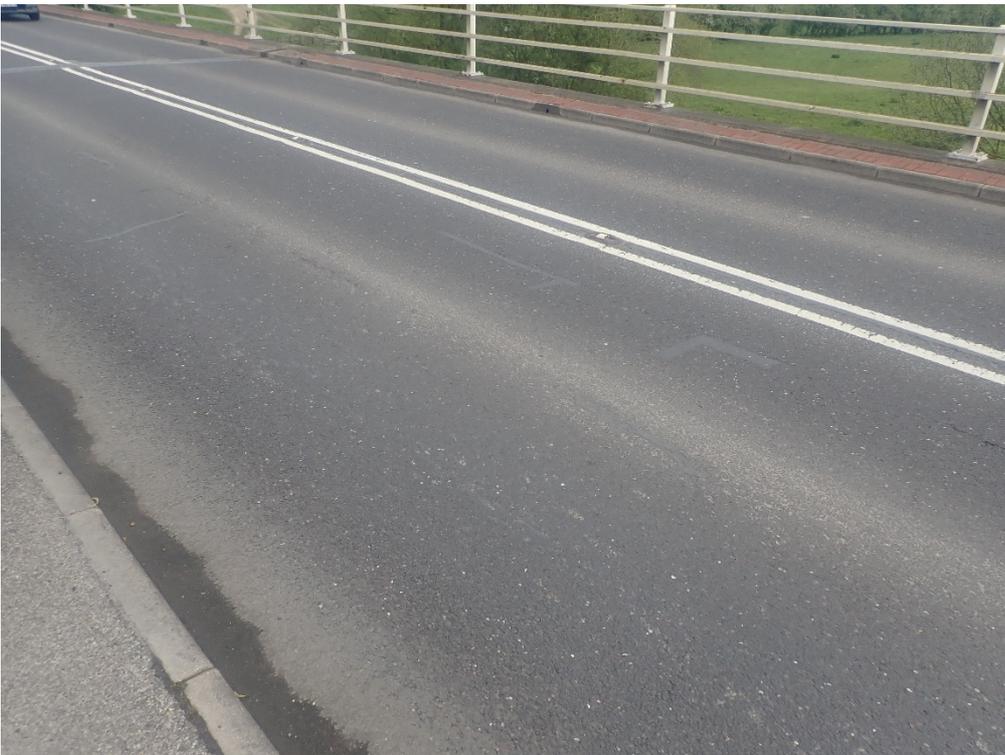
Plate 145. Failed Repair to Crack on the Inner West Span

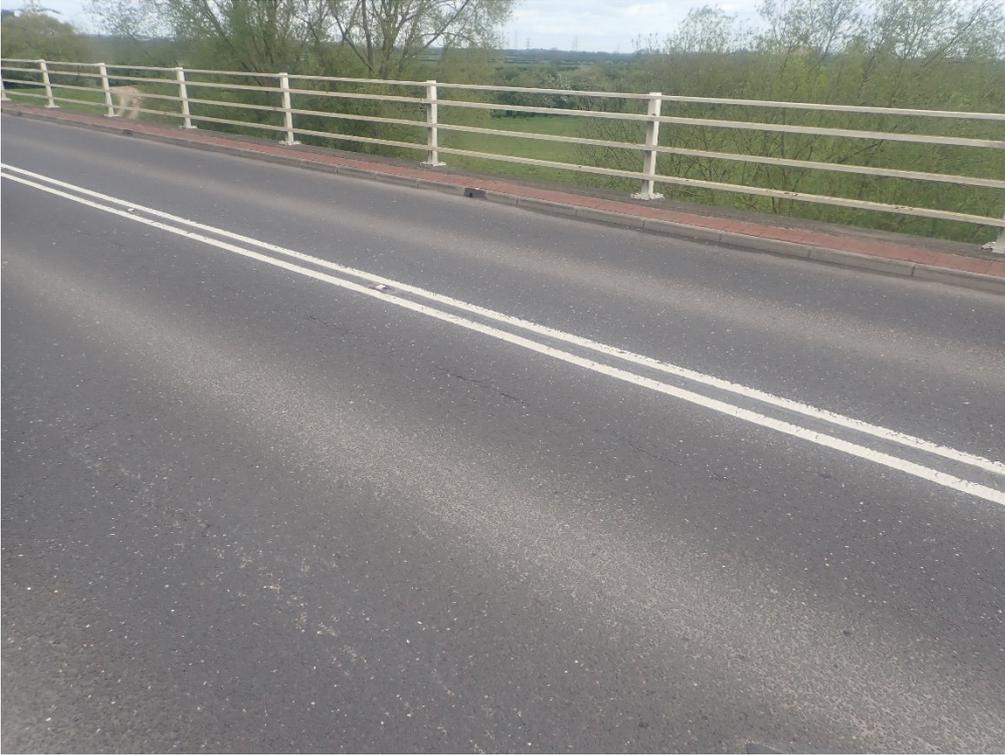
Plate 146. Open & Sealed Cracks on the Inner West Span

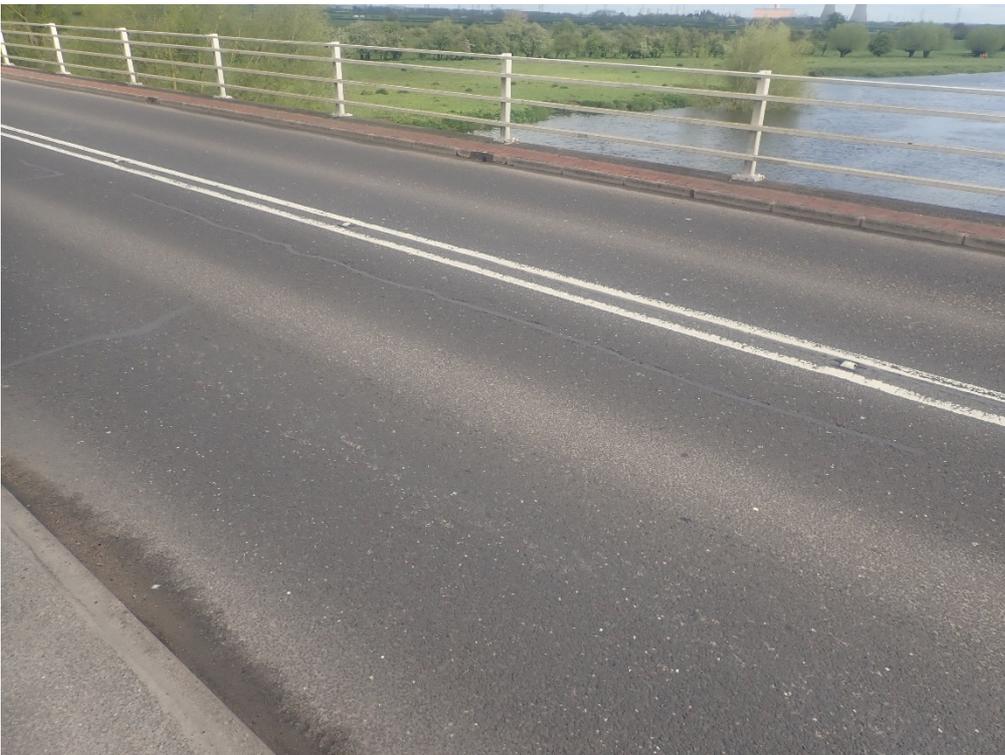
Plate 147. Open Longitudinal Crack on the Inner West Span

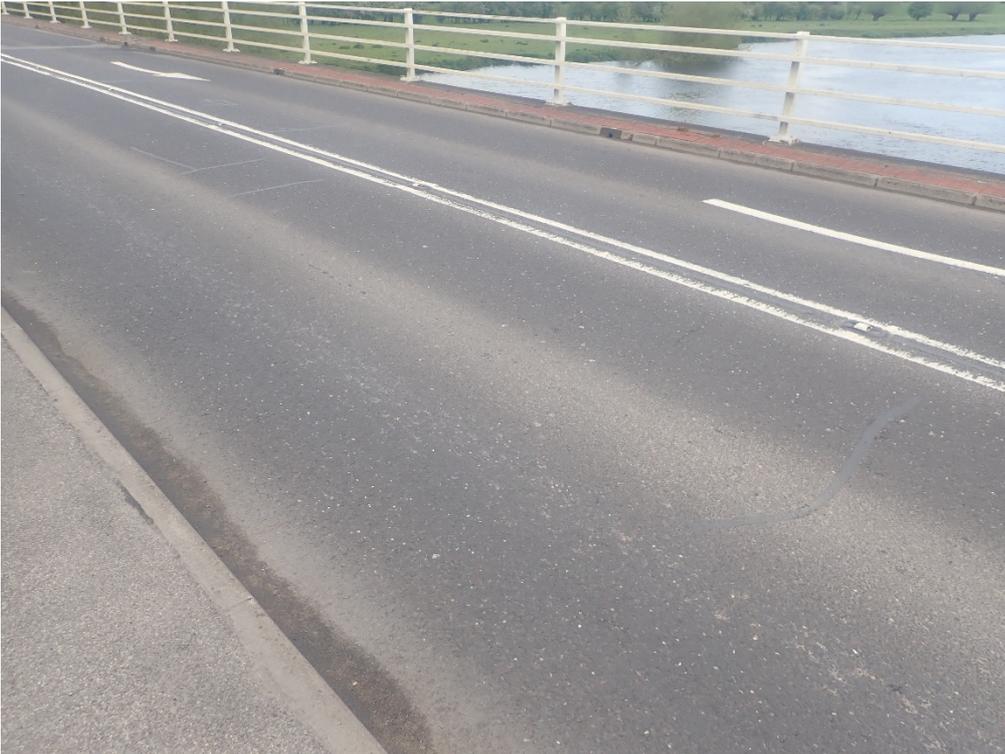
Plate 148. Sealed Cracks on the Inner East Span

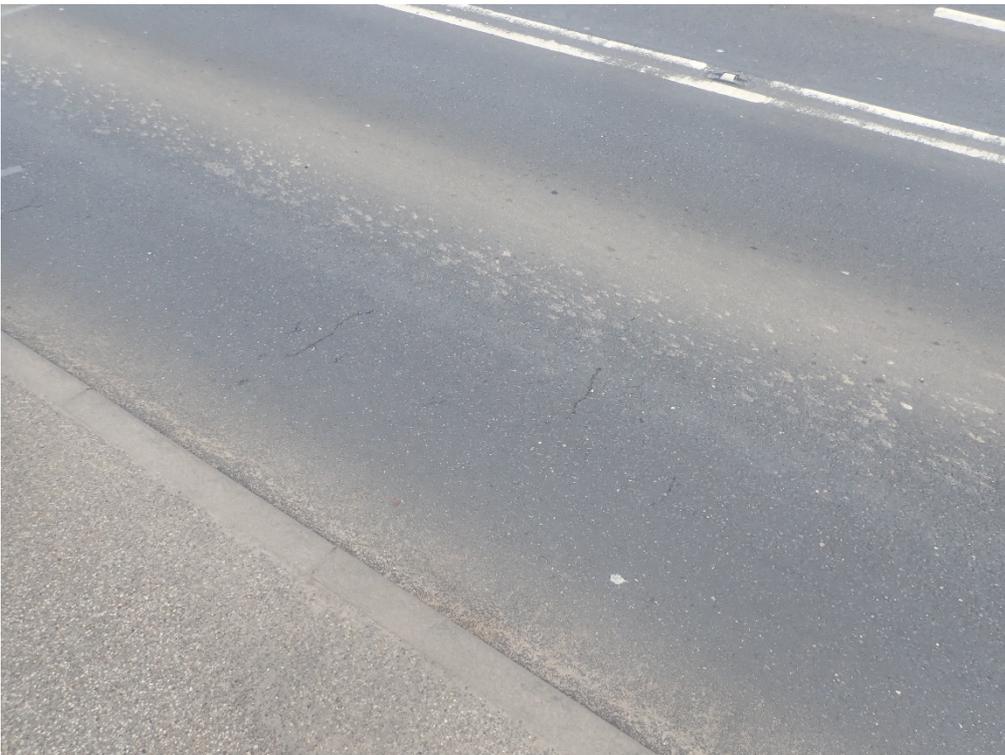
Plate 149. Sealed Cracks on the East Span

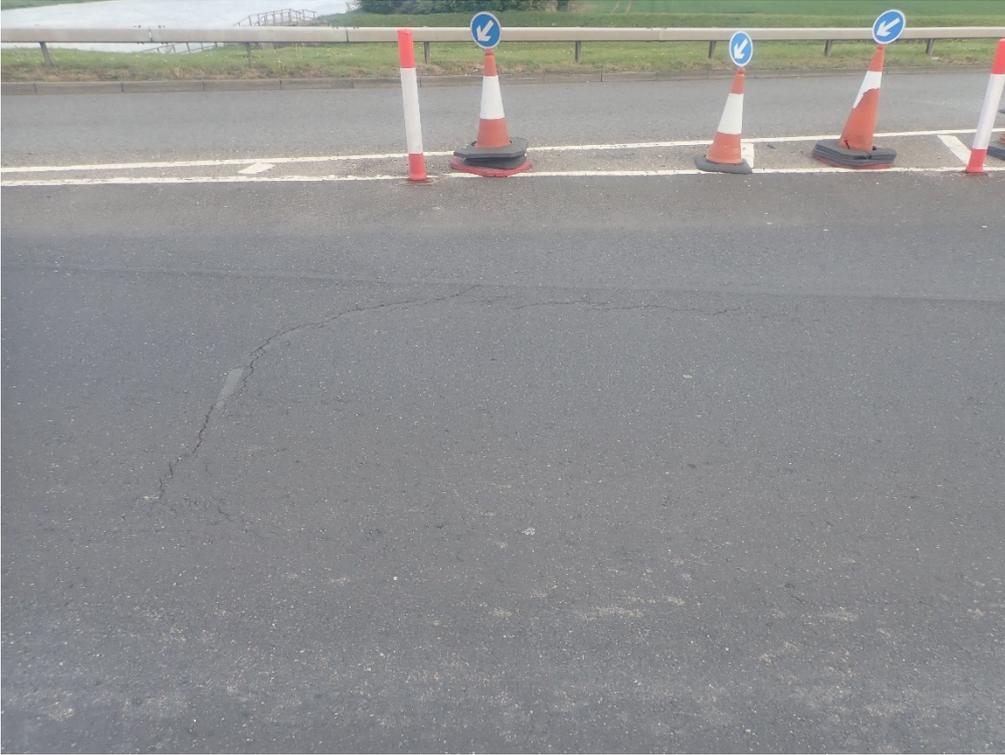
Plate 150. Open Cracks on the East Approach

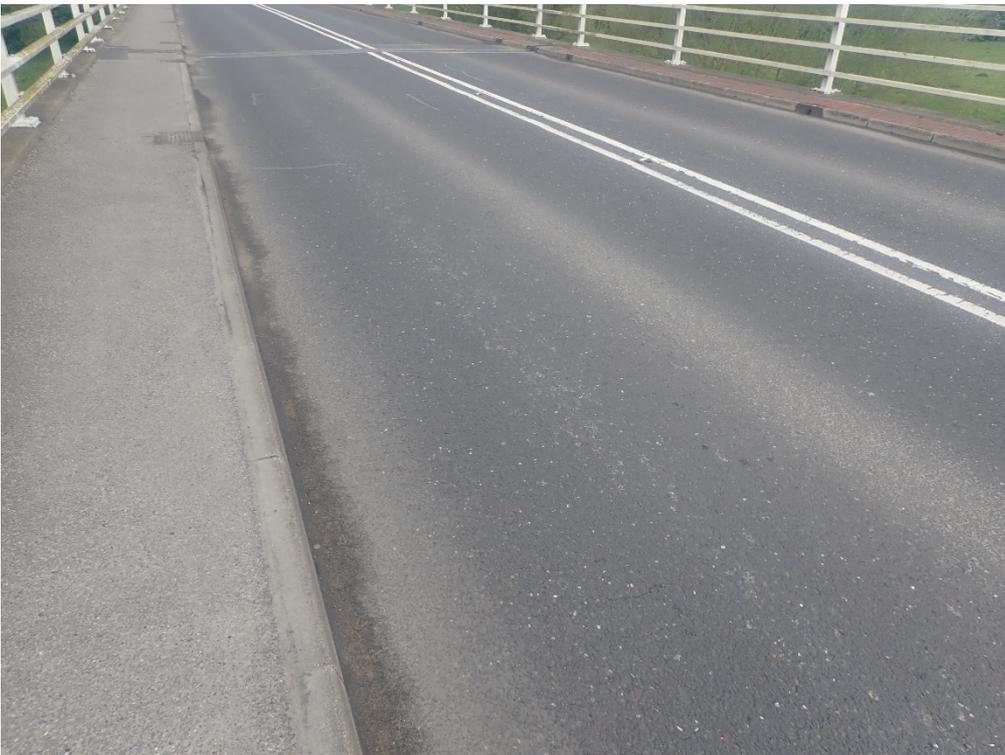
Plate 151. Open Crack on the East Approach

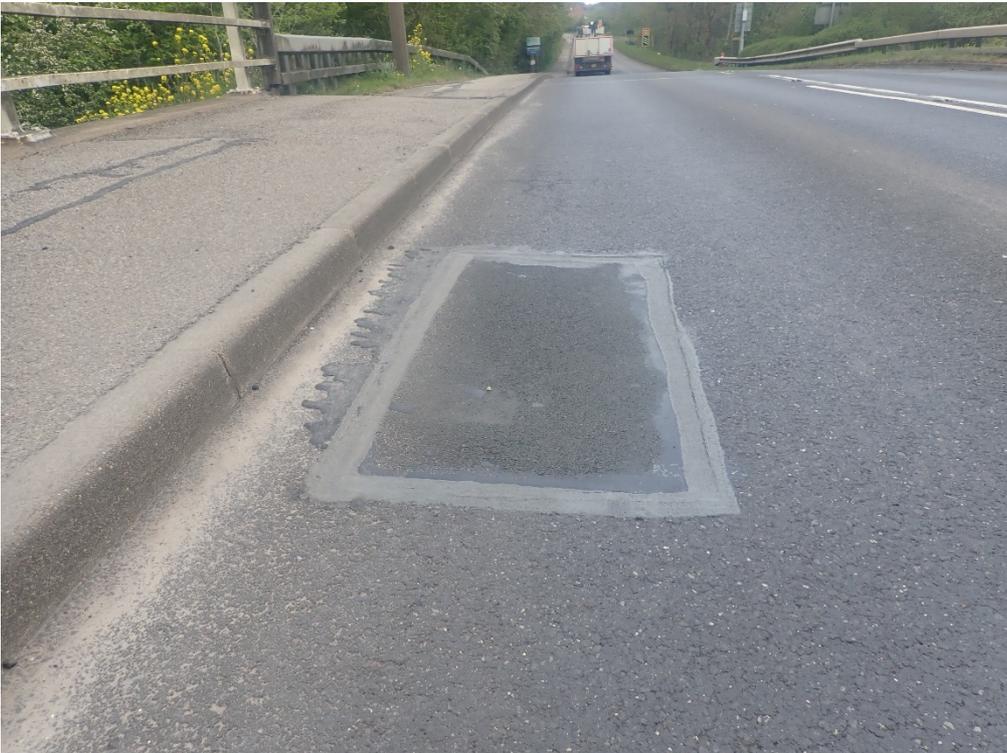
The surfacing had notable wear/weathering across the carriageway with minor polishing and tracking but still serviceable. Plates 152 - 154.

Plate 153. Cracking in a Slightly Rutted/Settled Area on the West Span

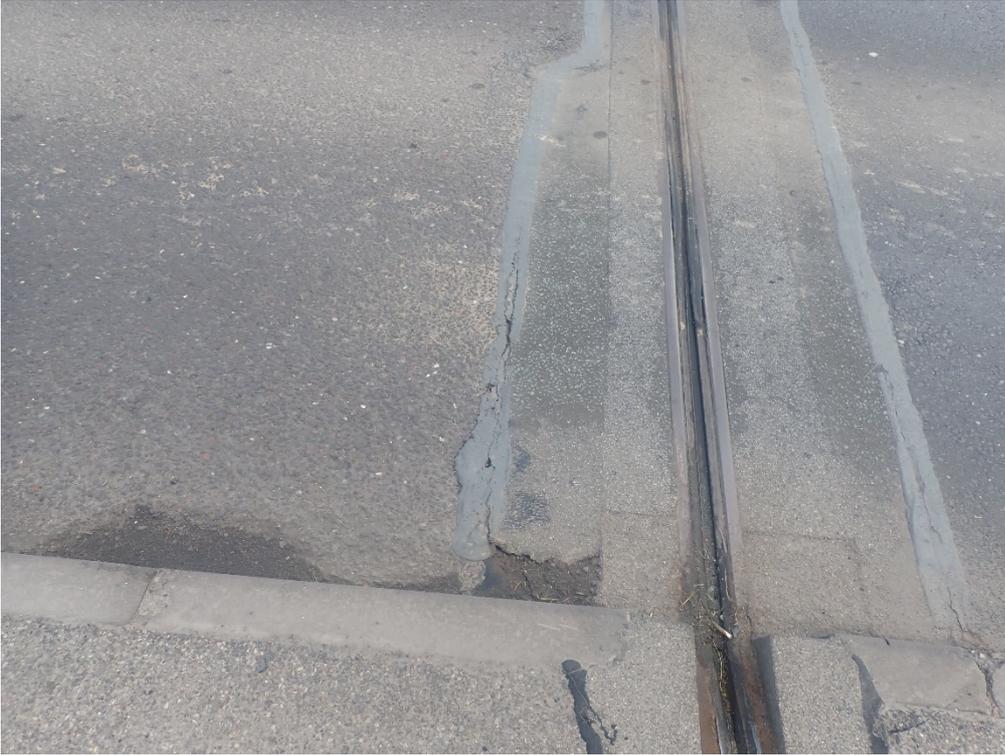
Plate 154. Slightly Settled/Rutted Repair, West Span

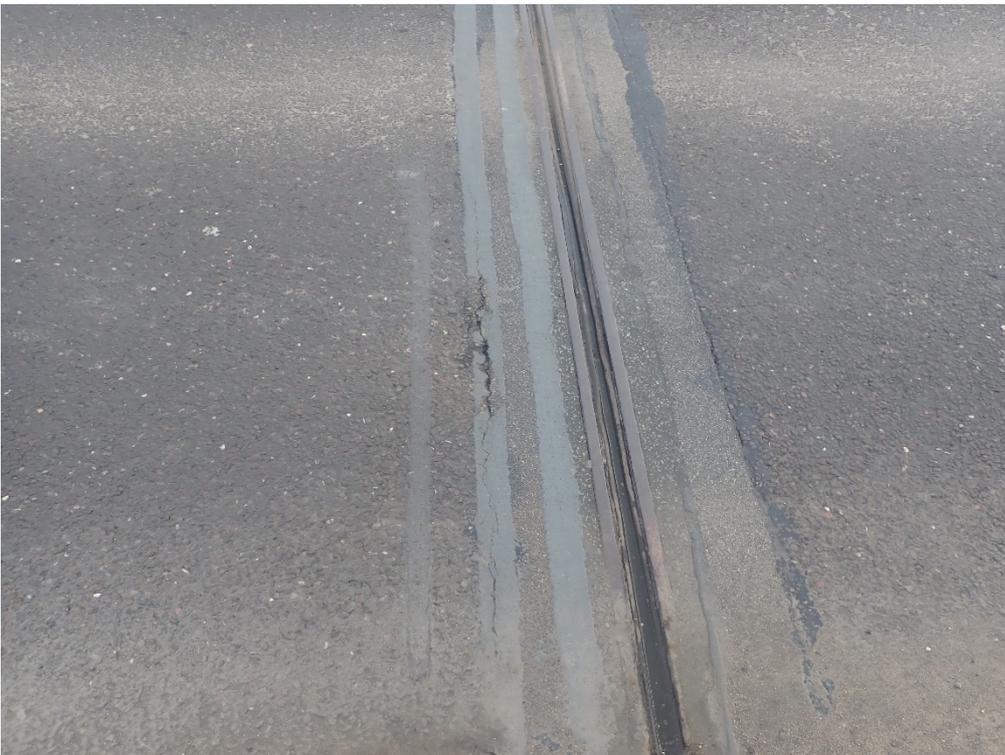
There was some debonding between the joint nosing material and the carriageway wearing course, adjacent to the East abutment joint. Cracking had occurred in the adjacent surfacing. Plates 155 – 157.

Plate 155. Failed Repair to Cracking Adjacent to the East Abutment Joint

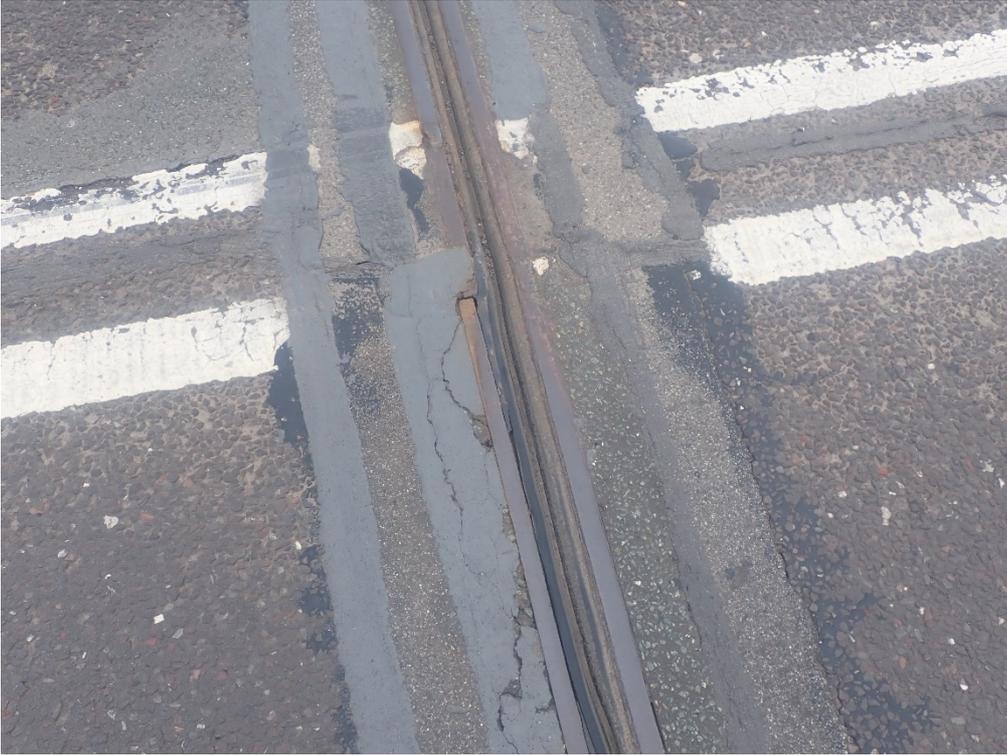
The steel nosing carrier rail in the West abutment and West pier joints was not continuous and was poorly installed. Movement here may have caused the cracking in the adjacent nosing mortar in the West pier joint. Plates 158 & 159.

Plate 158. Non-Continuous & Untidy Joint in the Nosing Rails, West Abutment

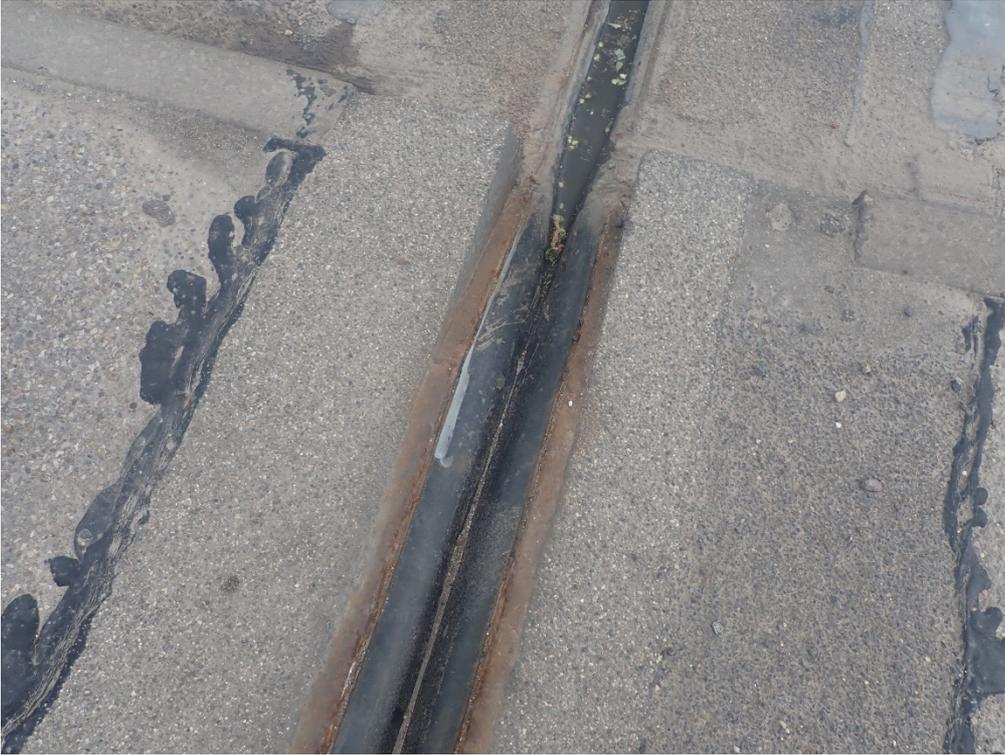
The steel nosings were commonly corroded, particularly in the verges where not polished by tyre wear. Plates 160 – 161.

Plate 160. Corrosion to the West Abutment Joint Nosing Rails

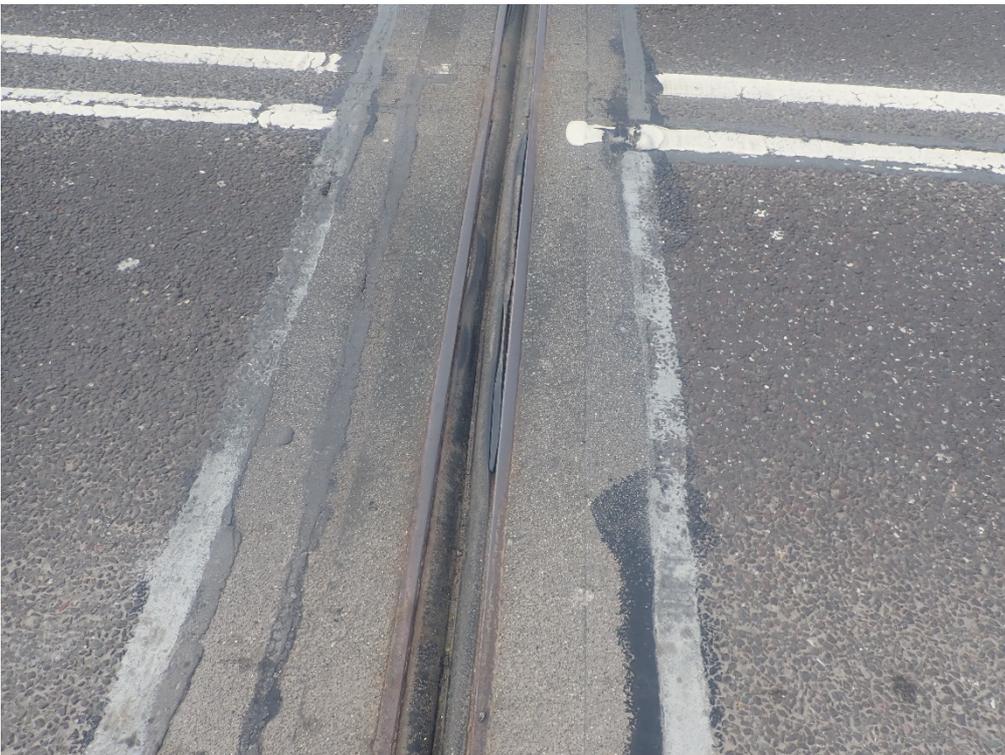
Plate 161. Corrosion to Nosing Rails of the Centre Pier Joint

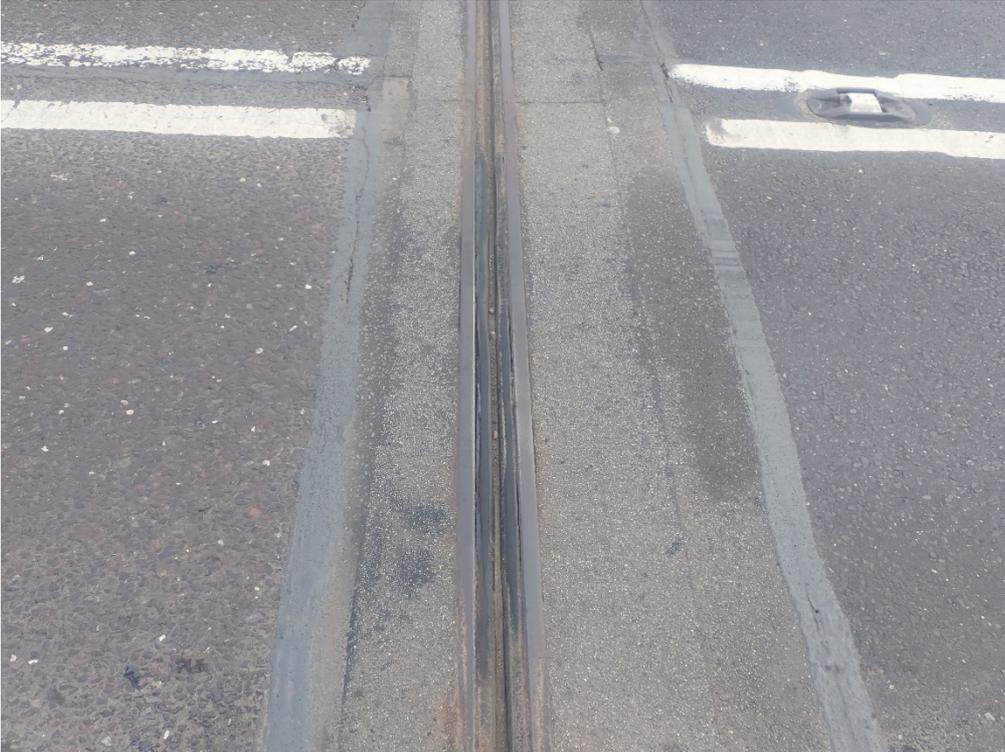
The joint seals were deformed in places across all five joints with areas visibly appearing to be detached. This was not confirmed due to live traffic. Plates 162 – 163.

Plate 162. Large Deformed Area of Joint Seal, Centre Pier Joint

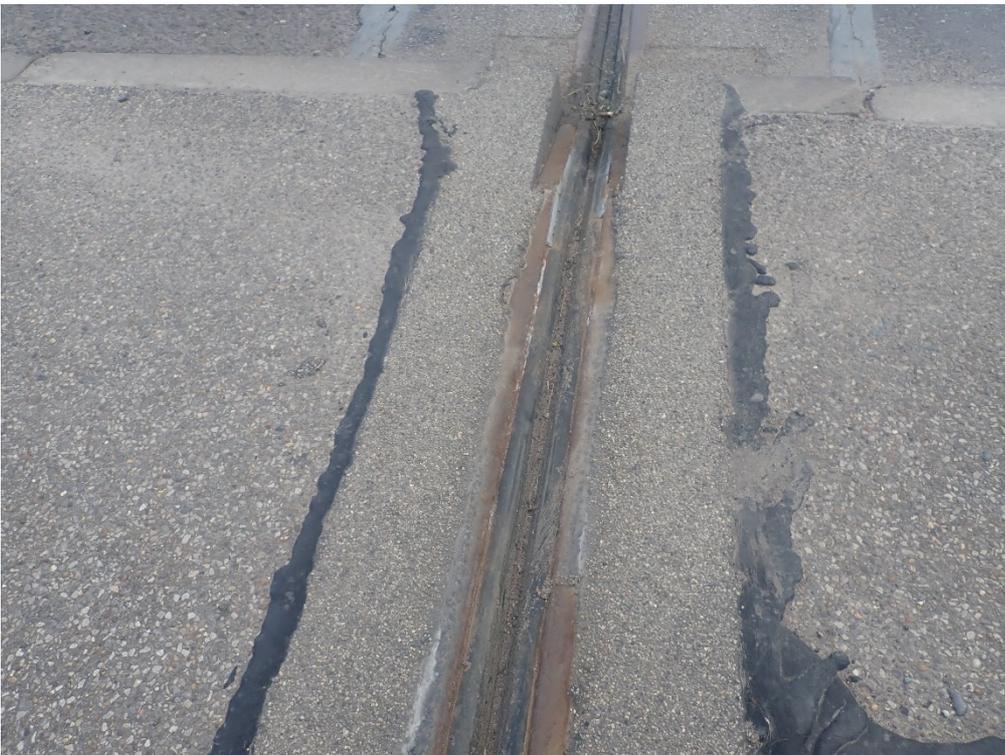
Plate 163. Deformed Seal in the East Abutment Joint
