DUNHAM BRIDGE COMPANY

APPLICATION TO REVISE TOLL CHARGES

THE DUNHAM BRIDGE COMPANY

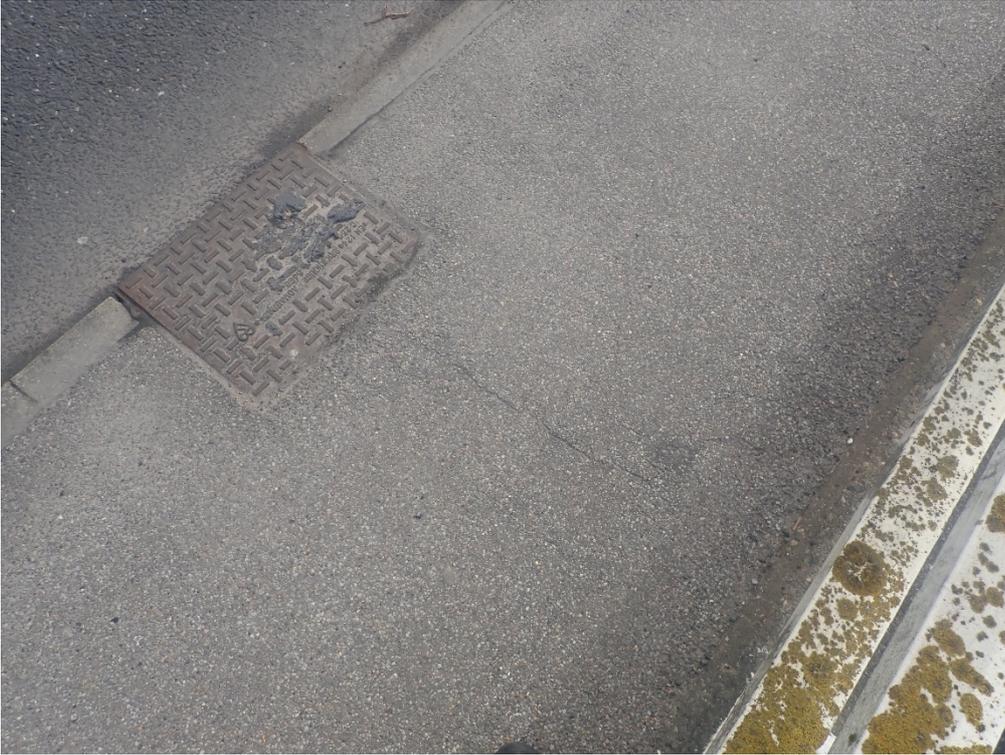
A longitudinal crack extended much of the length of the structure and was offset from the parapet edge beam by around 250mm. This gap extended at the West end where the footpath widens. Transverse cracks were found at drainage hole positions and raised bricks were also noted at drainage hole locations in the North verge. Plates 168 – 172.

Plate 170. Repair to Crack in the South Footpath

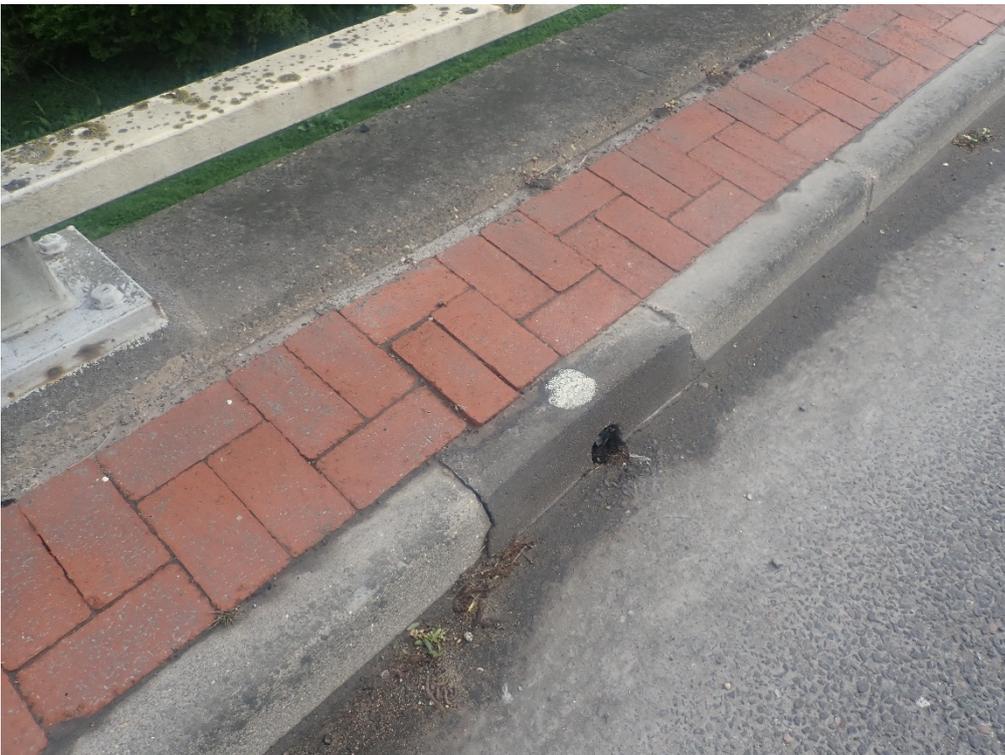
Plate 171. Transverse Crack Behind Drainage Cover in the South Footpath

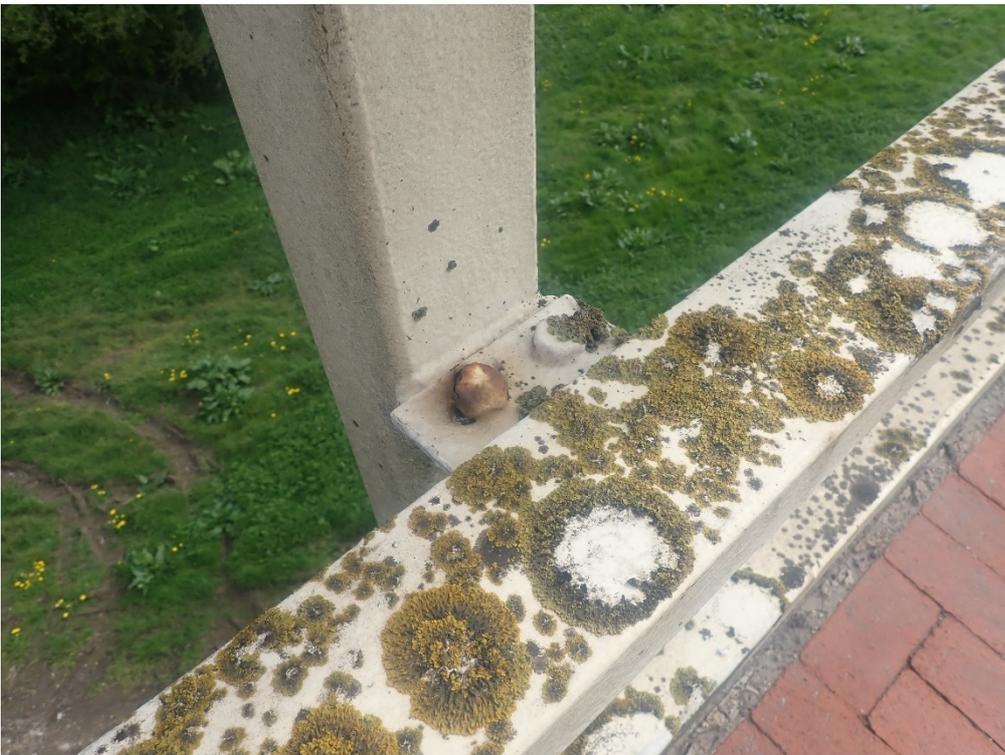
The parapets were in fair to good condition. Rust staining was common where the paintwork had failed. These areas were most common to the base plates of the parapet posts. A small number of fixings were corroded, and paint loss was noted at parapet expansion joints. Plates 173 – 176.

Plate 173. Typical Rust Staining to Parapet Post Base Plates

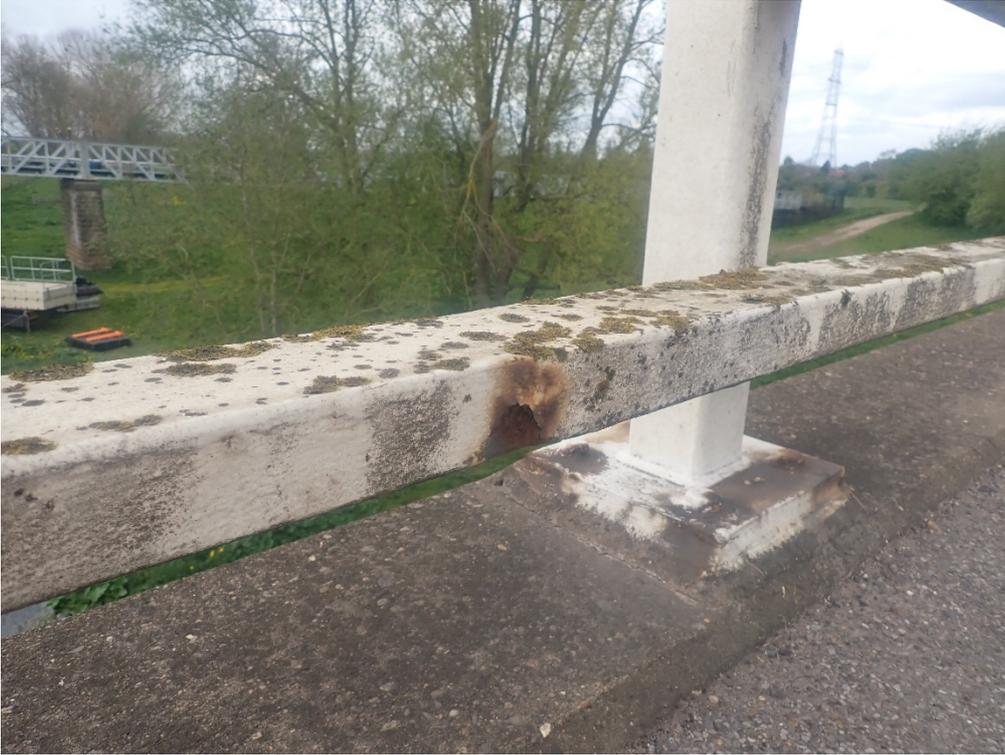
Plate 174. Typical Corrosion to Fixings Where Paint Has Failed

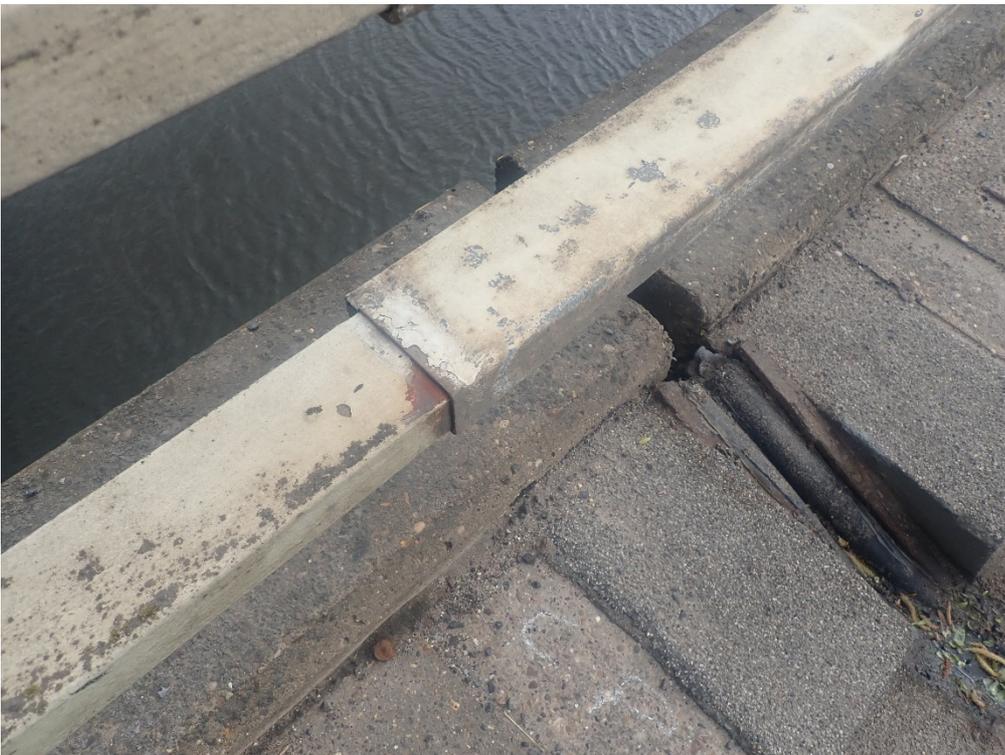
Plate 175. Typical Corrosion to Parapet Rails Where Paintwork Has Failed

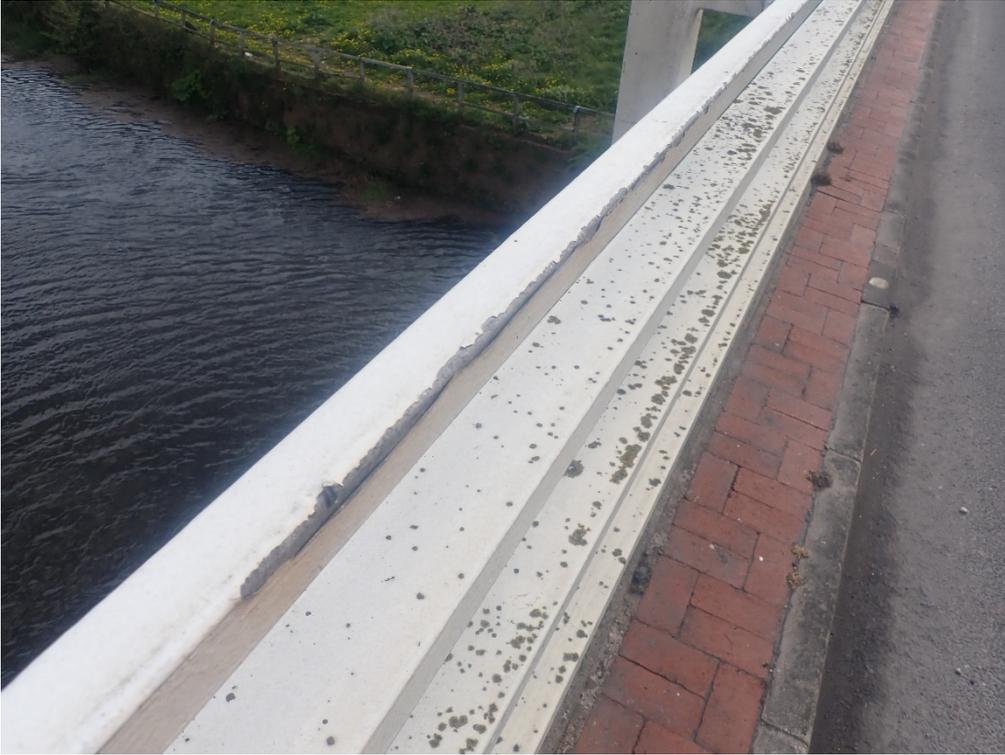
An area over 1m long was noted on the top rail of the North parapet where paint loss had occurred but had not led to any corrosion. Plate 177.

Plate 177. Area of Paint Loss to the North Parapet Where Corrosion Has Not Occurred

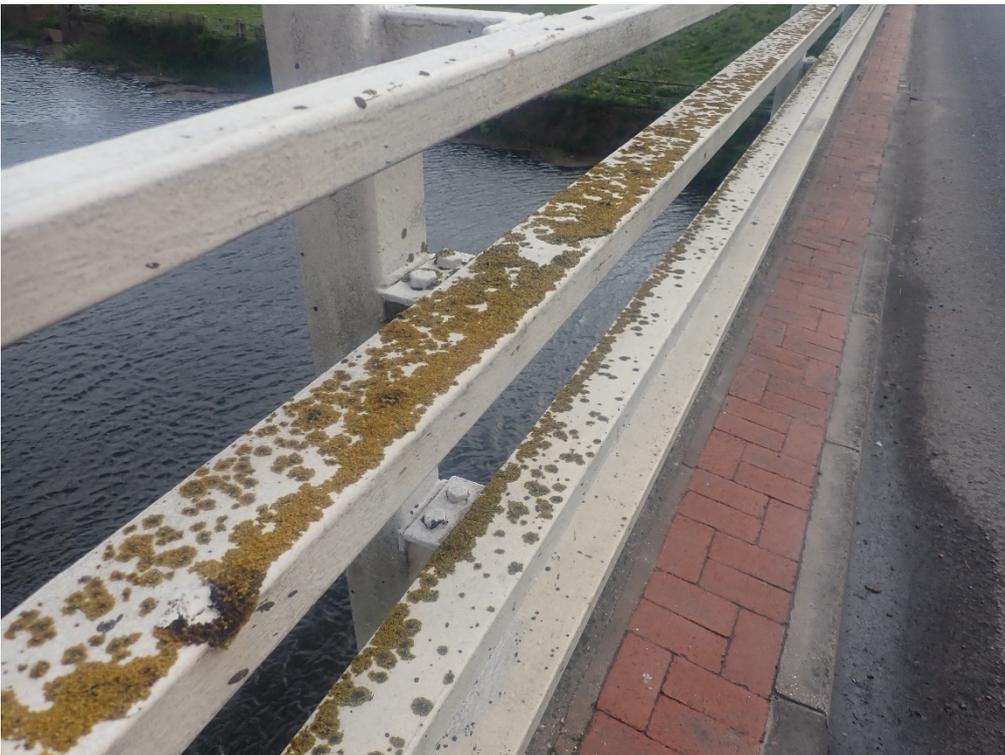
Lichen growth was common over much of the length of the parapet rails. Plate 178.

Plate 178. Typical Lichen Growth Across the Parapets

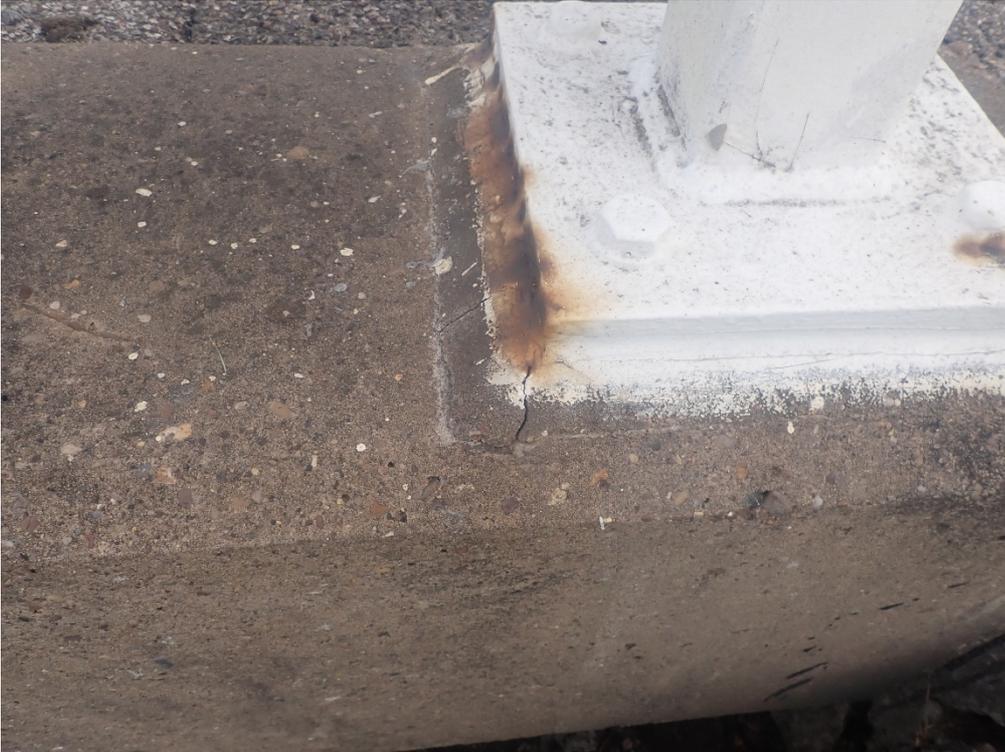
Cracking was found in several parapet post base plate plinths. Plate 179.

Plate 179. Typical Cracking to Parapet Post Base Plinths

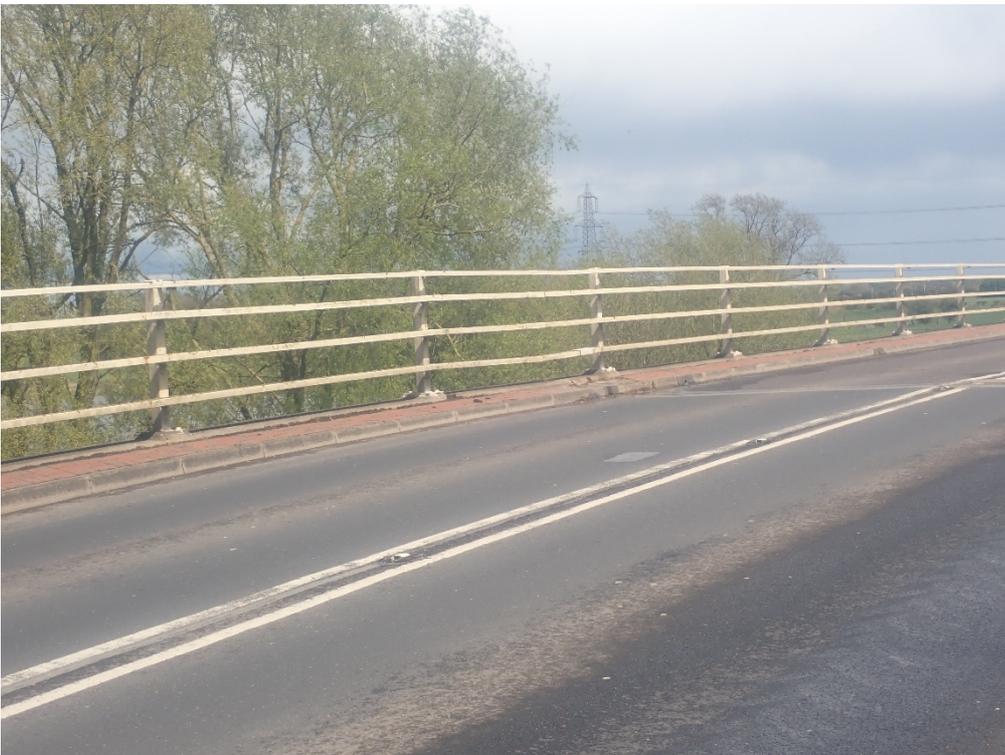
At the West end of the North parapet, particularly the bottom rail, the rails did not appear level. They were however secure when checked. Plate 180.

Plate 180. Apparent Deformation in the North Parapet at the West End

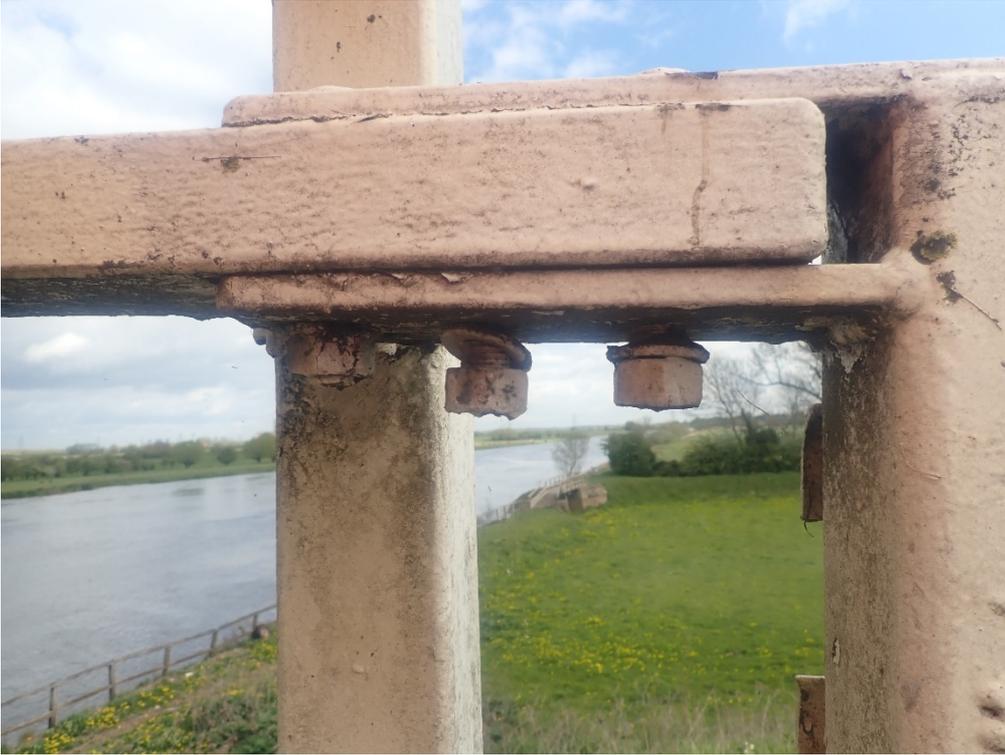
All the barriers and fences were in good condition and secure. Bolt assemblies were not fully tightened at the connection between the North parapet and the North-East barrier. Plate 181.

Plate 181. Loose Nuts on the Connection at the North-East Corner

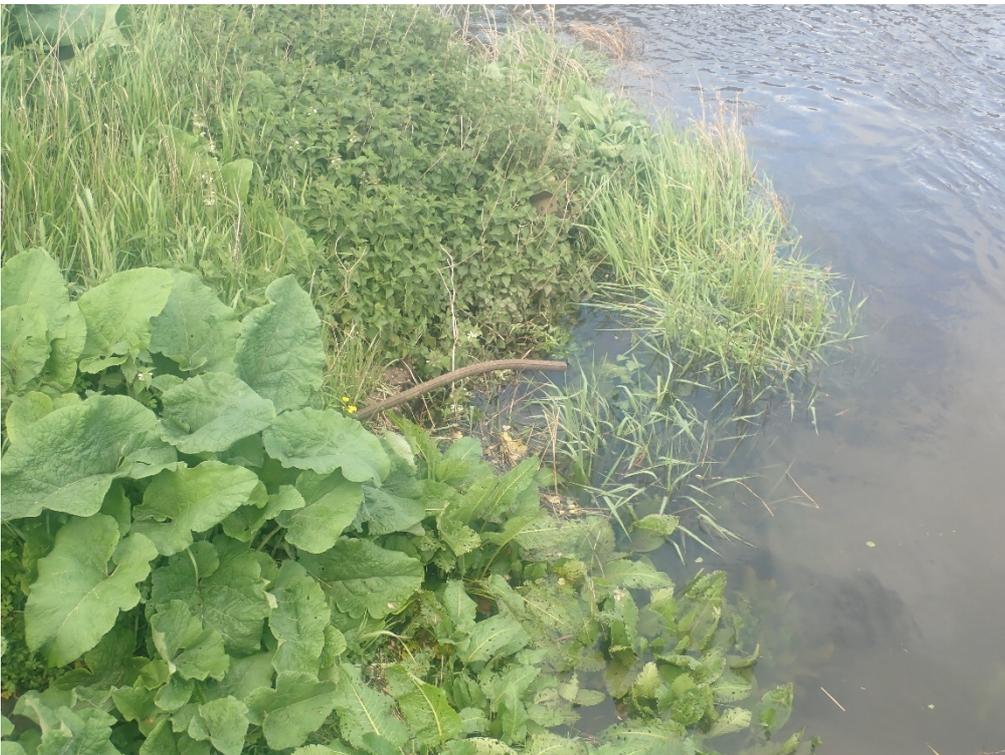
Two separate pieces of large protruding reinforcement bars were found on the West riverbank to the South of the centre pier. These could present a risk to craft using the watercourse. Whilst most craft using the navigation would be unaffected, inspection craft are at risk when inspecting close to banks. Plate 182.

Plate 182. Protruding Reinforcement from the West Bank

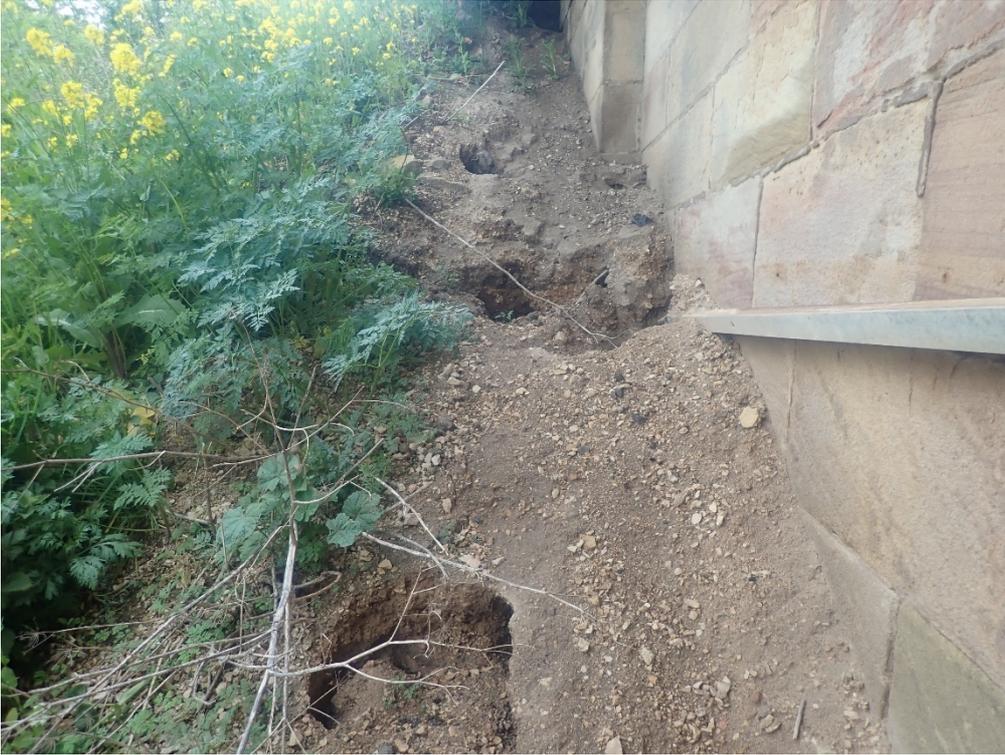
Animal burrows were regularly found on the banks adjacent to the wing walls of the structure, particularly adjacent to the North-East and South-West wing walls. Plates 183 – 185.

Plate 183. Animal Burrows on the Bank Adjacent to the South-West Wing Wall

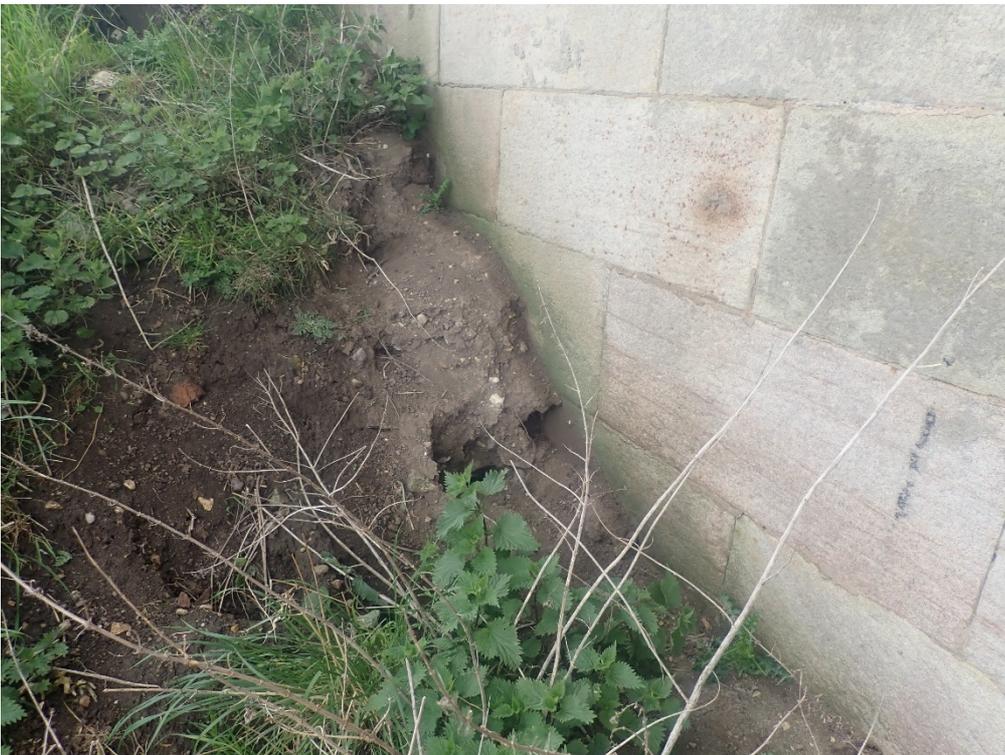
Plate 184. Animal Burrows on the Bank Adjacent to the North-East Wing Wall

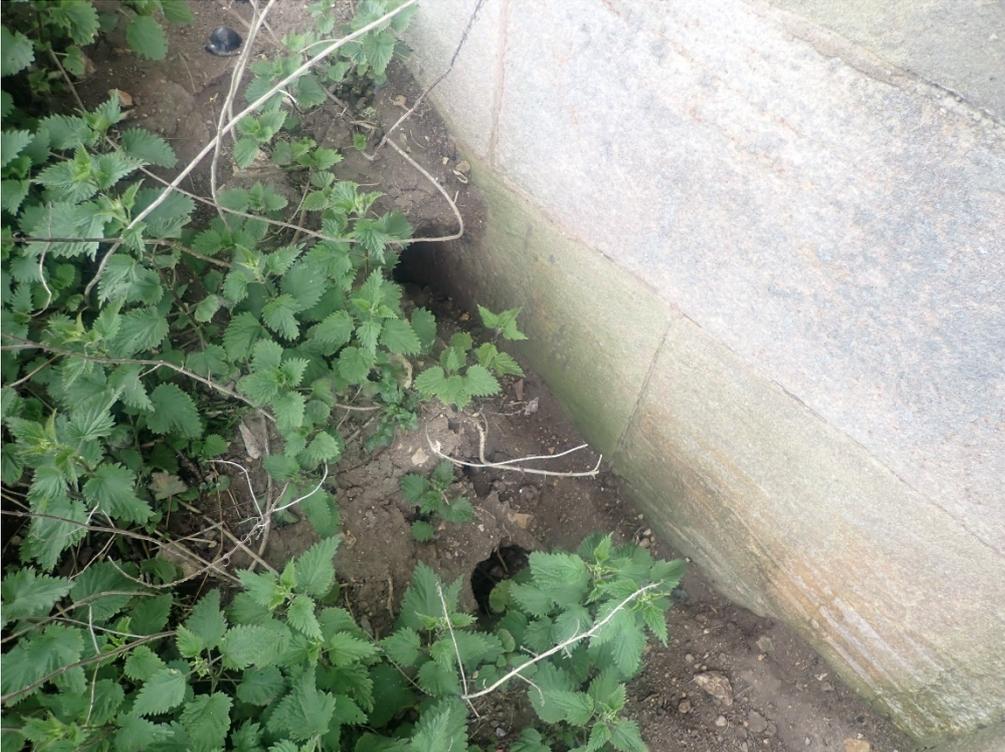
Plate 185. Animal Burrows on the Bank Adjacent to the North-East Wing Wall

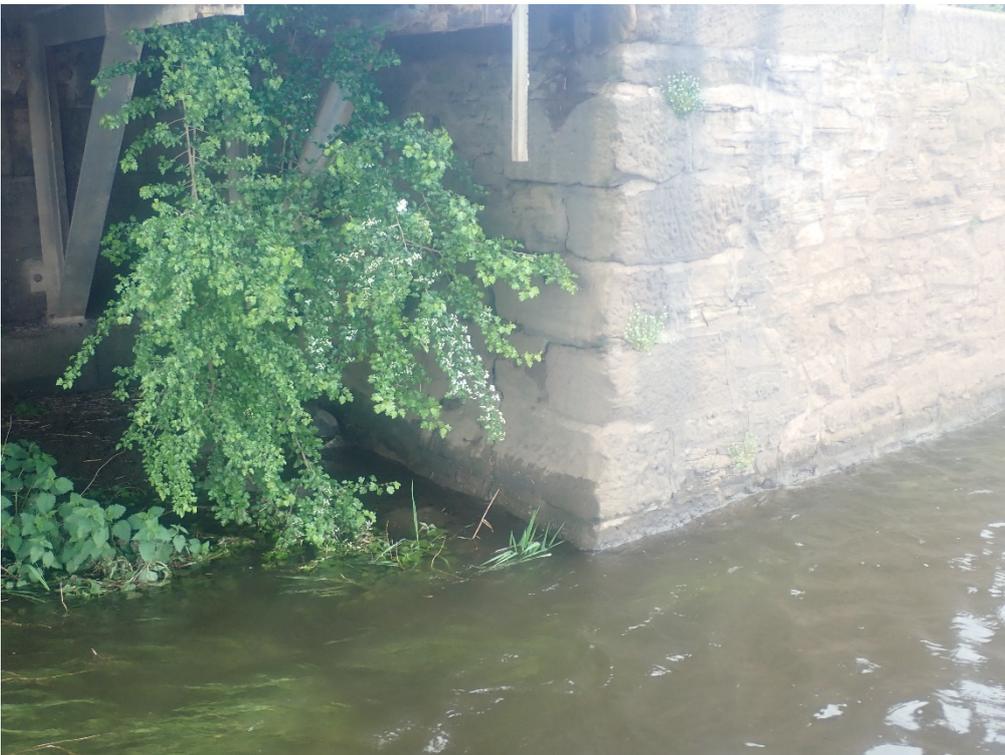
A vertical crack was visible in the North face of the South section. It was partially obscured by vegetation and difficult to access due to the position of riprap at the base of the wall. Plate 186.

Plate 186. Apparent Vertical Crack in the North Face of the South Retaining Wall

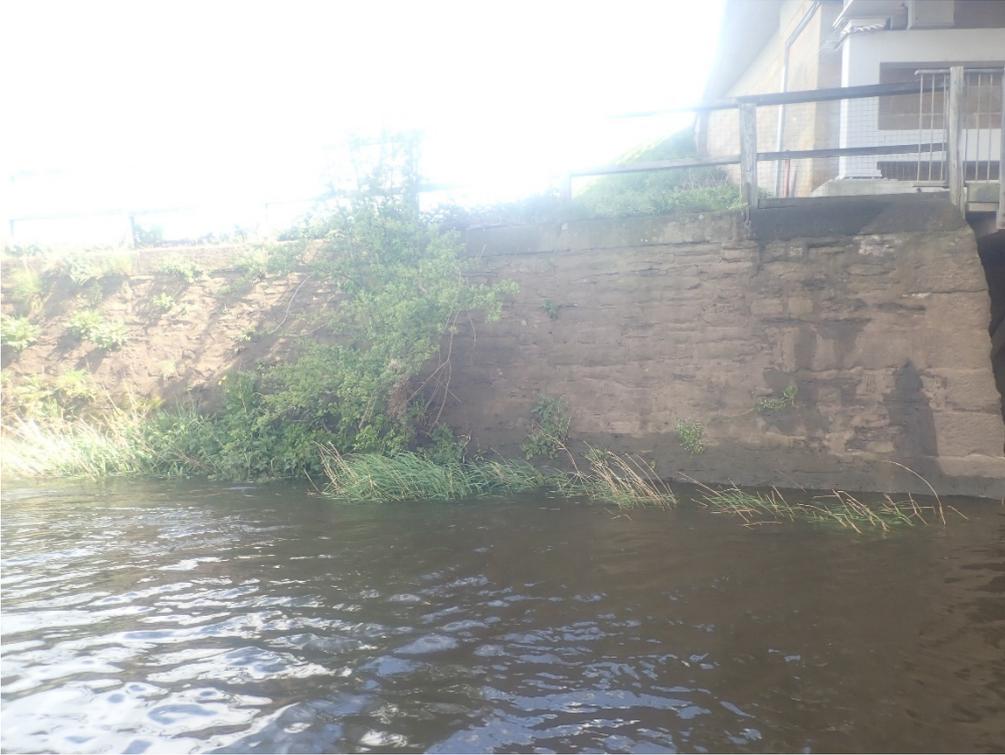
There was vegetation growth at the foot of the walls and growing from mortar joints. Plates 187 – 189.

Plate 187. Tree Growth at the Base of the North-East Retaining Wall

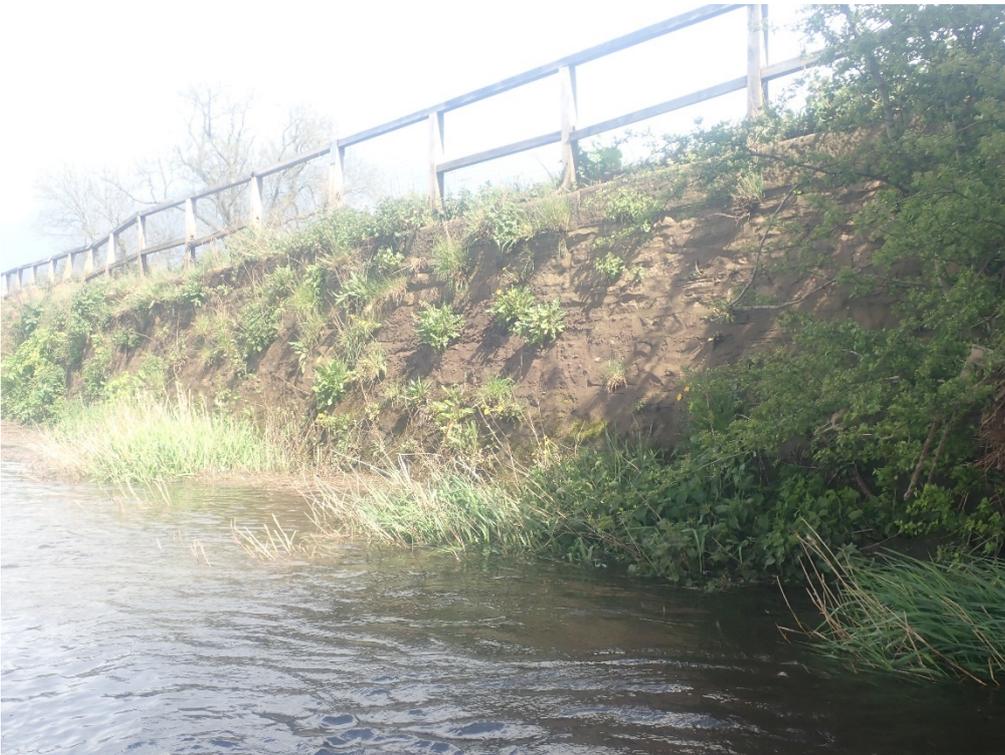
Plate 188. Vegetation Growth from the Mortar Joints of the North-East Retaining Wall

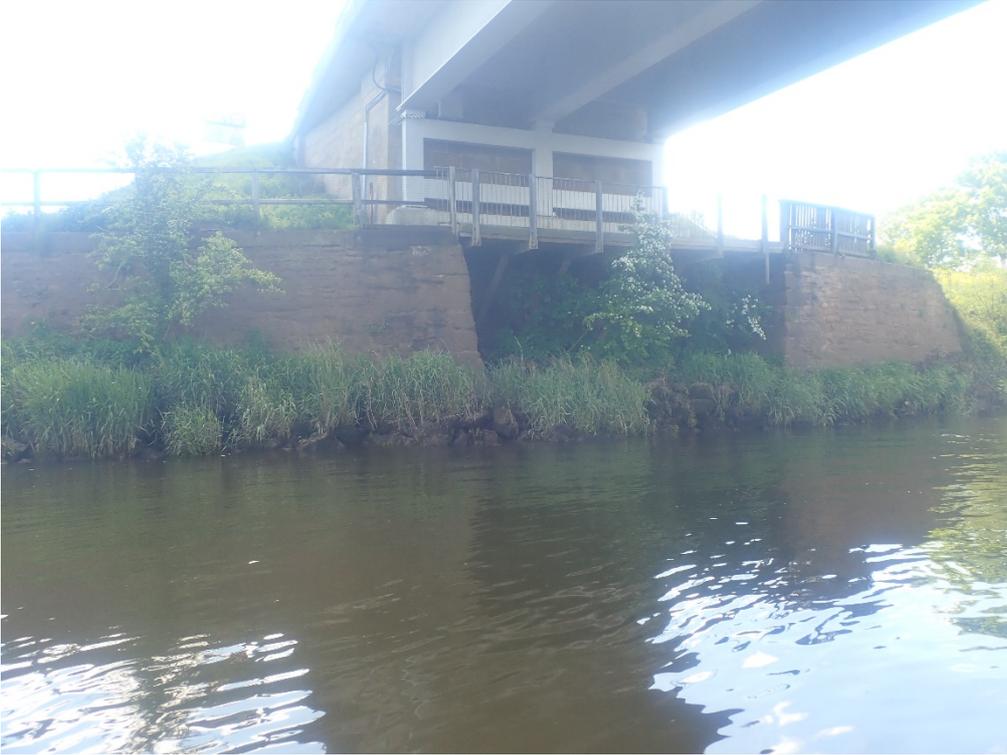
Plate 189. Tree Growth Between the Two Retaining Walls Beneath the East Abutment Walkway

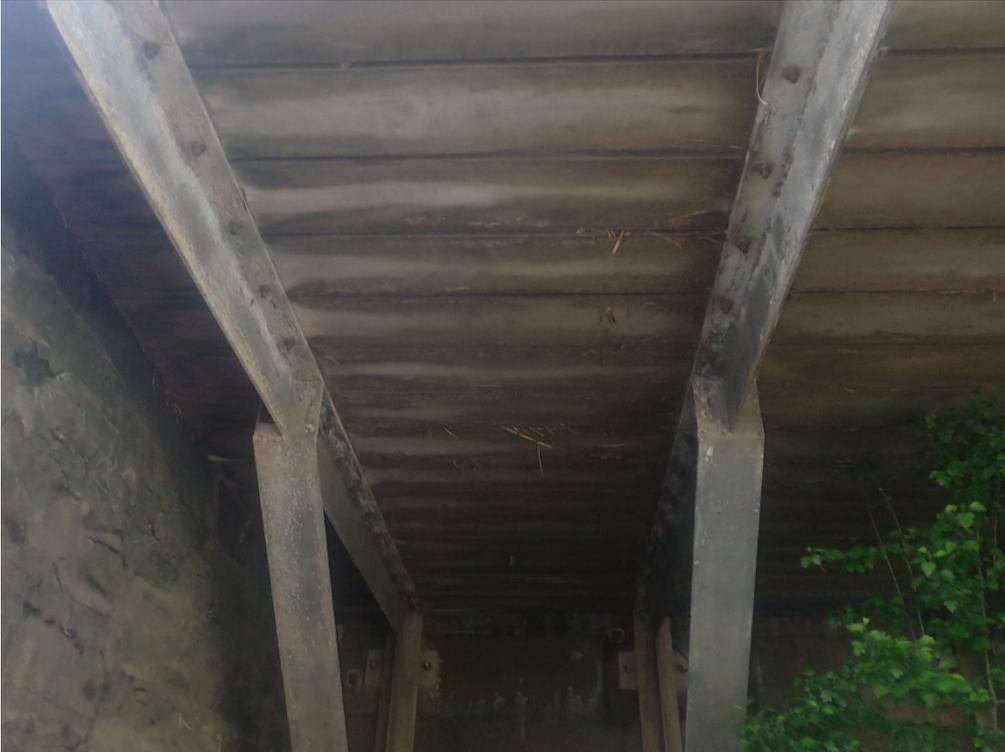
The steel support structure was in fair to good condition although surface corrosion was common across the frame and fixings where the protective paint system had failed, but no section loss was noted. Plates 190 & 191.

Plate 191. Typical Condition of Walkway Frame

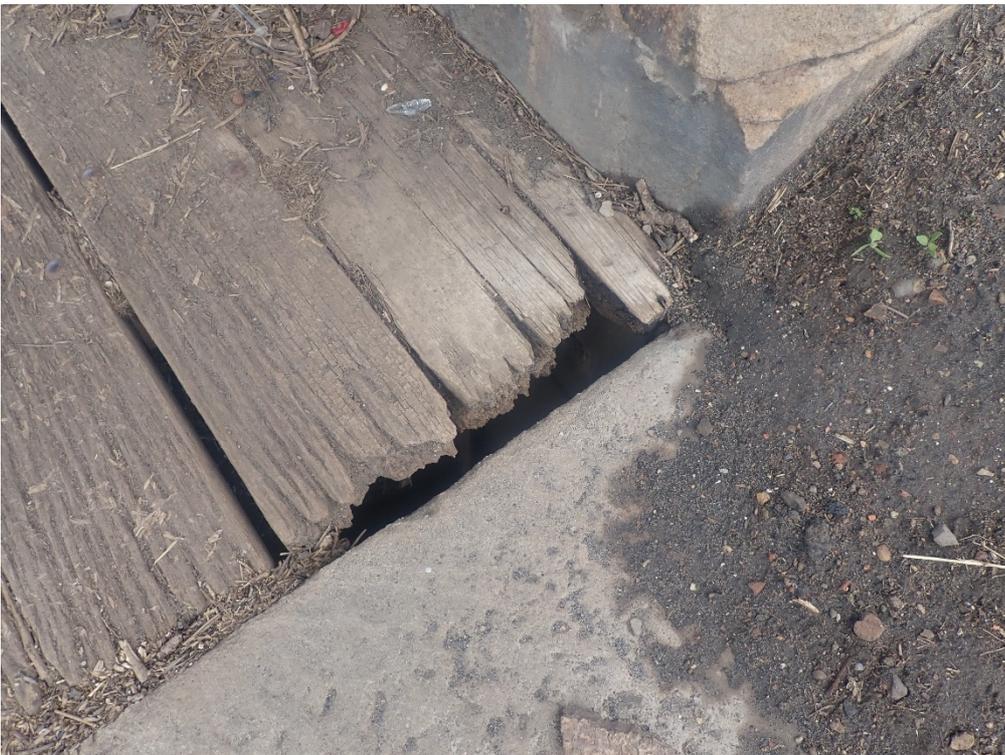
The walkway planks were rotting towards their ends creating a small gap at either end of the walkway. Plate 192.

Plate 192. Gaps Forming at End of Planks, South End of Walkway

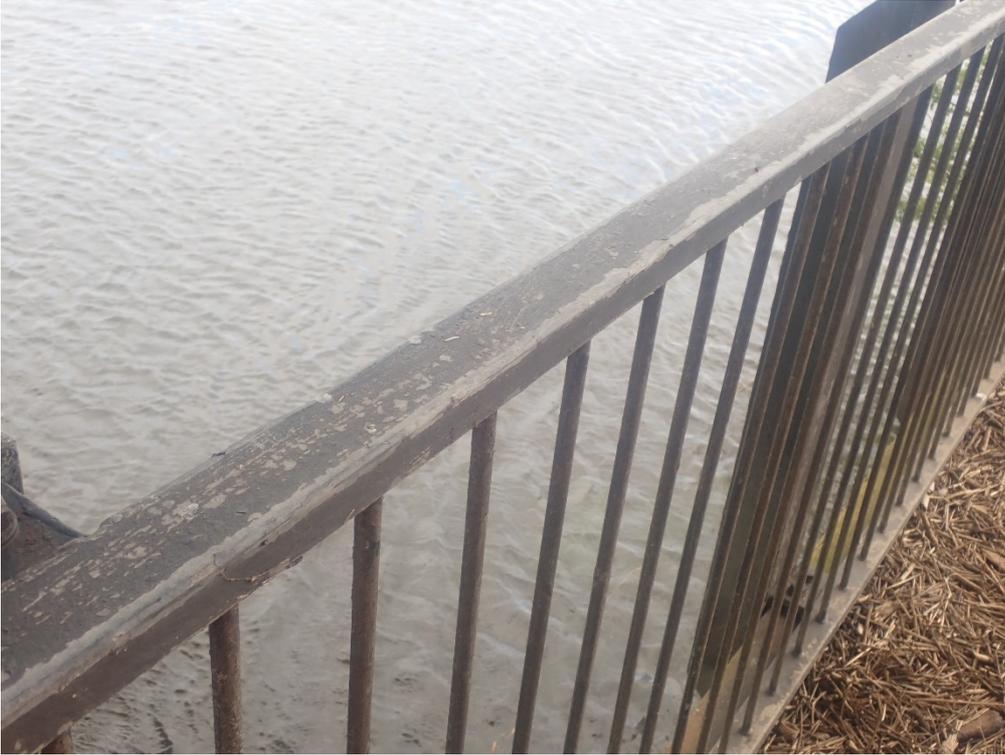
The parapet paint system had failed, and surface corrosion was common. A split in the top rail was also noted. Plate 193 – 195.

Plate 193. Failed Paintwork Across Walkway Parapet

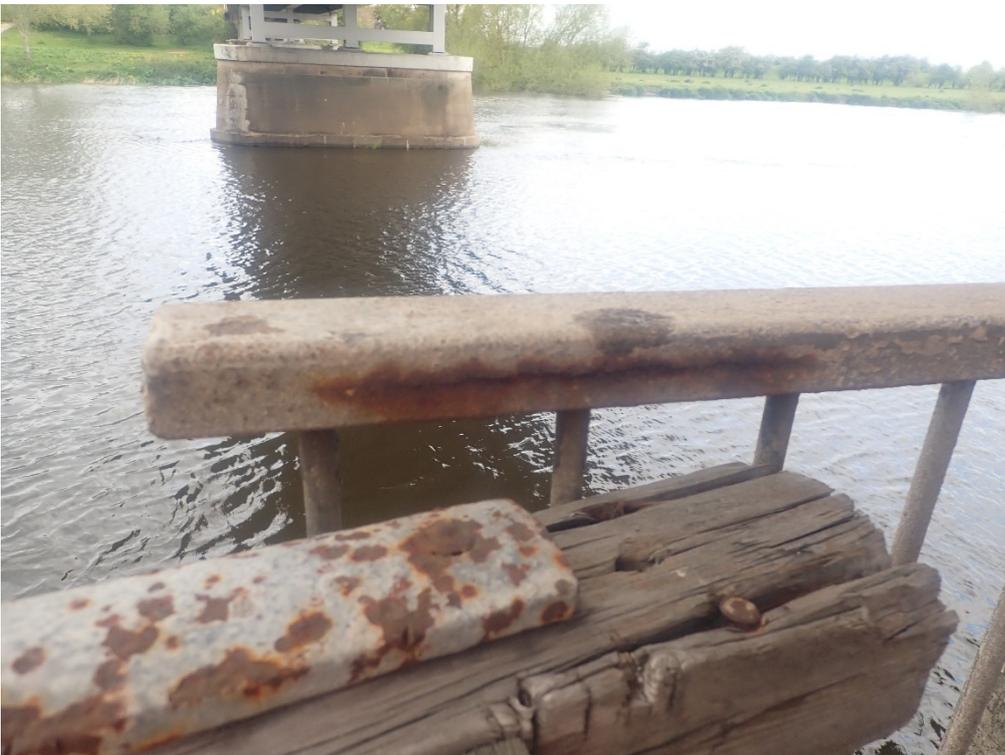
Plate 194. Split in Walkway Parapet Top Rail
